2007 Southeastern Friends of the Pleistocene Field Trip Guidebook

September 30, 2007

# Investigation of the Peeks Creek Debris Flow of September 2004 and Its Relationship to Landslide Hazard Mapping in Macon County, North Carolina

Rebecca Latham, Rick Wooten, Anne Witt, Ken Gillon, Tommy Douglas,  
Stephen Fuemmeler and Jennifer Bauer  
North Carolina Geological Survey, Swannanoa, North Carolina

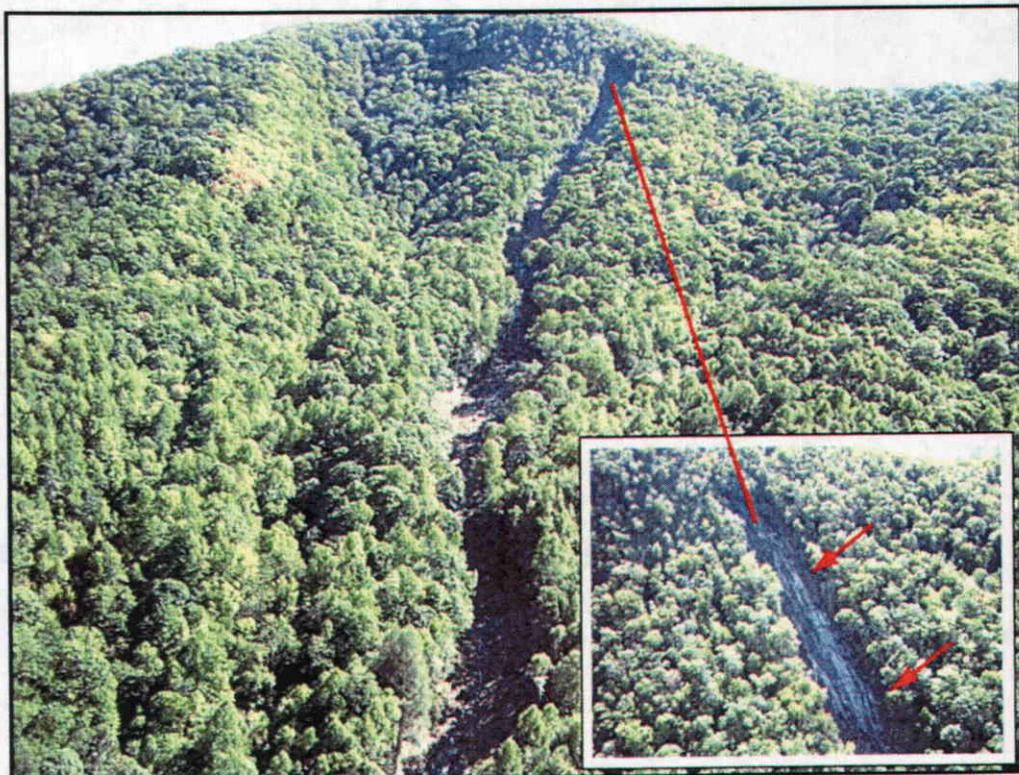
**Figure 1:** Initiation zone (shown in inset) and upper track of the September 16, 2004 debris flow on Fishhawk Mountain.

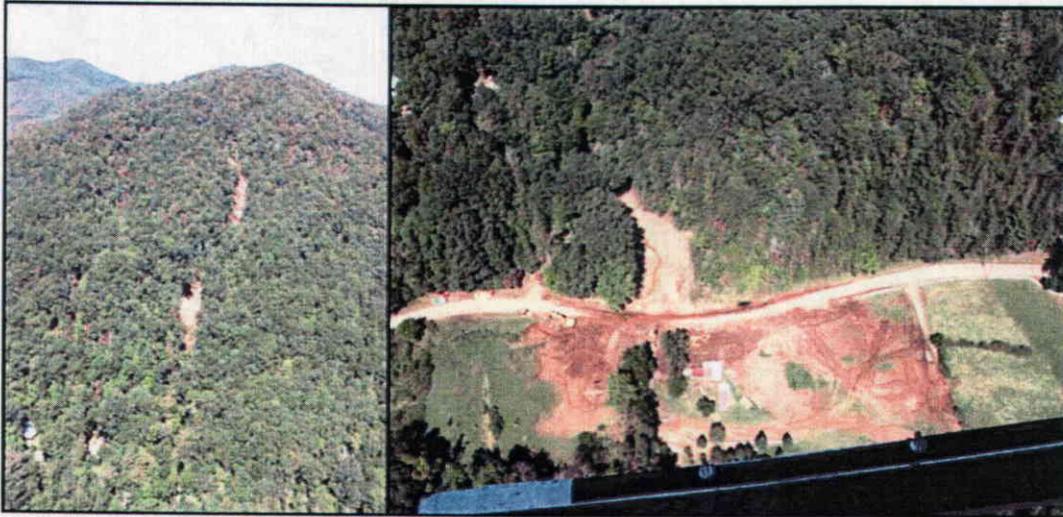
**Figure 6.** Wayah 1 debris flow triggered in 2004 by Hurricane Ivan (Photos courtesy of U.S. Forest Service-Coweeta Hydrologic Laboratory). Photo at left shows the initiation zone and upper portions of the track. Photo at right shows the debris flow deposit that blocked the road and destroyed a barn.

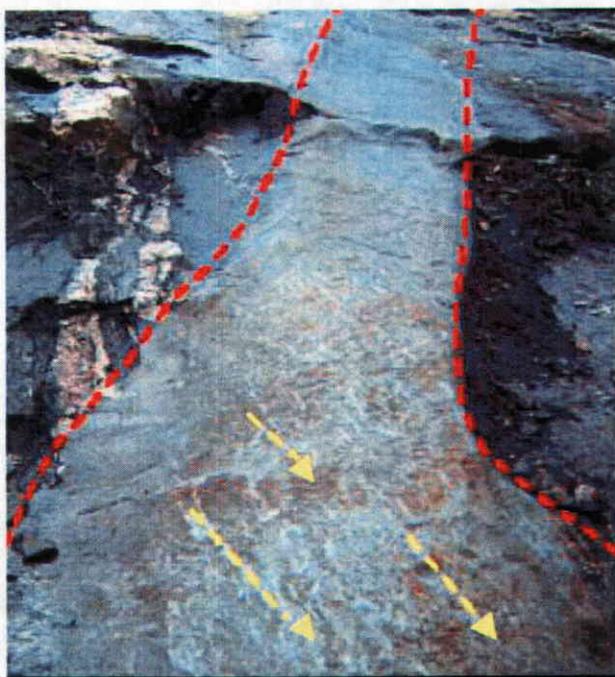
**Figure 12.** One of two tonalite-trondhjemite dikes that crosscuts the foliated metagraywacke exposed in the initiation zone. The arrows show the direction of the grooves created by the rock fragments in the sliding soil mass.

The Peeks Creek debris flow most likely began as a debris slide. Parallel scratch marks caused by rock fragments in the colluvial soil moving over the bedrock surface indicate that movement was in one direction as opposed to the turbulent motion associated with a debris flow (figure 12). The initial debris slide was approximately 75 feet wide, 350 feet long, and about 3 feet thick (figure 22, point 1 in figure 23). It quickly began to mobilize into a debris flow as water was added to the system. Erratic impact marks observed on bedrock in the debris flow track indicate that the material transformed into a debris flow and/or hyperconcentrated streamflow. The existence of a superelevation angle across a channel bend at section K-K' approximately 1,700 feet below the headscarp confirms that the transformation to flow had already occurred at that point.

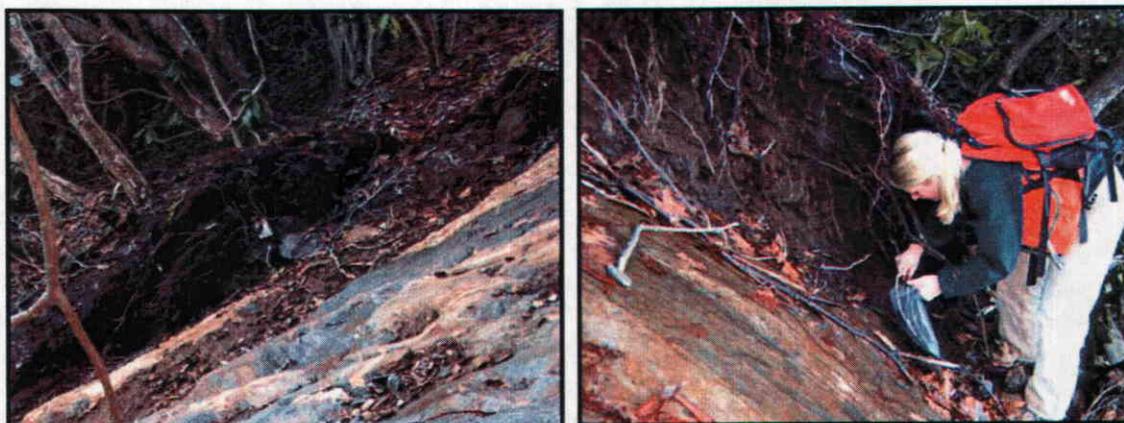
**Figure 13.** Soil in the initiation zone of the debris flow. Soil here is generally less than three feet thick and is in sharp contact with the steeply dipping ( $35-55^{\circ}$ ), underlying bedrock.

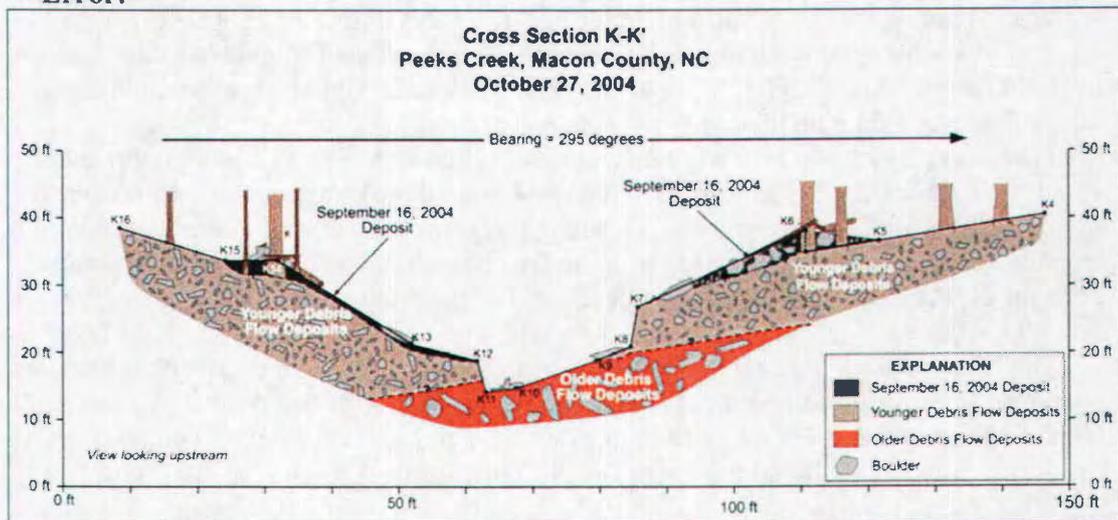
In the upper portion of the debris flow track, at least two generations of ancient debris flow and colluvial deposits are exposed. These consist of crudely imbricated, weathered boulders in a silty-sand/sandy-silt matrix. These deposits have been documented by cross sections of the upstream flow track (figures 15 and 16). The location of the K-K' cross section is shown later in the text in figure 32. In the lower third of the debris flow track, preexisting stream deposits are concentrated in the channel, and colluvium is located on the side slopes.

**Figure 15.** Cross-section in upper portion of the debris flow track showing older debris flow and colluvial deposits.

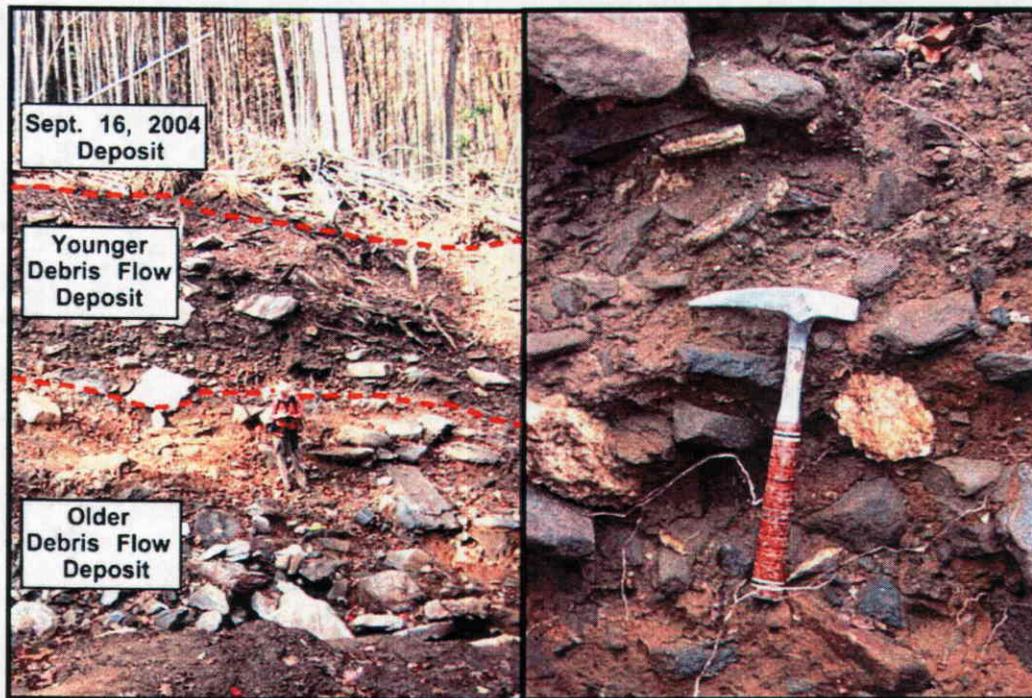
**Figure 16.** Multiple debris flow deposits exposed in the modern Peeks Creek debris flow track. Note crude imbrication and alignment of clasts in pre-2004 deposits in right photo.

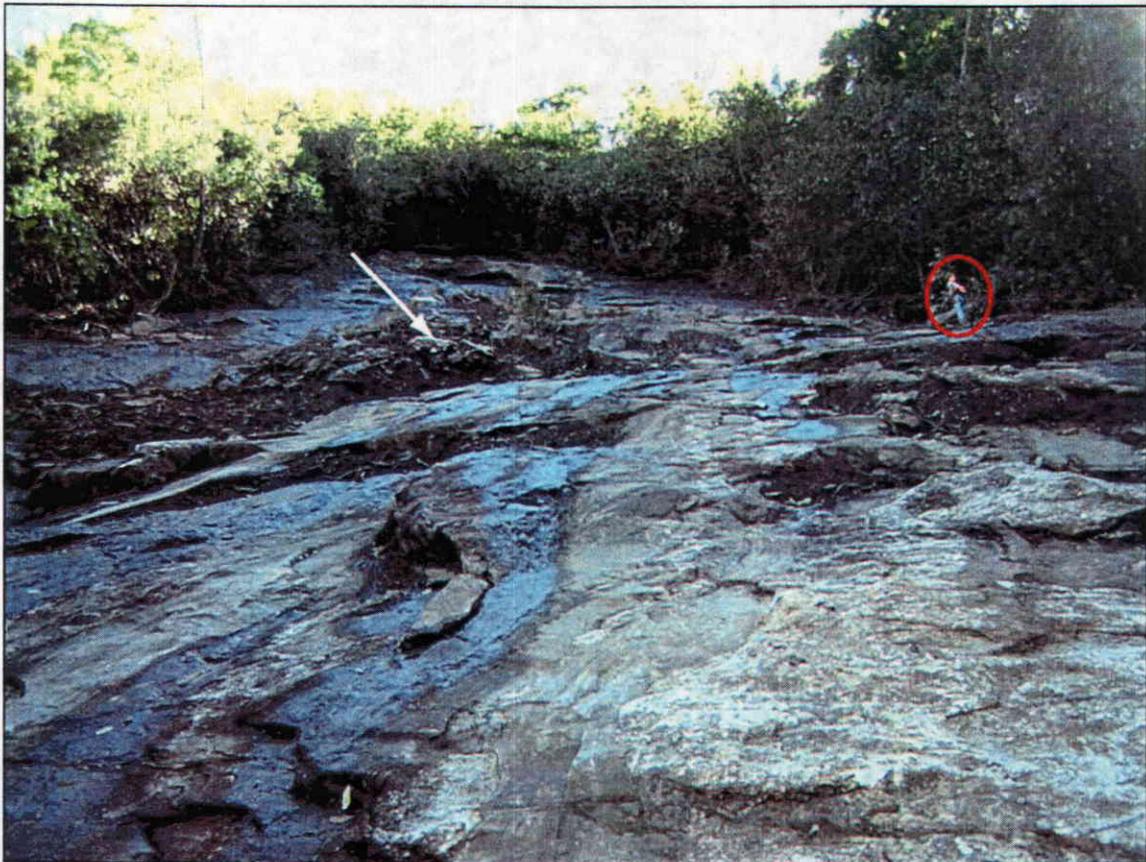
**Figure 22.** Looking uphill at the head scarp created by the debris slide. Arrow points to patch of colluvium not removed by the initial slide. Note person, circled in red, for scale.

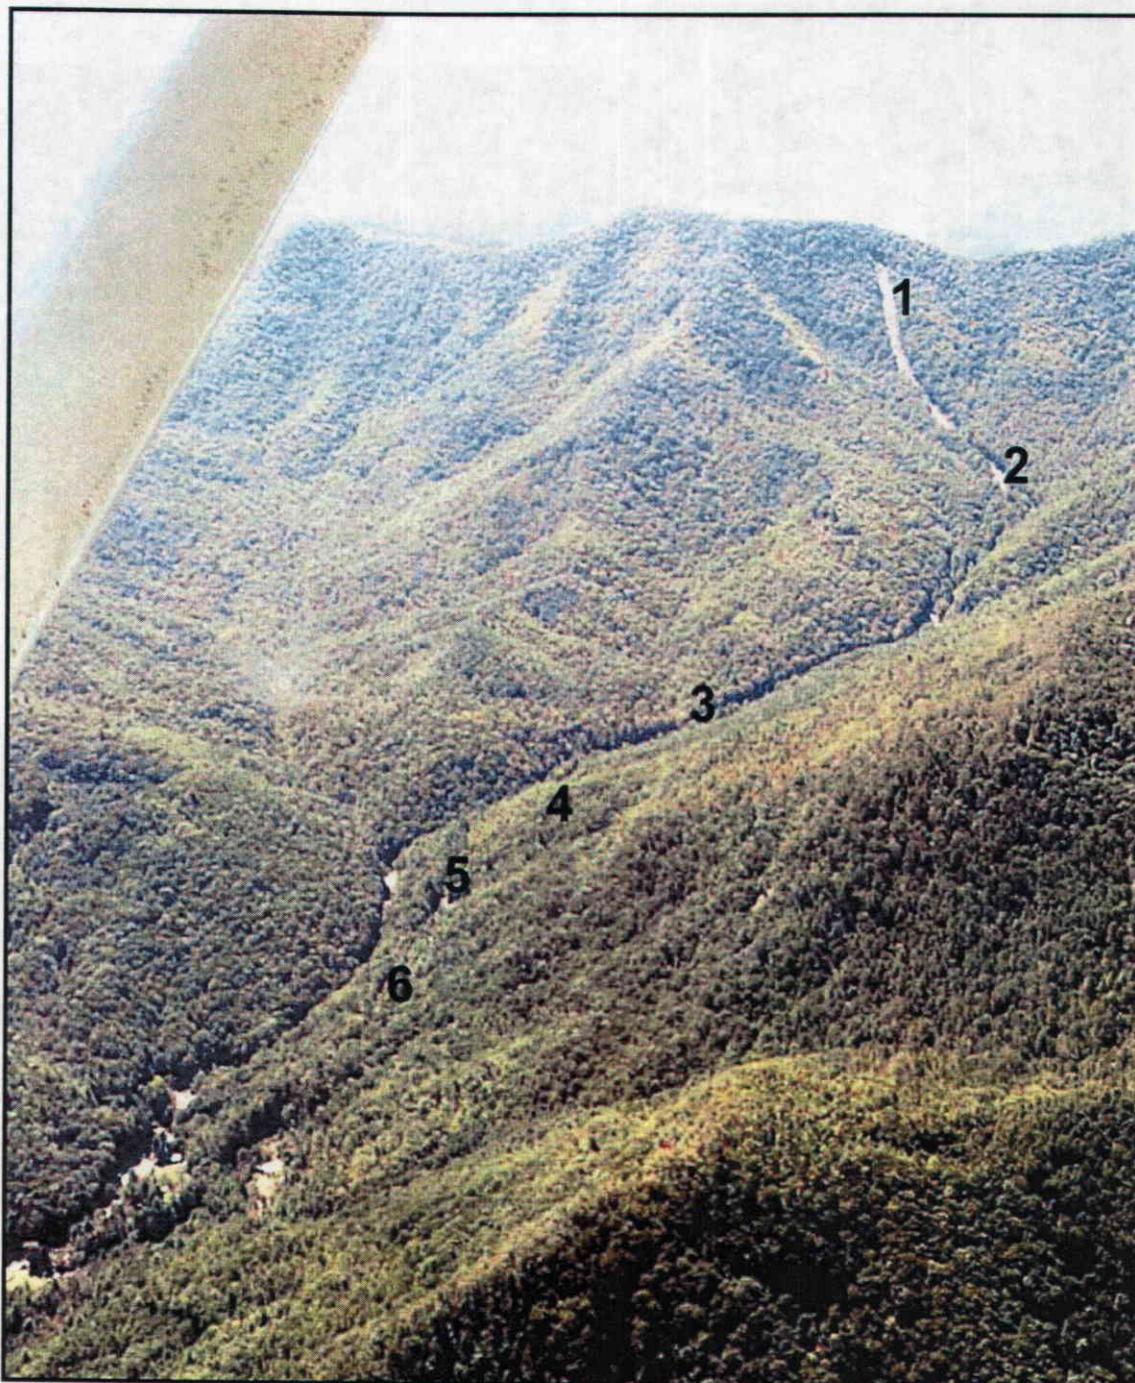
Downstream from the broad, flat area is a 0.6-mile, steeper, more incised portion of the track that ends just upstream of the Peeks Creek community (point 4 on figure 23). The upper boundary of this section is near the confluence of the North Fork of Peeks Creek with the main Peeks Creek channel. There are two side slope failures (figure 25) in this section that originated from Fishhawk Mountain Road on the north side of the stream channel. The

upstream failure appears to have been related to poor drainage along the road (point 5 on figure 23). Tension cracks and scarps continue to develop along this portion of the roadway. The downstream failure began as an embankment failure that quickly scoured the steep bedrock surface that leads down to the creek (point 6 on figure 23). It is possible that both these embankment failures created temporary debris dams along Peeks Creek before the main debris flow occurred, however any evidence for this was destroyed by the main debris flow. At the end of this section, the channel takes a nearly right angle turn to the north just before entering the Peeks Creek community. As the material in the debris flow rounded the bend, the woody debris was skimmed off the top and slammed into the house shown in figure 26. The house was pushed several feet off its foundation. Fortunately the woman inside did not sustain any major injuries. Major damage to homes began below this section and continued along the last quarter of the track.

**Figure 23.** Aerial view looking southwest at the Peeks Creek debris flow track. Numbered points refer to locations described in the text. Photo from Macon County News & Shopping Guide, September 23, 2004 issue

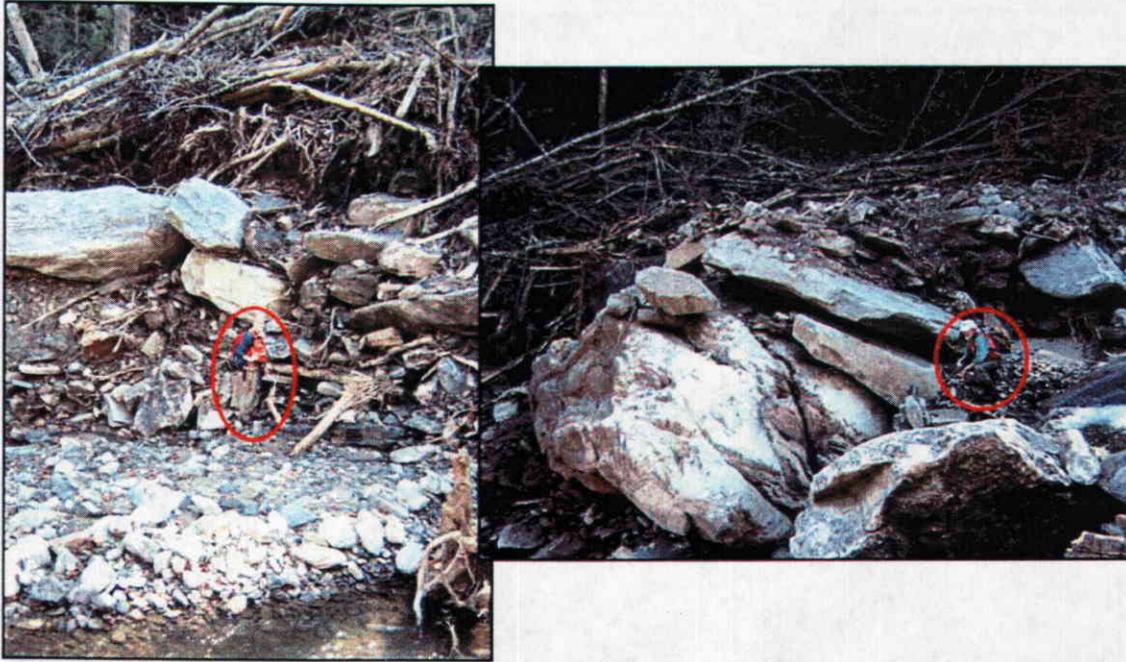
**Figure 24.** Imbricated boulders with woody debris deposited on top. Note people (circled in red) in each photo for scale.

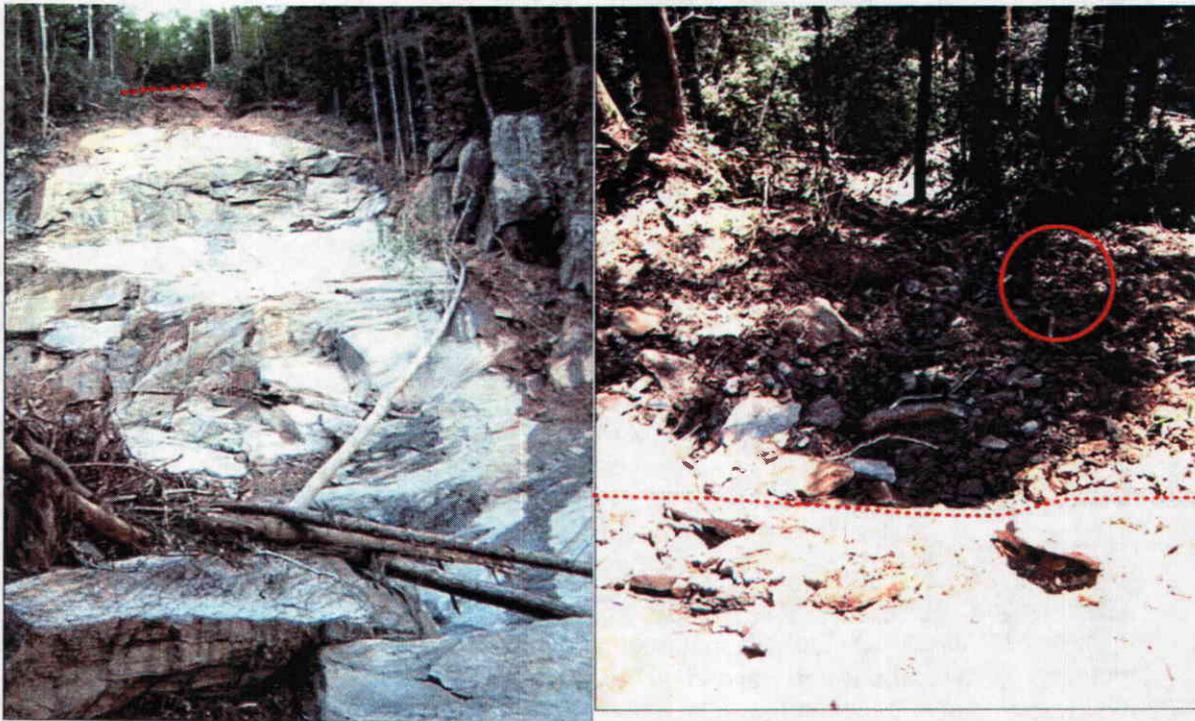
**Figure 25.** Embankment failures along Fishhawk Mountain Road upslope of the steep, incised portion of Peeks Creek. Photo at left is looking upslope from Peeks Creek at one of the failures. The red line indicates the location of Fishhawk Mountain Road. Photo on right is looking downslope from Fishhawk Mountain Road toward Peeks Creek at the second side slope failure. The red line indicates the edge of the road.

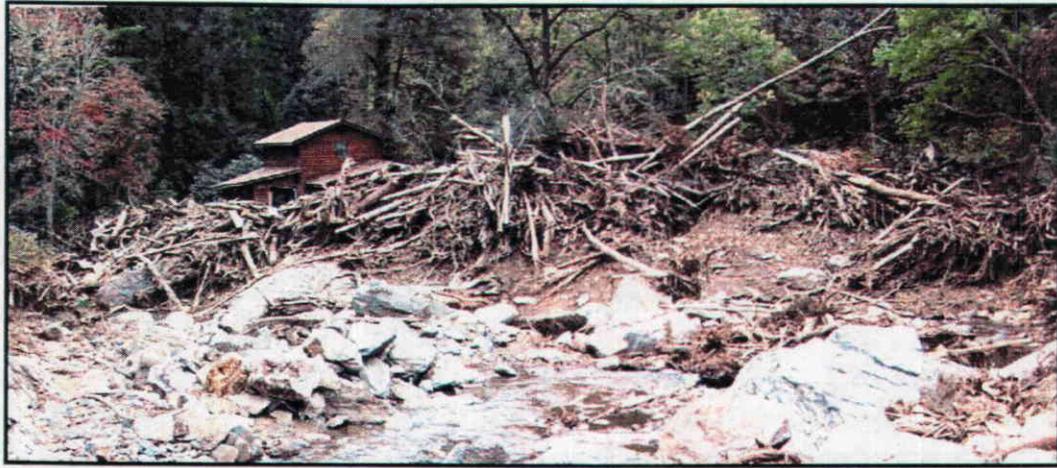
**Figure 26.** Base of the steep incised section of the channel in the lower portion of the debris flow track just upstream of the Peeks Creek community. The house in the left center was pushed several feet off its foundation by the woody debris (located about 500 feet below section H-H' in figure 32).

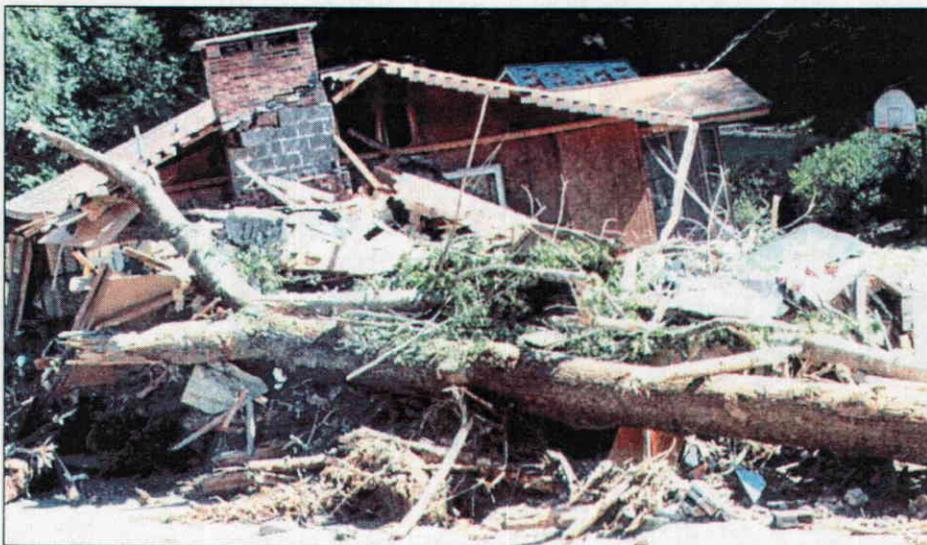
The Peeks Creek community was devastated by the debris flow. Several homes were pushed off their foundations. Figure 27 shows the Jones' residence displaced 30-40 feet downstream and debris that accumulated on the upstream side. Just before the debris flow, Mr. Jones was leaving for work and started down the road in his truck but stopped and returned to his house. He and his wife heard the flow coming down the valley and scrambled up the bank just before their house was destroyed (personal communication with Marilyn Jones, 2006). The debris flow moved another small house nearly 500 feet downstream where it collided with the Morris residence (figure 28). A woman inside the house at the time survived the ordeal with no major injuries (Lewicki, 2004).

**Figure 27.** Jones residence destroyed by debris flow (Photo courtesy of Marilyn Jones).

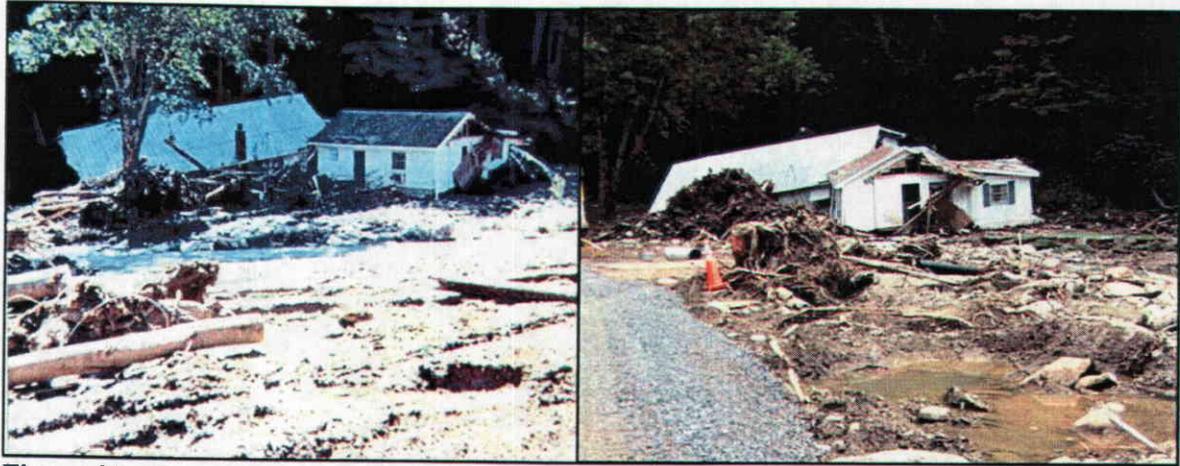
**Figure 28.** Two views of smaller house that moved 500 feet before colliding with the Morris' residence. Photo on left shows the valley before construction of the temporary road shown in the photo at right.

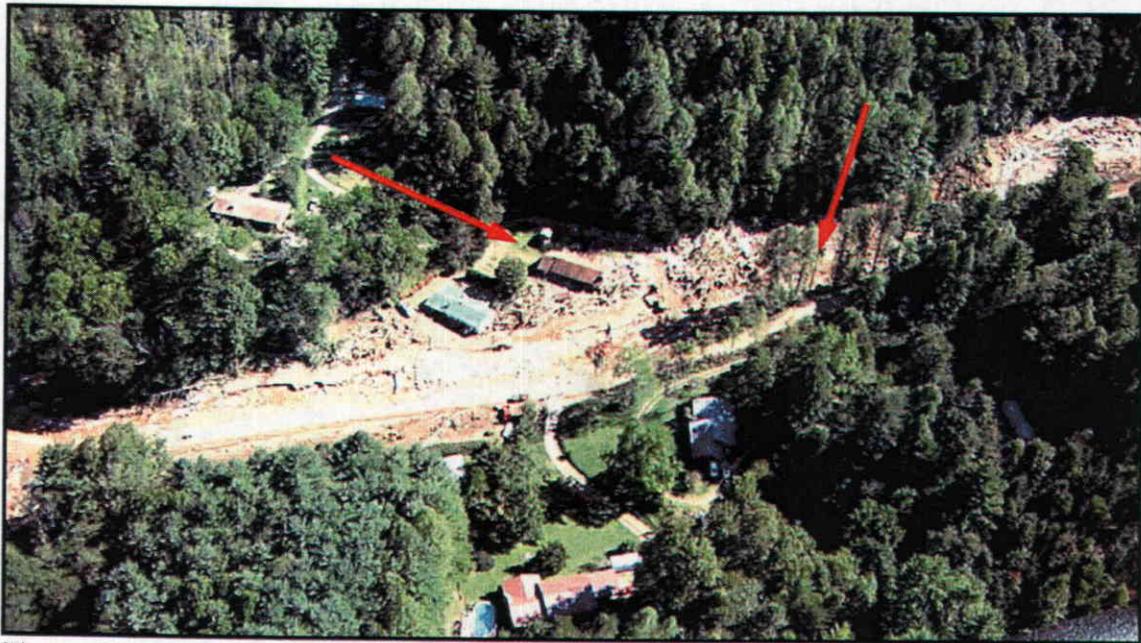
Other homes were completely destroyed. In all, five people were killed, and two others sustained serious injuries. Fifteen homes were destroyed, and most, if not all, of this property damage was not covered by insurance. Aerial photos of the Jones residence and the location of three of the fatalities are shown in figures 29 and 30. The home with the three fatalities was completely destroyed by the debris flow.

**Figure 29.** Aerial photo of debris flow damage. The red arrow on the left points to the Jones' residence, and the red arrow on the right points to the location of the three fatalities.

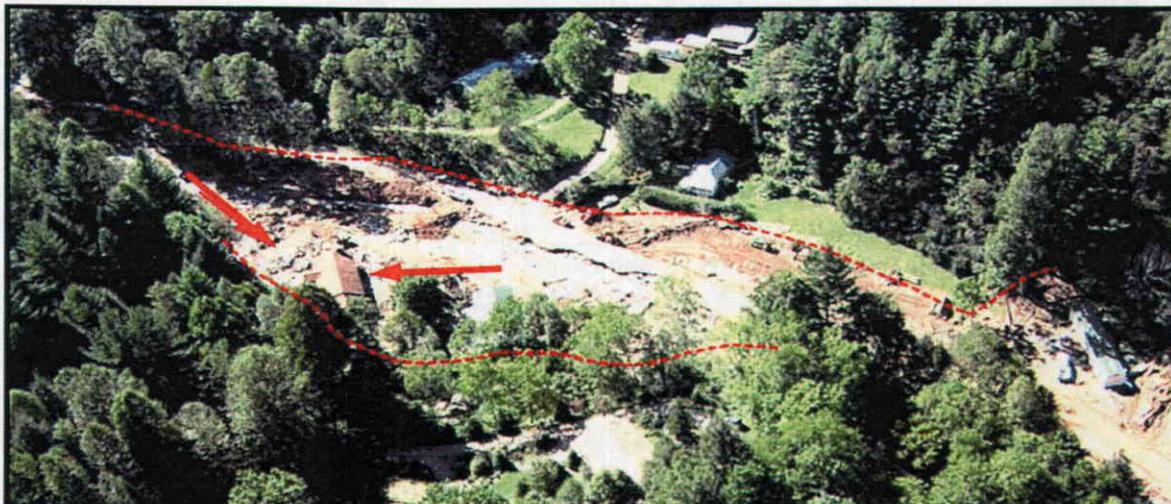
**Figure 30:** Aerial photo of some of the damage. The red arrow on the left points to the location of the 3 fatalities, and the red arrow on the right points to the Jones' residence. The red line indicates the boundary of the debris flow track. The main road was destroyed and the Creek cut a new channel.

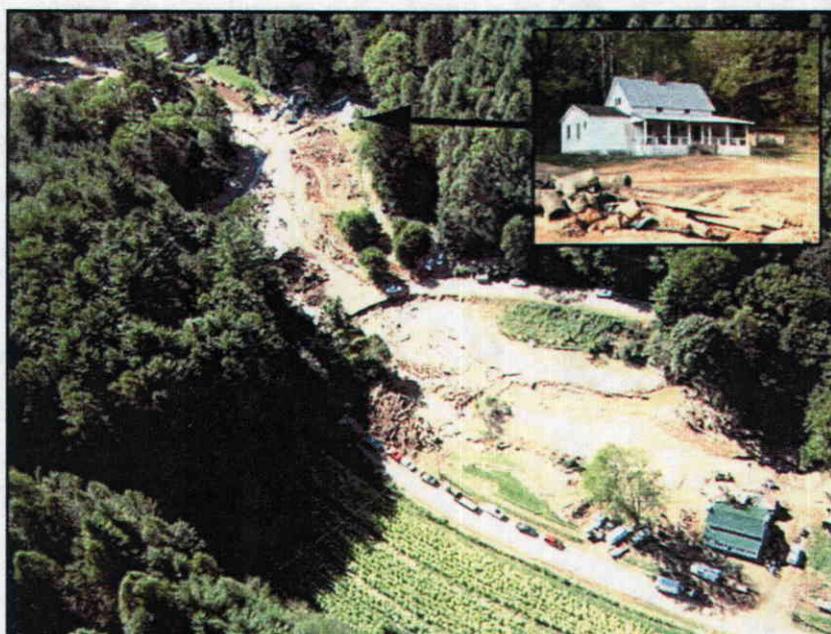
Not all of the houses in the Peeks Creek Community were destroyed. Several of the homes suffered only minimal damage. An aerial photo of the valley just downstream from the above images (figures 29 and 30) is shown in figure 31. The white house shown in the inset had a few mud splatters on it but was not damaged. The arrow points to its location in the air photo. Setbacks from the Creek could have reduced damage and possibly saved lives. The house with the green roof in the bottom right of the photograph is where some partial remains were reportedly found.

**Figure 31:** Aerial photo of lower part of valley showing house in floodplain that experienced only minor damage from the debris flow. This shows the value of setbacks.

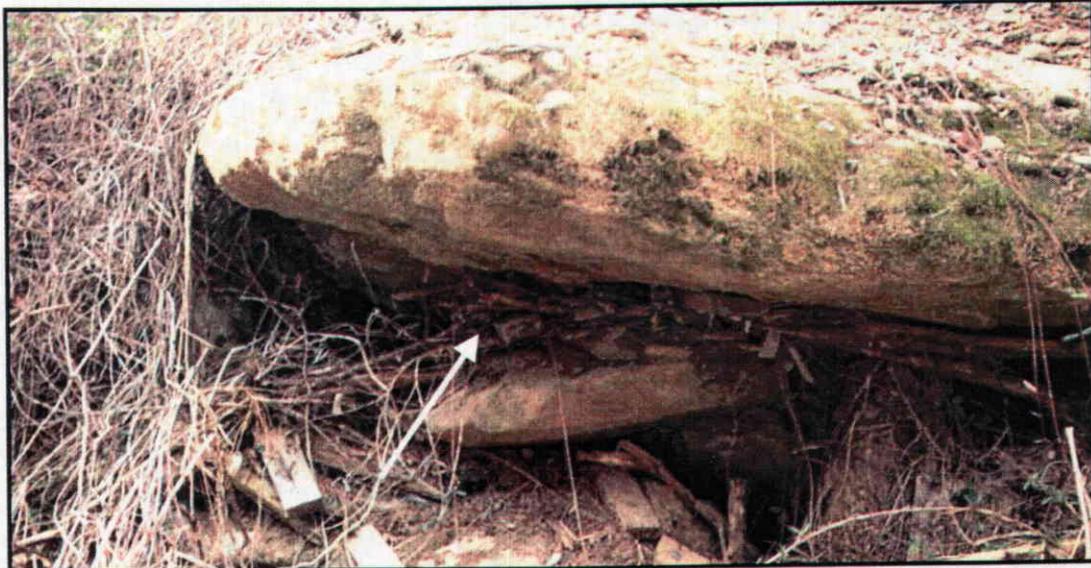
**Figure 37.** Imbricated boulder from an older debris flow deposit with lumber and other debris (shown by arrow) from the September 16, 2004 debris flow.

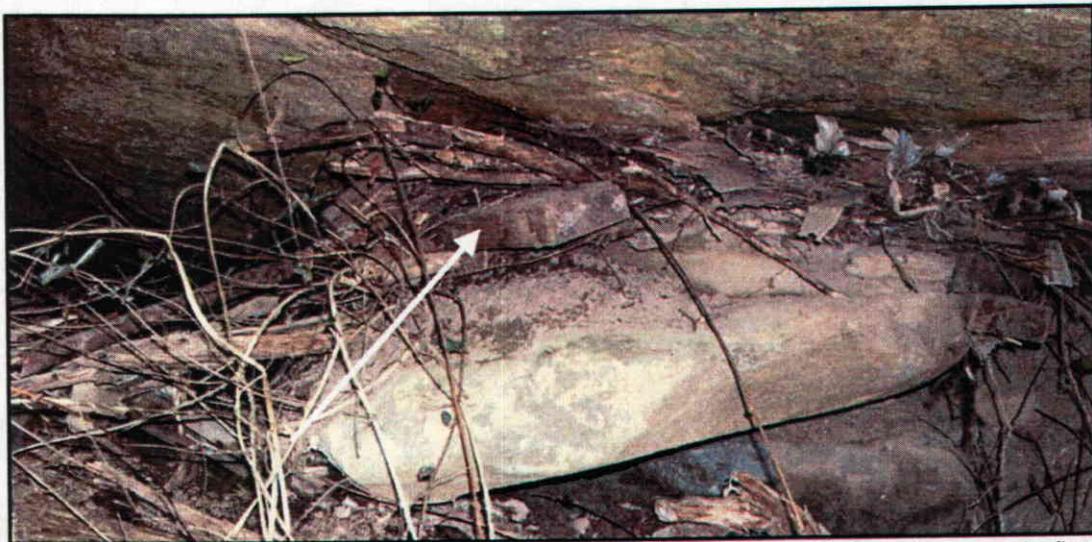
**Figure 38.** Close-up of 2"x 4" wedged between imbricated boulders of an older debris flow deposit exposed along the lower reach of Peeks Creek..

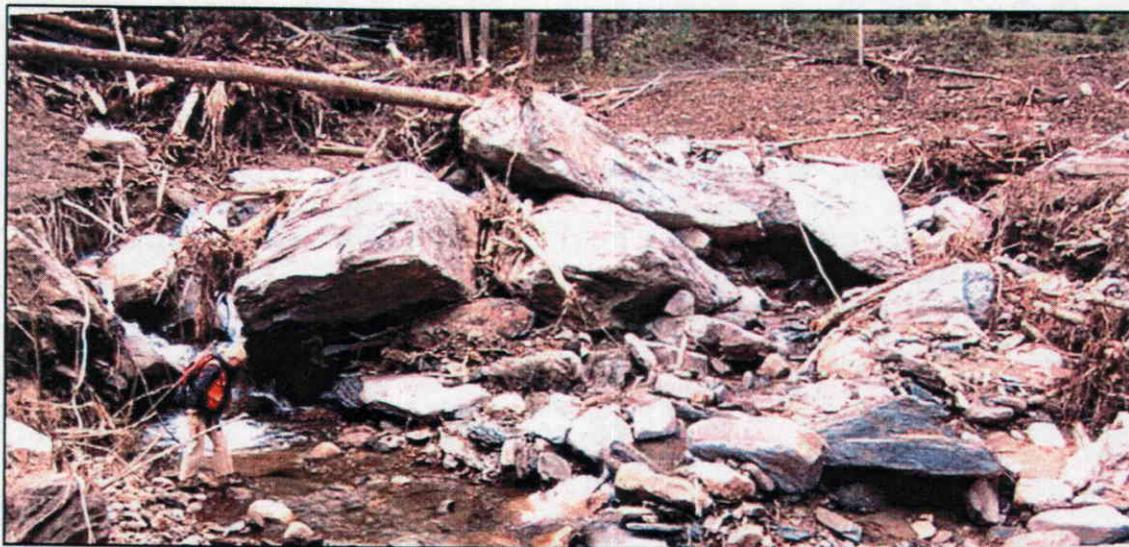
Unfortunately, no photos of the stream next to Mrs. Treadwell's house could be located. All of her photos were in her bedroom and were destroyed by the debris flow. She reported the stream next to her house as being "quite lovely" with 2 small waterfalls. Figure 39 shows the current condition of her streamside.

**Figure 39.** Peeks Creek next to the Treadwell property after the debris flow.

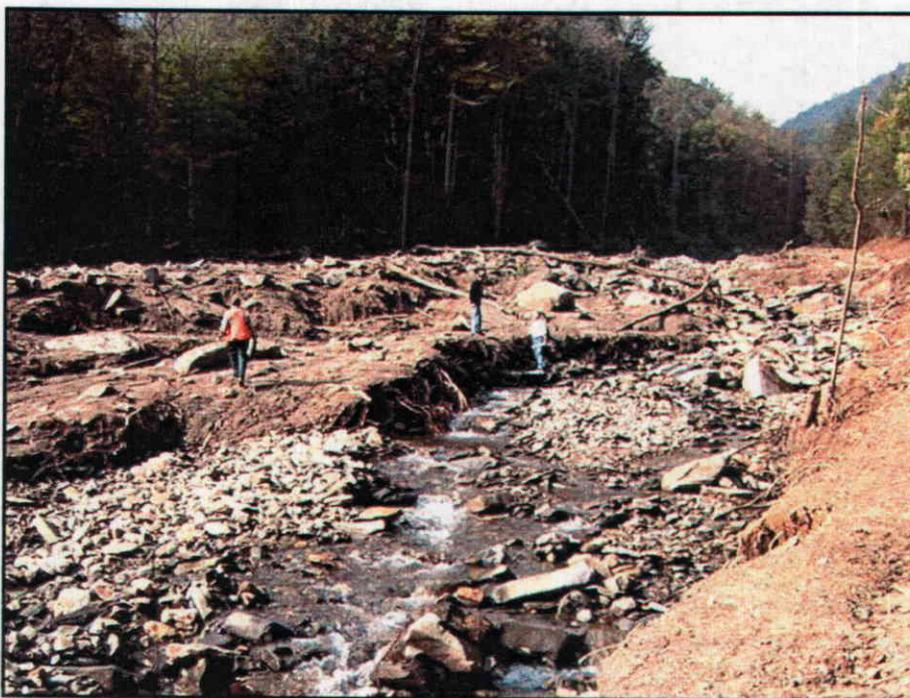
**Figure 40.** Wide, devastated channel of Peeks Creek at Stop 4.

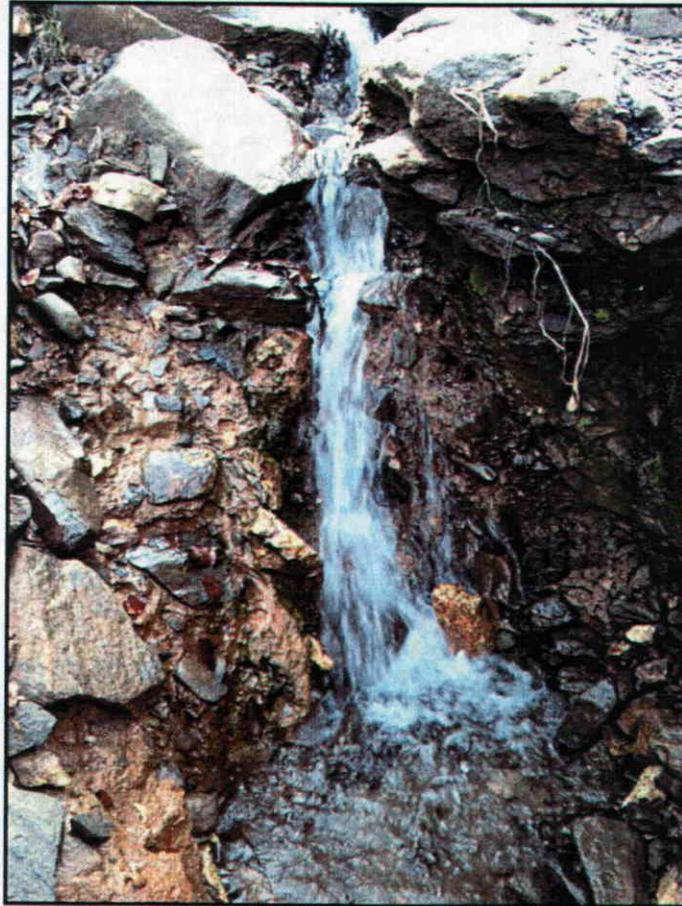
A culvert and bridge crosses the stream near Stop 5. From here, a short hike upstream shows the nature of the track up to the initiation zone. A short distance up the channel, the stream can be observed flowing over older debris flow deposits as opposed to bedrock (figure 41). Three distinct debris deposits can be observed here (Stop 6): the September 2004 event and two older deposits that are relatively aged as “younger” and “older” at this time. Age dating has been performed on these deposits.

**Figure 41.** Peeks Creek eroding away older debris flow deposits.

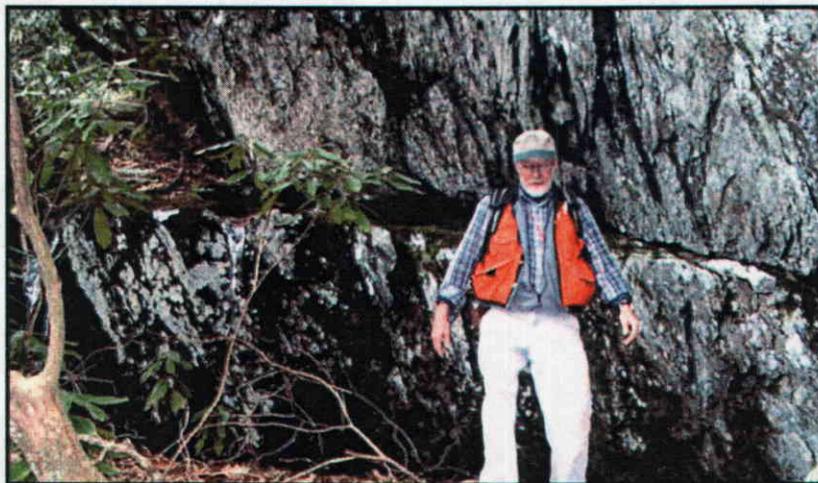
On the left side of the scar (if looking down from the top) is a nearly vertical foliation plane hidden in the trees (figure 43). The prominent horizontal fracture in the photo is an exfoliation plane; a similar type structure does not exist on the right side of the headscarp. The assumption is that slabs of rock were released along these fractures and created an exposed bedrock catchment. Over time the catchment accumulates soil and vegetation until an extreme rainfall event triggers a failure. The ~100 ft-wide by ~400 ft-long area that failed during Ivan is only a portion a larger colluvial catchment below the peak of Fishhawk Mountain (figures 1 and 44).

**Figure 43.** Rick Wooten of the NCGS in front of the steeply dipping foliation planes located off to the left flank of the scar and obscured by vegetation (see figure 44). The gently dipping discontinuity along the cliff face is an exfoliation fracture.
