BIG SLOW MOVERS: A LOOK AT WEATHERED-ROCK SLIDES IN WESTERN NORTH CAROLINA

Abstract: The North Carolina Geological Survey (NCGS) is currently implementing a landslide hazard-mapping program in western North Carolina authorized by the North Carolina Hurricane Recovery Act of 2005. To date, over 2700 landslides and landslide deposits have been documented. A small number of these landslides are relatively large, slow-moving, weathered-rock slides, termed “big, slow movers” (BSMs). Three examples of BSMs are described in this paper.

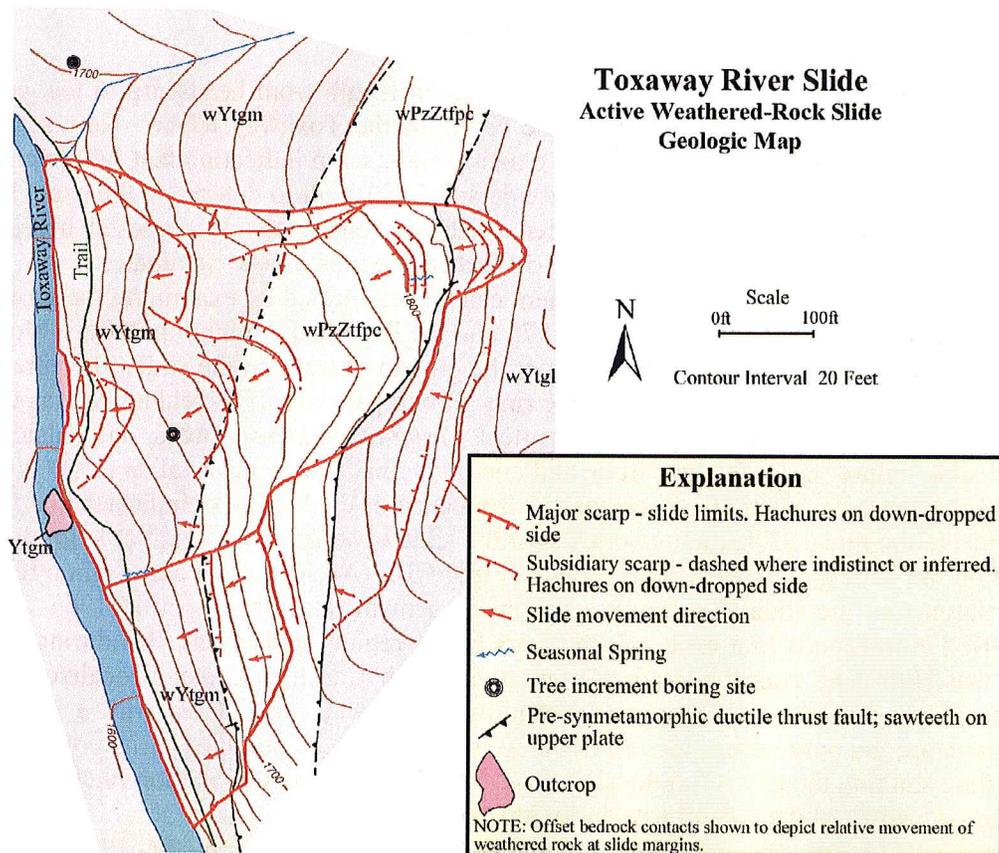
Figure 2. Geologic map of the Toxaway River BSM. Ytgm – megacrystic biotite, granitic gneiss of the Toxaway Gneiss. wYtgm – partly to completely decomposed, megacrystic biotite, granitic gneiss that weathers to a mica-bearing, silty sand. wYtgl – partly to completely decomposed, layered, biotite, quartzo-feldspathic gneiss of the Toxaway Gneiss that weathers to a mica-bearing, silty sand. wPzZtfc – partly to completely decomposed feldspar and mica porphyroclastic schist and metagraywacke of the Tallulah Falls Formation, which weathers to a micaceous sandy silt. Both rock types are mylonitic along the thrust fault. Adapted from Wooten *et al.*, 2003*b*.

The Toxaway River BSM measures over 500 feet in length from headscarp to toe, and over 700 feet in width at its widest part along the banks of the Toxaway River. New scarps and tension cracks are developing upslope of the existing main scarp indicating that failure continues to propagate upslope. With limited subsurface data, it is difficult to determine the exact location of the failure plane, but the contact between partly to completely decomposed bedrock and competent bedrock (approximate depth of 10-50 feet) is the most likely candidate.

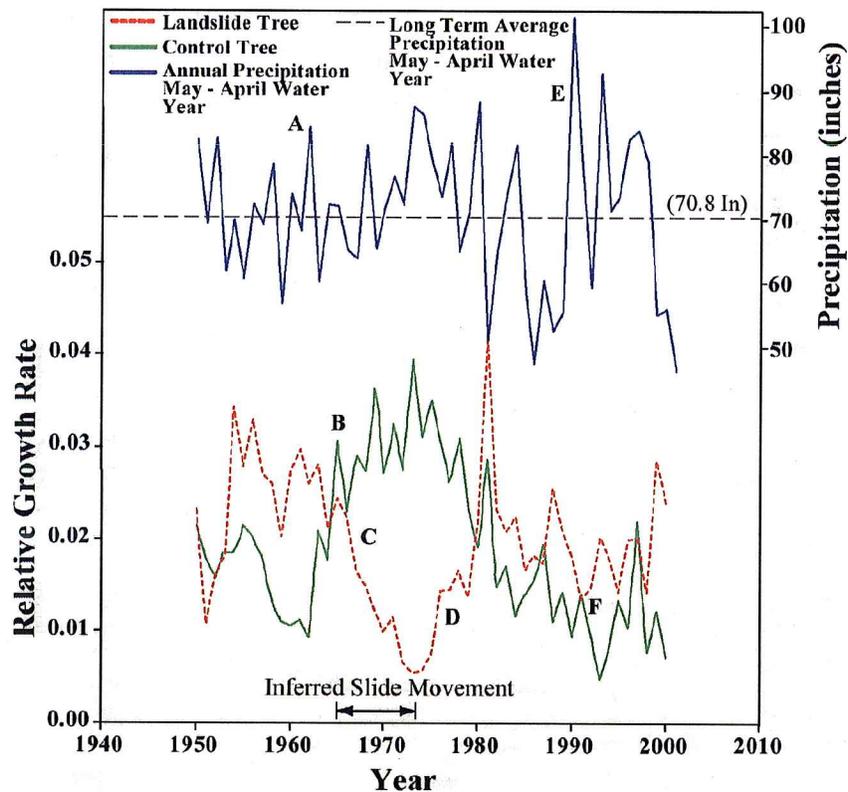
Subsequent, shorter time periods of above-average precipitation in the 1980s and 1990s yielded similar, small-scale responses in the growth of the control tree and the slide tree. A precipitation peak in 1989 could indicate continued movement of the slide. This corresponds to a decrease in the growth rate of the landslide tree and an increased growth rate for the control tree (Figure 3).

Figure 3. Plot showing the correlation between precipitation and the relative growth rate of an Eastern Hemlock on the Toxaway River BSM and a control tree off of the slide mass. While an increase in precipitation (A) corresponds to increased growth of the control tree (B), it also corresponds to decreased growth of the tree on the slide (C). This suggests that above average precipitation during the mid-1960s to the mid-1970s triggered movement of the slide, disrupting the root network of the tree on the slide and stunting its growth while causing the tree off the slide to grow more rapidly. The rapid growth of the slide tree during the late 1970s and early 1980s (D) could be the result of bulking of the tree on one side in an attempt to re-establish vertical growth (Jacoby, 2000). Shorter periods of above average precipitation in the 1980s and 1990s (E) produced similar responses in tree growth rate but on a smaller scale (F) (Adapted from Wooten *et al.*, 2003a).

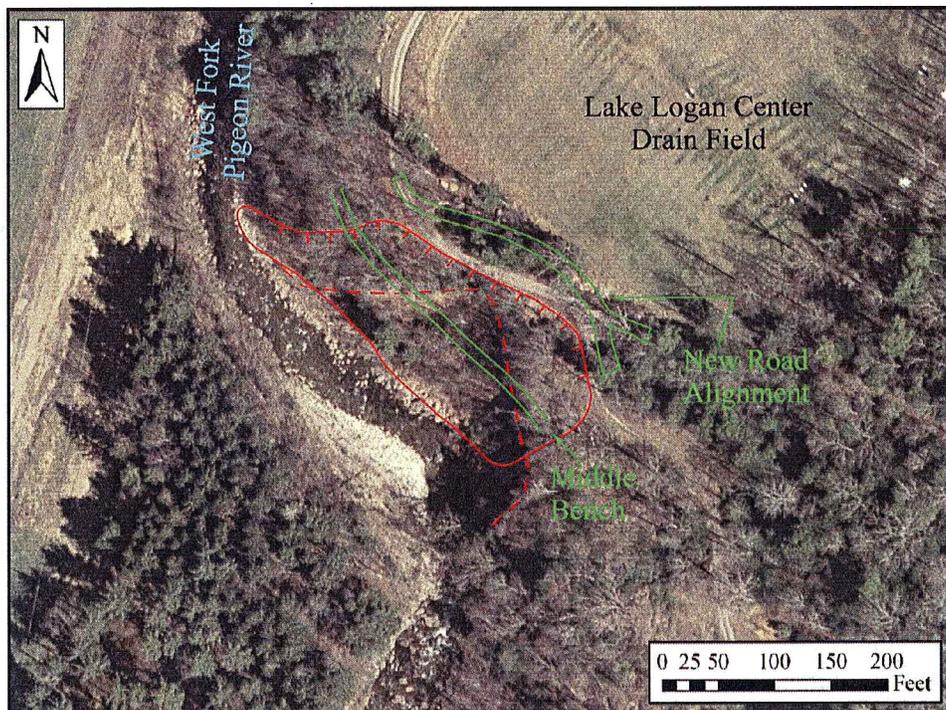
Figure 4. True-color orthophotograph from Spring 2004 of the Lake Logan Center BSM. September 2004 failure approximated by solid red line; hachures are on the down-dropped side. Red dashed line outlines a possible pre-existing scarp in the vicinity of the more recent failure. The north flowing, West Fork of the Pigeon River may have eroded the toe of the slope triggering the initial and recurring failure. Approximate locations of selected slope repairs are shown in green for reference.

The Lake Logan failure that occurred in September 2004 does not appear to be the first slope movement at this location. True-color orthophotography flown of the area in Spring 2004 indicates this slide may have started to fail prior to the hurricanes (Figure 4). Little is known about the slope configuration at the time of the initial failure. NCGS staff did not visit the site

When NCGS staff first visited the site in August 2005, a new scarp had developed at the southeast end of the newly constructed middle bench (Figure 4); displacement was approximately two feet. By December 2005, ten feet of offset had occurred at this location. No bulging or displacement was readily observed at the toe. This could indicate that the river is eroding material as movement takes place and progresses, the toe daylight in the riverbed or confined failure is occurring. No drilling was done to confirm the depth of the failure plane, and it is not clear whether movement is translational or rotational. The lack of bulge or oversteepened ground at the toe suggests movement is likely translational, possibly along the contact between residuum and competent bedrock and facilitated by pre-existing, iron-manganese oxide coated slip surfaces. The depth of the rupture surface within the slide mass itself has not been determined.

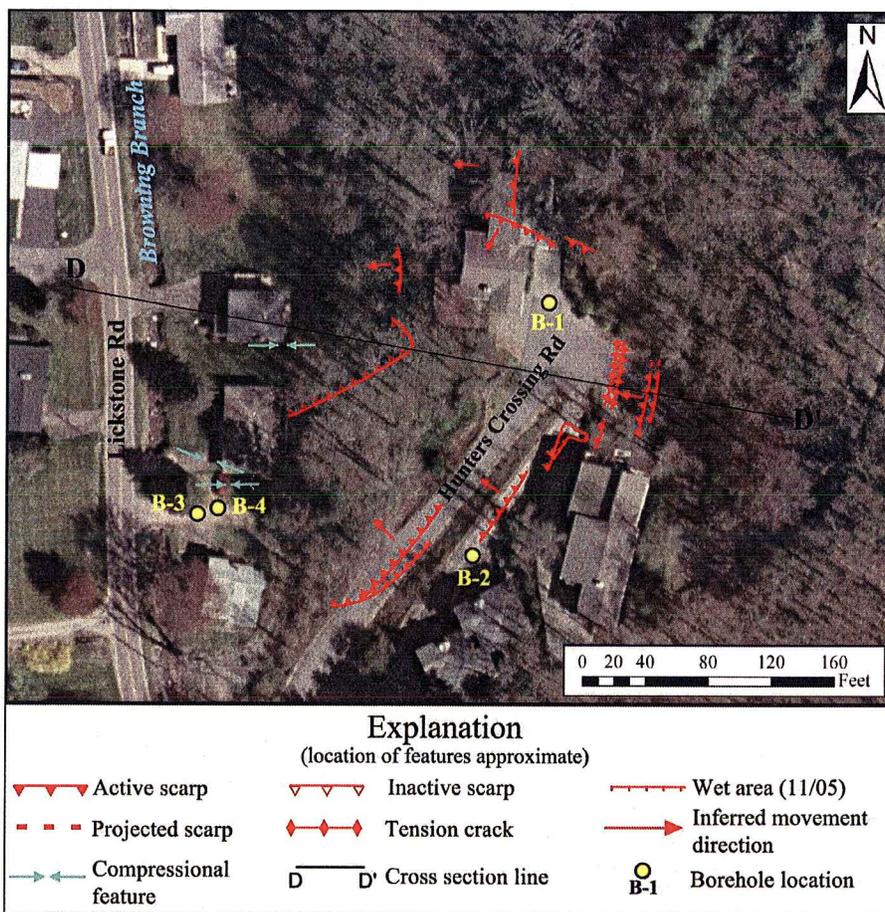
Figure 5. Preliminary map of slope movement features at the Hunters Crossing BSM. The two-unit condominium adjacent to borehole B-1 has been condemned for occupancy. The three houses on the east side of Lickstone Road at the base of the failure are currently unoccupied due to damage to the structures and the potential for future failure. The slide mass covers an area of approximately 1.5 acres.

Several mappable scarps cross the slope at Hunters Crossing. Figure 5 shows an aerial view of the community overlain by mapped scarps and tension cracks. Cracking walls and ground bulges at the base of the slope indicate that movement is primarily rotational. Figure 6 shows a schematic cross section through the slide. The homeowners association retained Alpha Environmental Sciences, Inc. (AES) in late 2005 to conduct a more detailed analysis of the slope movement. AES drilled two boreholes in the upper part of the slide (Figure 5) to depths of 46 and 50 ft without encountering groundwater, competent bedrock, or a distinguishable failure surface. Boring B1 was terminated at 50 ft without auger refusal, and the material encountered is predominantly silty sand with varying amounts of mica and some relict bedrock structural fabric. Boreholes B3 and B4 at the toe of the slide predominantly contain silty sand, and auger refusal occurred at depths of eight feet and ten feet respectively.

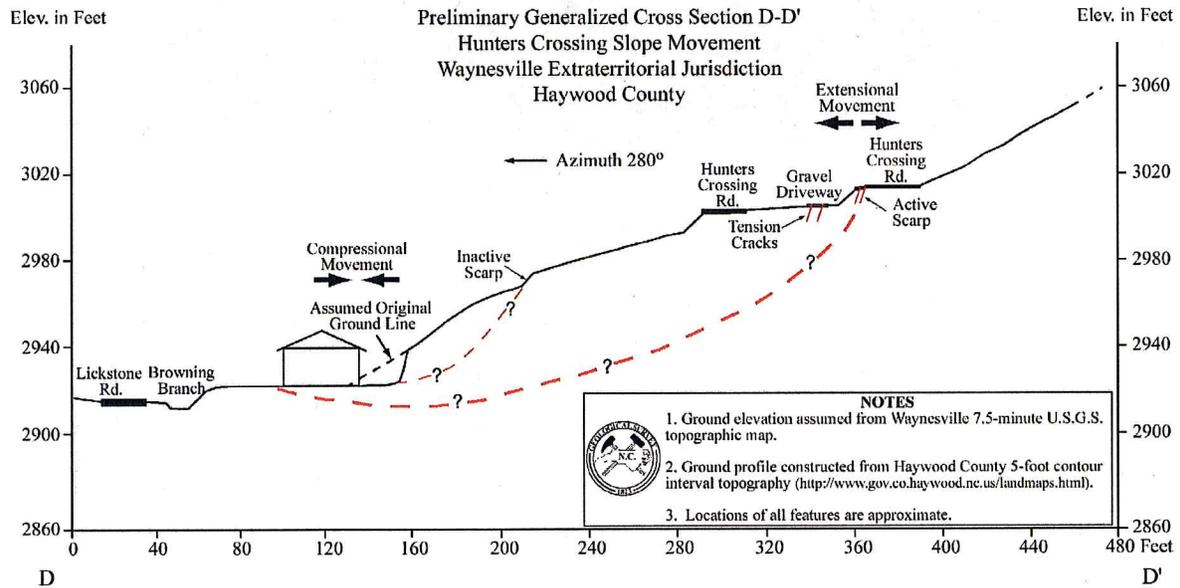
Figure 6. Generalized preliminary cross section through the Hunters Crossing BSM. Lightweight red line indicates the location of the potential failure surface that extends down from an inactive scarp. Heavy weight red line indicates the possible location of the deep-seated failure plane along which movement is currently occurring. Near the active scarp, buildings are being pulled apart due to the extensional movement. At the base of the slope, buildings are being compressed by uplift forces exerted by the slide toe. See Figure 5 for location of cross section.

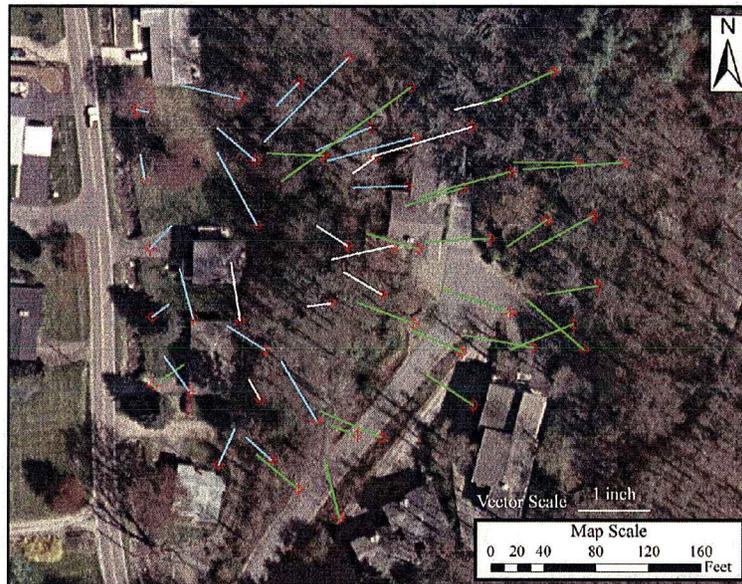
Benchmarks were also installed across the slope for surveying the vertical and horizontal displacement across the slide. Baseline measurements were made on January 10, 2006 with subsequent surveys performed on January 16, 2006 and March 3, 2006. January 16 readings appear to be more representative of the movement than the March 3 readings, so for comparison purposes, measurements from that survey were evaluated. Figure 7 shows the vector displacement at each survey point on the slope. Areas north and east of the known scarps and

tension cracks show the greatest displacement indicating the size of the failure could be considerably larger than initially thought. Future monitoring is planned in conjunction with Western Carolina University.

Figure 7. Vector displacement map showing movement of the Hunters Crossing BSM. This represents movement between an initial January 10, 2006 survey, and a second survey conducted on January 16, 2006. Vector colors indicate elevation changes between surveys. Blue indicates an increase in elevation, green a decrease in elevation, and white indicates no elevation change (Survey data from Herron Surveying, PC).
