DEFECTS IN HARDWOOD VENEER LOGS: Their Frequency and Importance

E. S. Harrar

SOUTHEASTERN FOREST
EXPERIMENT STATION
Asheville, North Carolina

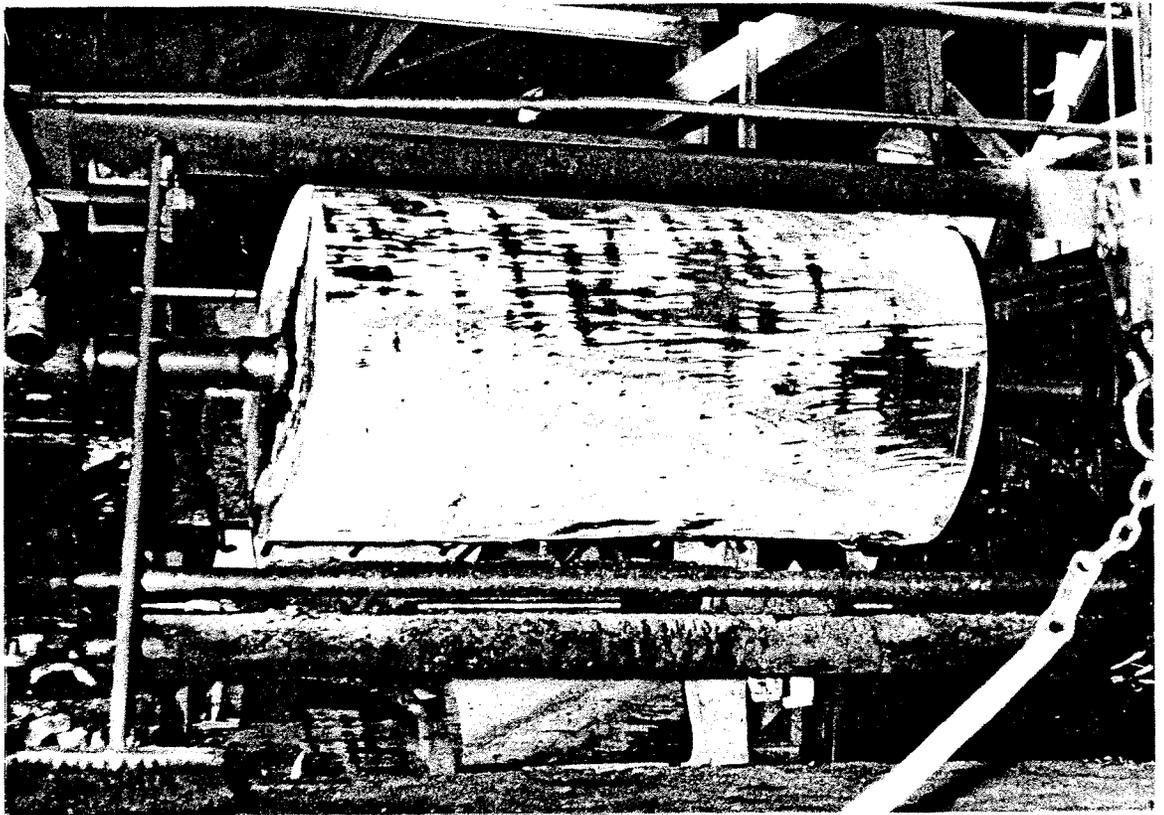
Figure 2.--Areas of discoloration in **sweetgum** caused by bird peck.

callus tissue or included bark, and practically all of them are the focal **points** of unsightly stains and streaks of decay. The initial attack may have been made many years before the log was harvested, but the defects continued to develop as new wood was laid down on the cylinder and very **frequently** may be observed by merely removing the bark.

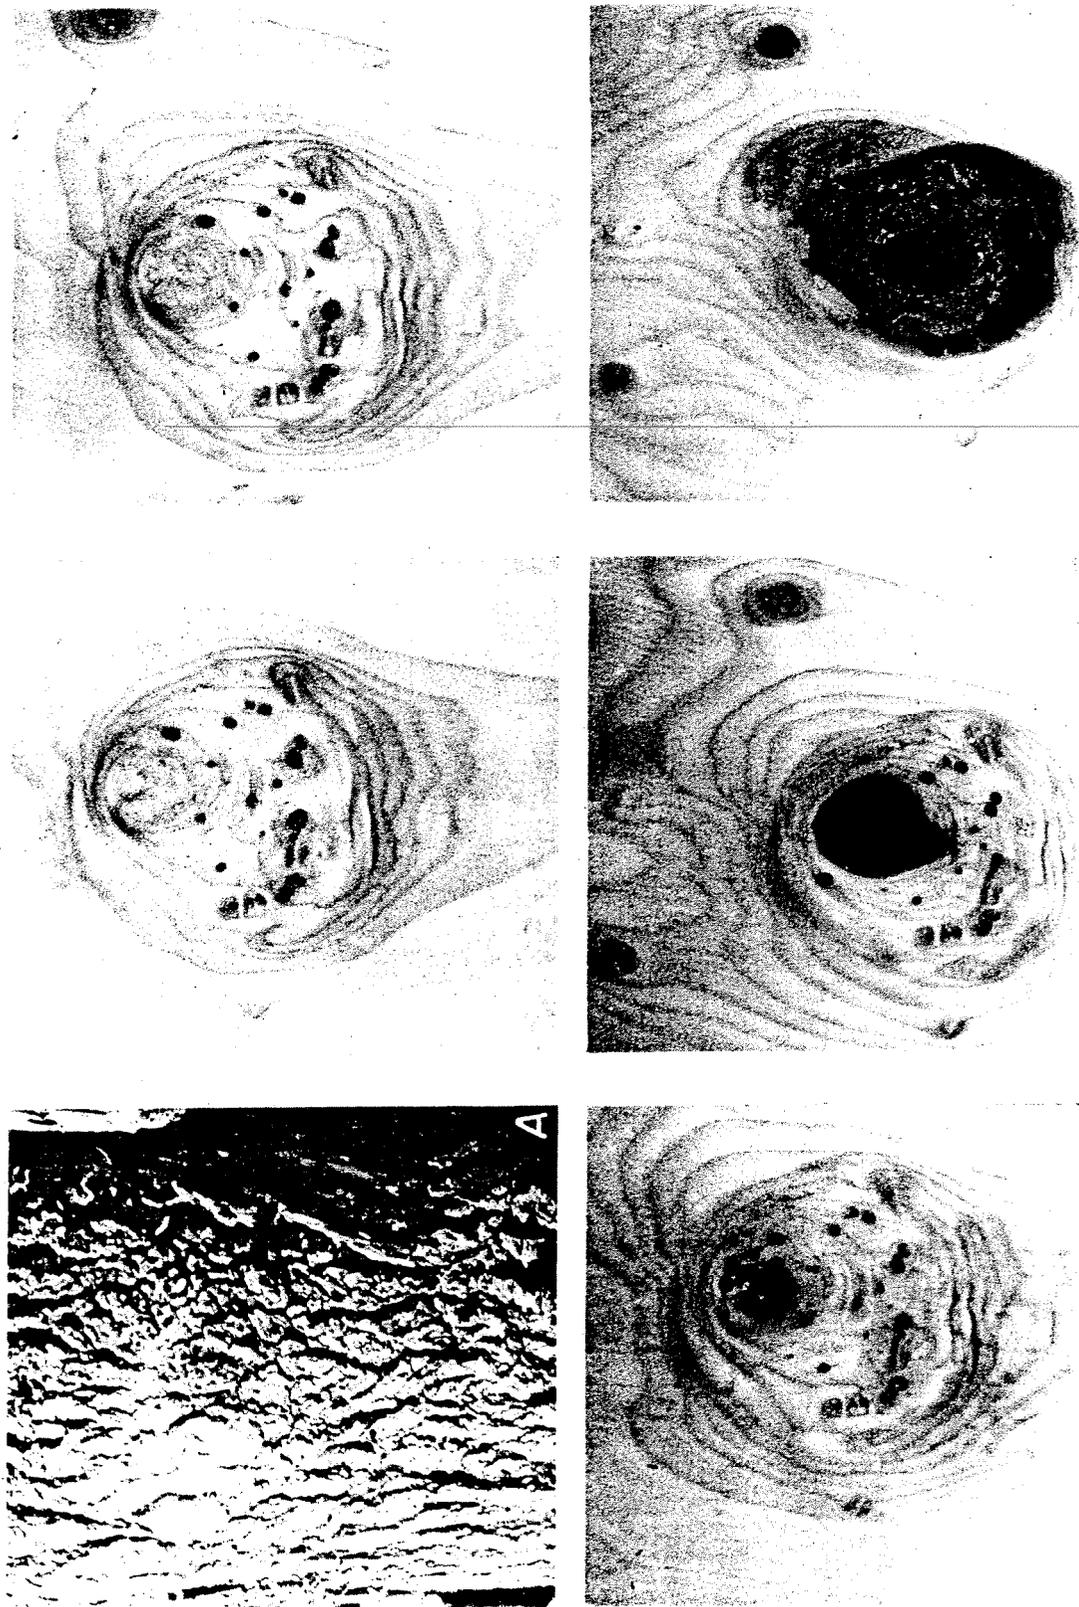
In general, clusters of adventitious buds on yellow-poplar and **sweetgum** logs not only in themselves produce blemishes in sheets of rotary-cut veneer, but also signal the presence of larger and far more serious defects below.

Figure 3.--Adventitious buds. A, Bark pattern in yellow-poplar above a cluster of adventitious buds. B, C, D, E, F, Pattern in veneer at 2-inch intervals across the radius of the block following rounding of veneer bolt to core.

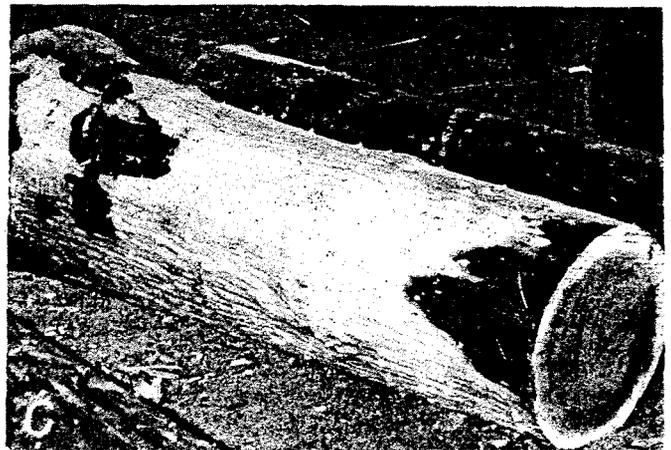
In rotary-cut veneers, these radially aligned tissue bundles appear on the face of sheets of veneer as minute pin knots. These are not of sufficient magnitude to affect sheet quality adversely except in face stocks, and then only when their frequency is greater than two per square foot of surface area.

Figure 4.--Dormant buds. A, Dormant bud sprouting on sweetgum log. B, Pin knot in veneer traceable to dormant bud. C, Traces of dormant buds on peeled tupeLO log.

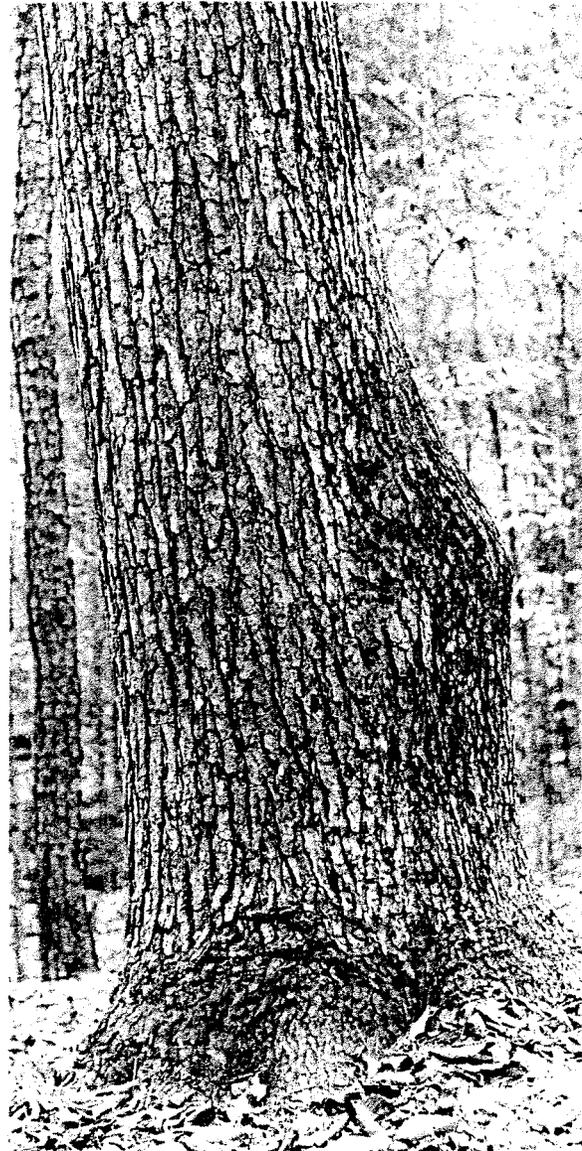
Lockard et al.^{3/} describe bulges as abrupt barreling effects at the base of trees or upward at any level along their boles, and point out that these malformations are indicative of advanced stages of heartwood decay. A butt bulge usually signifies a hollow core with varying amounts of decay above the swelling. Stem bulges, although seldom hollow, signify localized heart rot, and hence are also a region of cull. Blocks or logs featuring butt or stem bulges contain volumes of merchantable wood in the outer regions of the cylinder, but since it is impossible to chuck material of this sort firmly in a lathe, such logs are ordinarily considered worthless for the production of rotary-cut veneer. Trees with prominent butt bulges are either jump-butteted at the time of felling or left standing; stem bulges are commonly removed from felled timber as a part of the logging operation.

Figure 5. --Butt bulge in sweetgum.

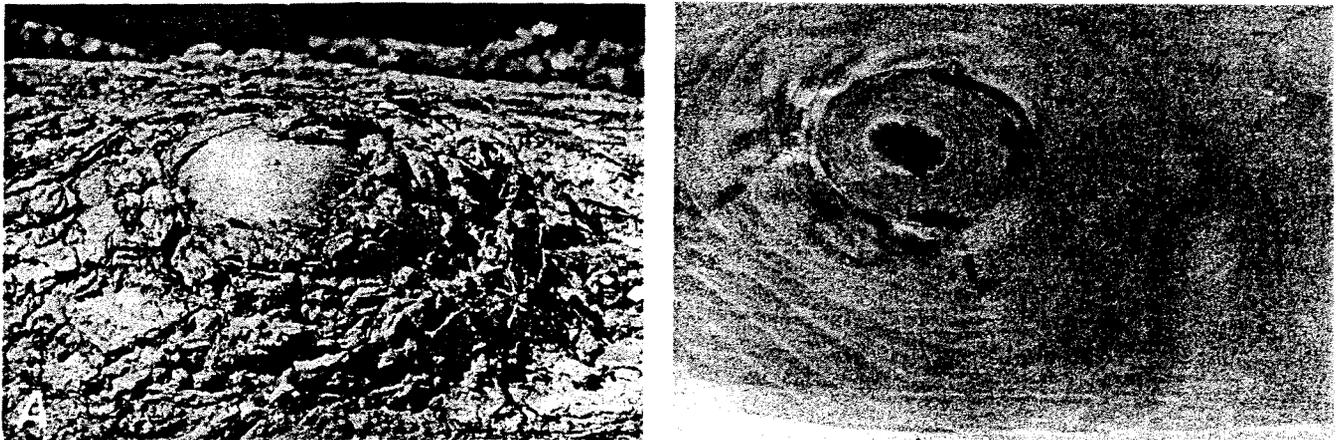
High bumps.--High bumps (fig. 6) may appear at any point along a log, and as a rule foretell the presence of sound or rotten projecting limb stubs and knots, well developed clusters of adventitious buds, localized splits or seams, or ingrown bark. Bumps on butt logs and blocks harvested from local woodlots should be carefully scrutinized since they frequently encase nails, spikes, barbed wire, or other pieces of metal which would severely damage knife and pressure bar if undetected (fig. 7).

Figure 6. --High bump on yellow-poplar. A, Bark removed to show layer of wood over branch stub. B, Veneer underlying bump, showing recently buried branch stub and associated decay.

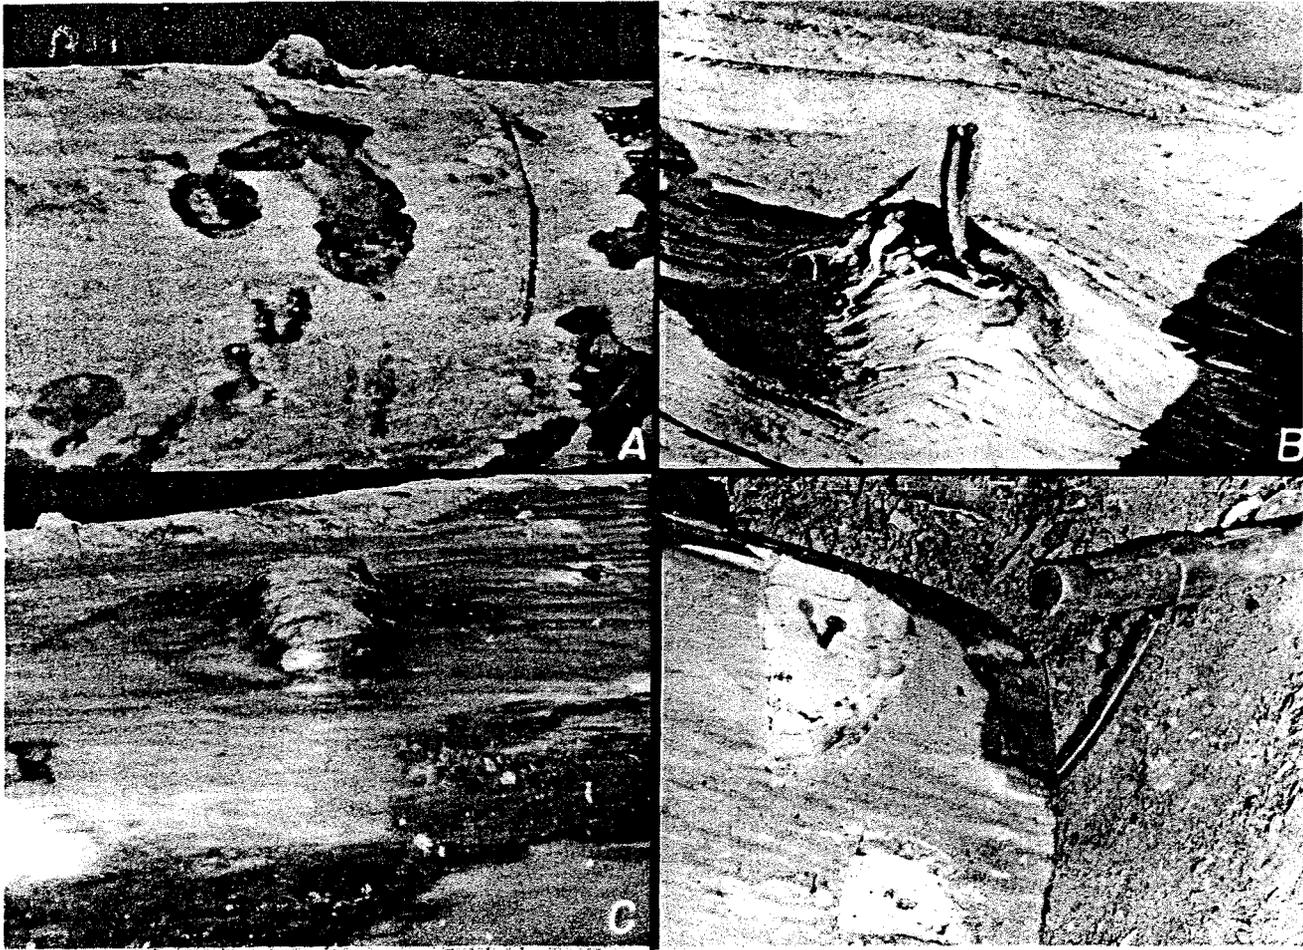
Figure 7.--High bumps. A and B, high bump on basal log of tupelo caused by embedded wire. C and D, High bump on basal sweetgum log caused by spike. Bumps on basal logs should be examined carefully for incased bits of metal.

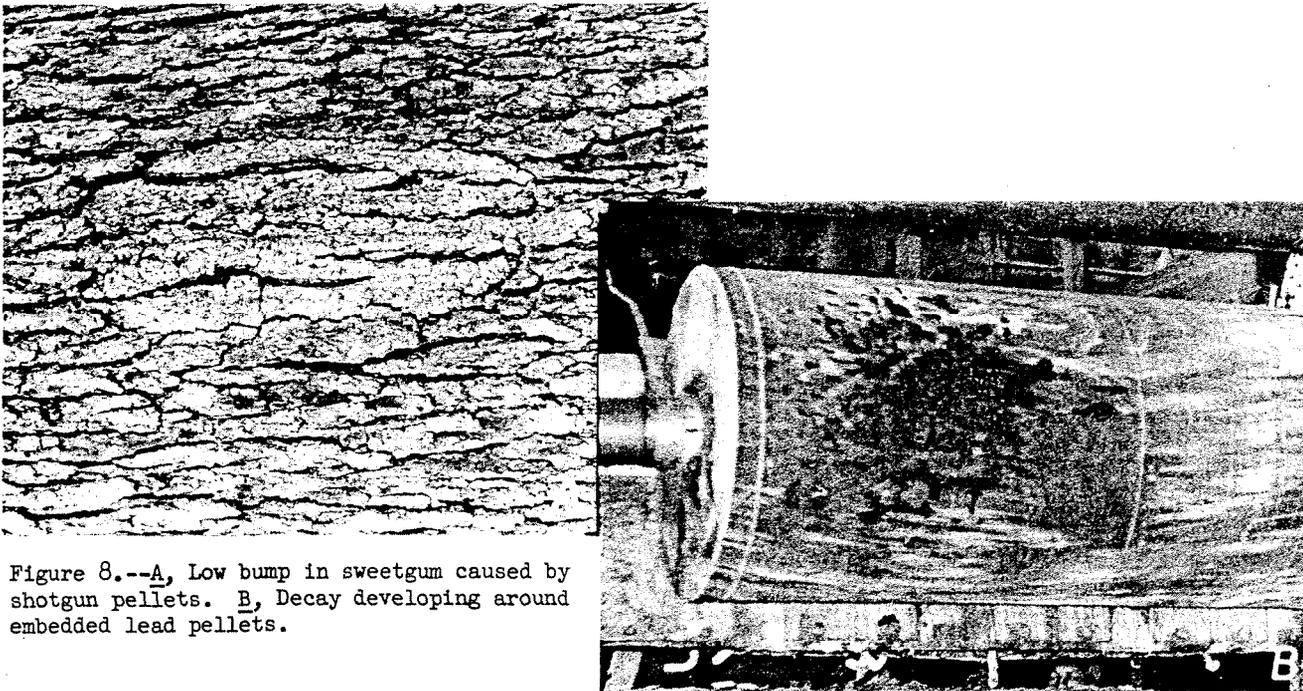
Figure 8.--A, Low bump in sweetgum caused by shotgun pellets. B, Decay developing around embedded lead pellets.

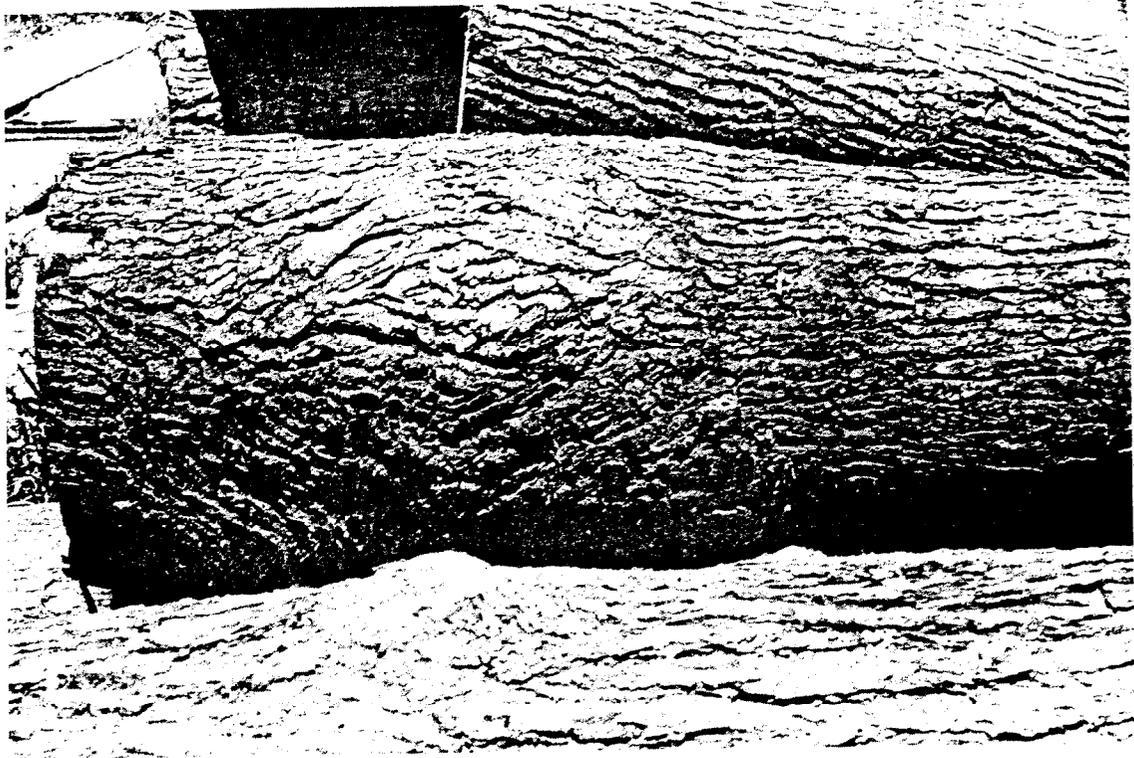
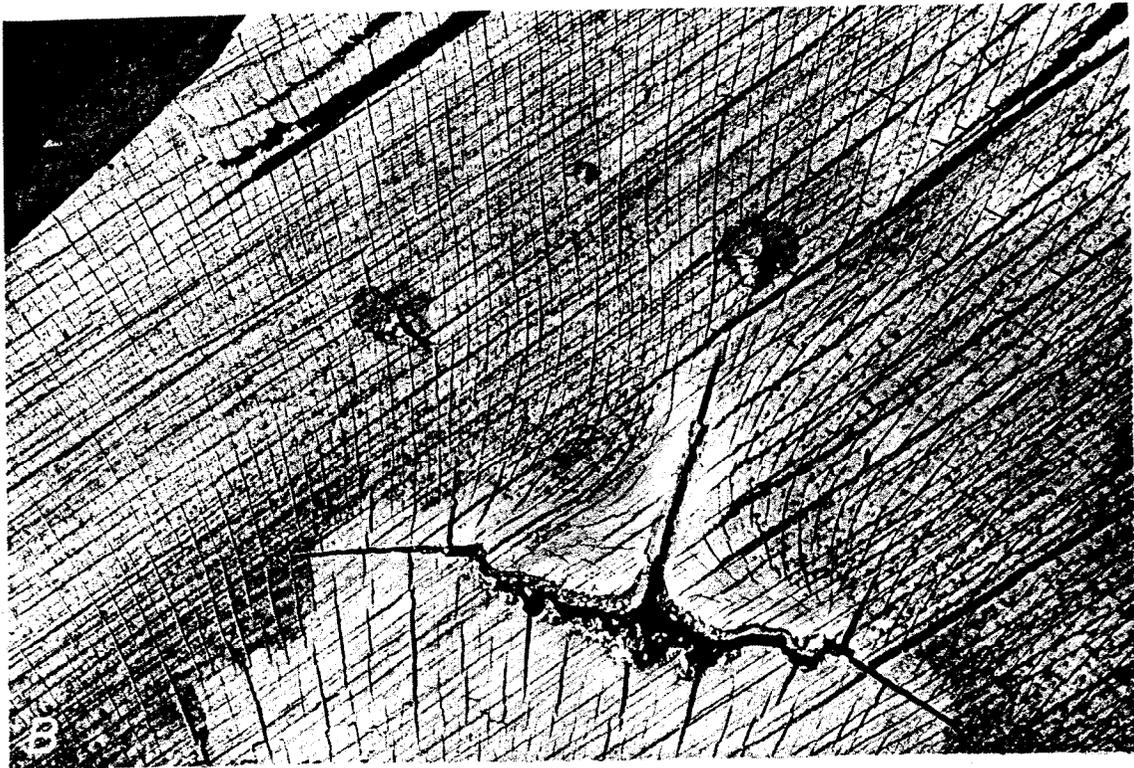
Low bumps.--Low bumps (including surface rises) usually connote the presence of wounds, bark inclusions, localized decay, and in some cases rather deeply recessed branch stubs and knots. Occasionally, low bumps on sweetgum logs indicate the presence of superficial gum cysts. Logs receiving shotgun blasts not infrequently develop low bumps in the vicinity of the wound, with decay developing around the embedded lead pellets (fig. 8). Figure 9 shows a buried seam with included bark under an elongated low bump.

Figure 9.--**A**, Elongated low bump in **sweetgum** log 22 inches in diameter. **B**, Buried seam with included bark under low bump of **A**.

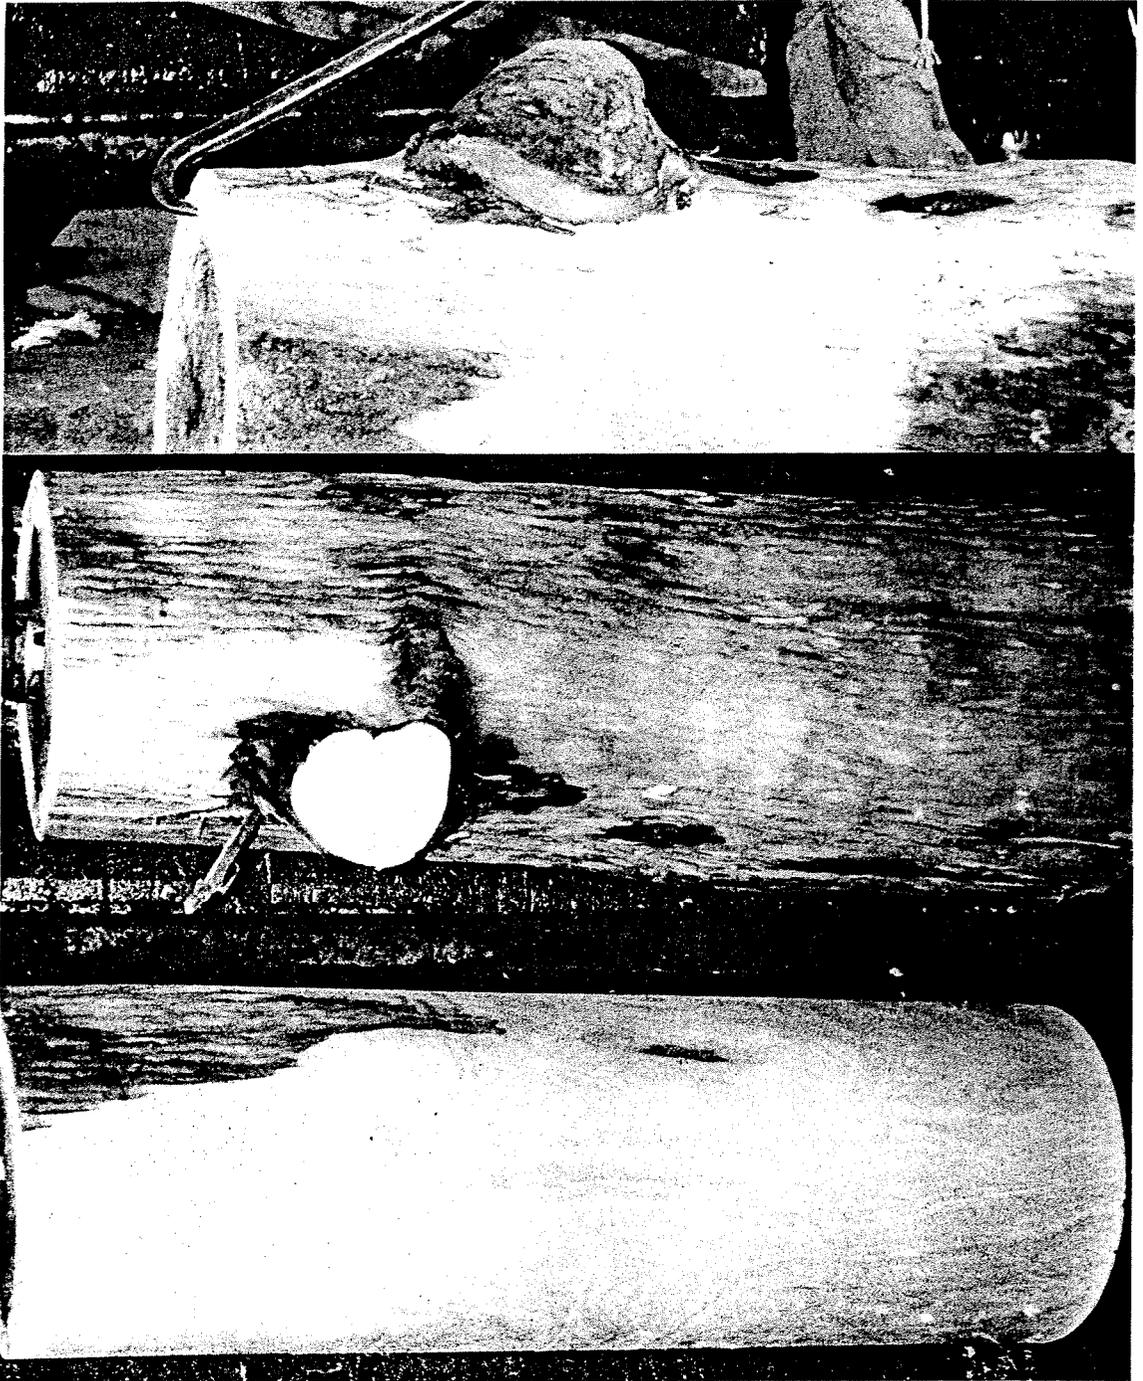
Figure 10.--Burl on tupelo log. Note complete obliteration of burl following rounding, and solid, defect-free wood below.

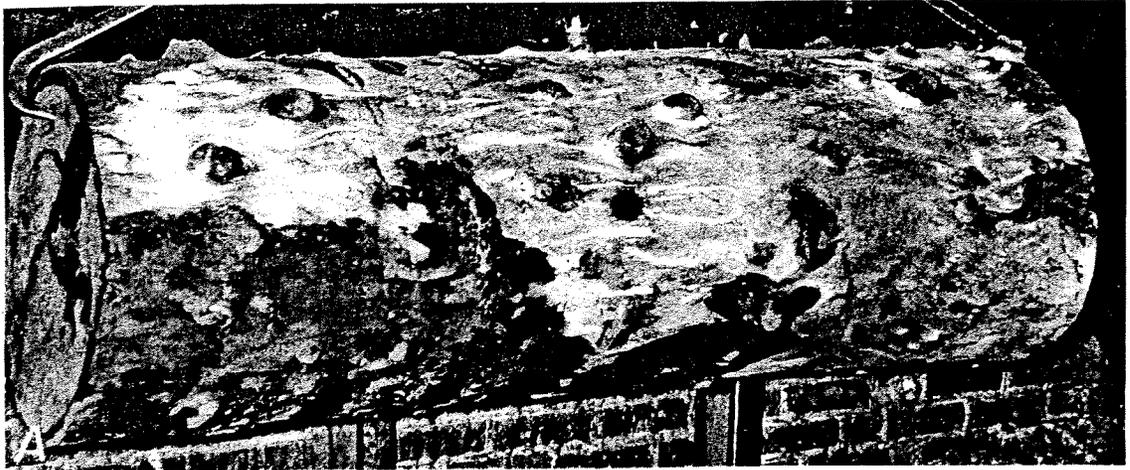
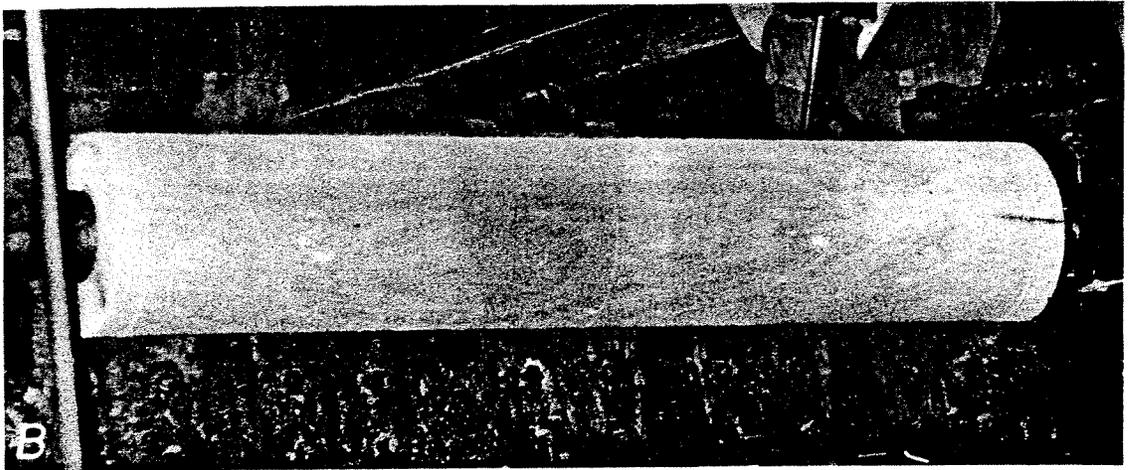
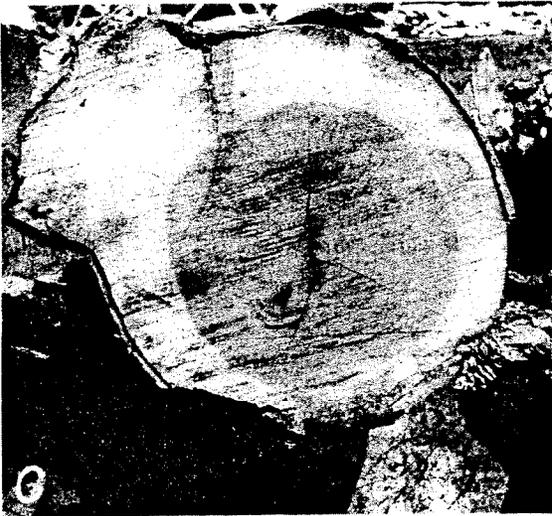
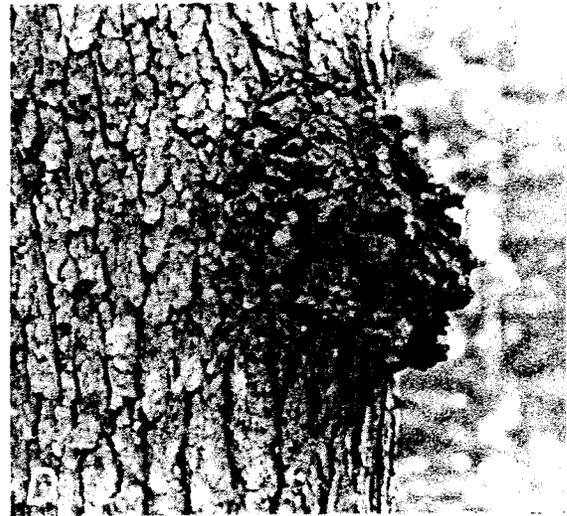
Figure 11. --A and B, Small burls on blackgum log which "washed out" in the rounding. C, Cross-section through a burl on tupelo. Note absence of defect below burl. D, Small burl on a sweetgum log. Burls on the gums are more commonly defective.

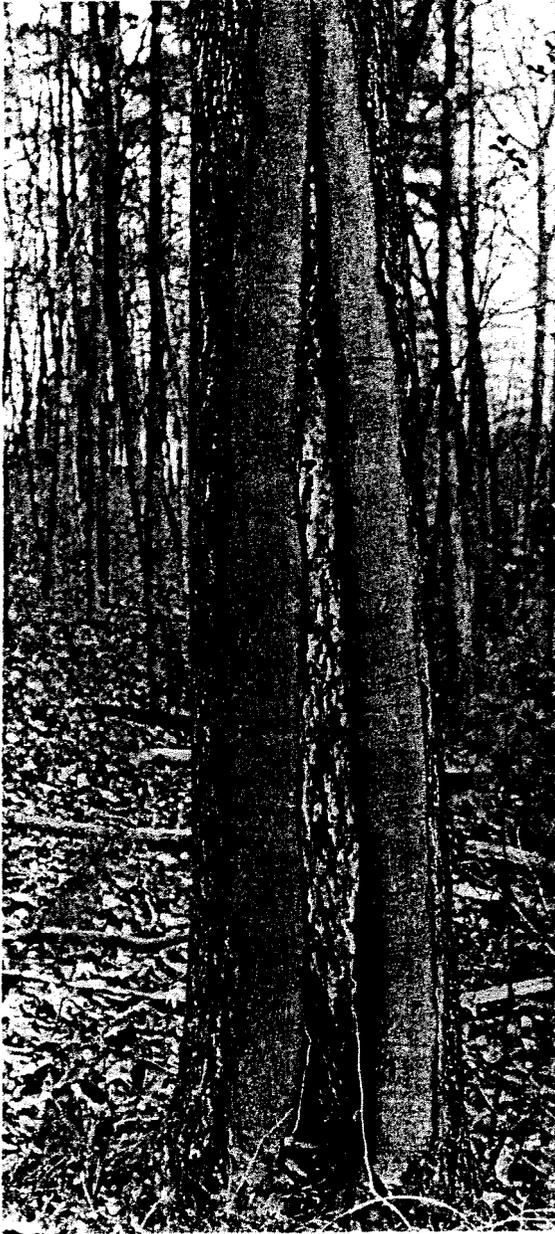
Figure 12.--Butt scar.

that a portion of the woody cylinder is exposed (fig. 12). This injury, known as butt scar, is often traceable to repeated fires or logging damage. Green healthy **sapwood** laid bare in this manner usually becomes the focal point of insect infestations, stains, and wood-rotting fungi. The wood in old scars is often completely destroyed and hollow butts result, while above the open face of the wound, decay of the heartwood has advanced upward in the bole from a few inches to several feet. Trees with butt scar, like those with butt bulge, are usually jump-butted at the time of felling.

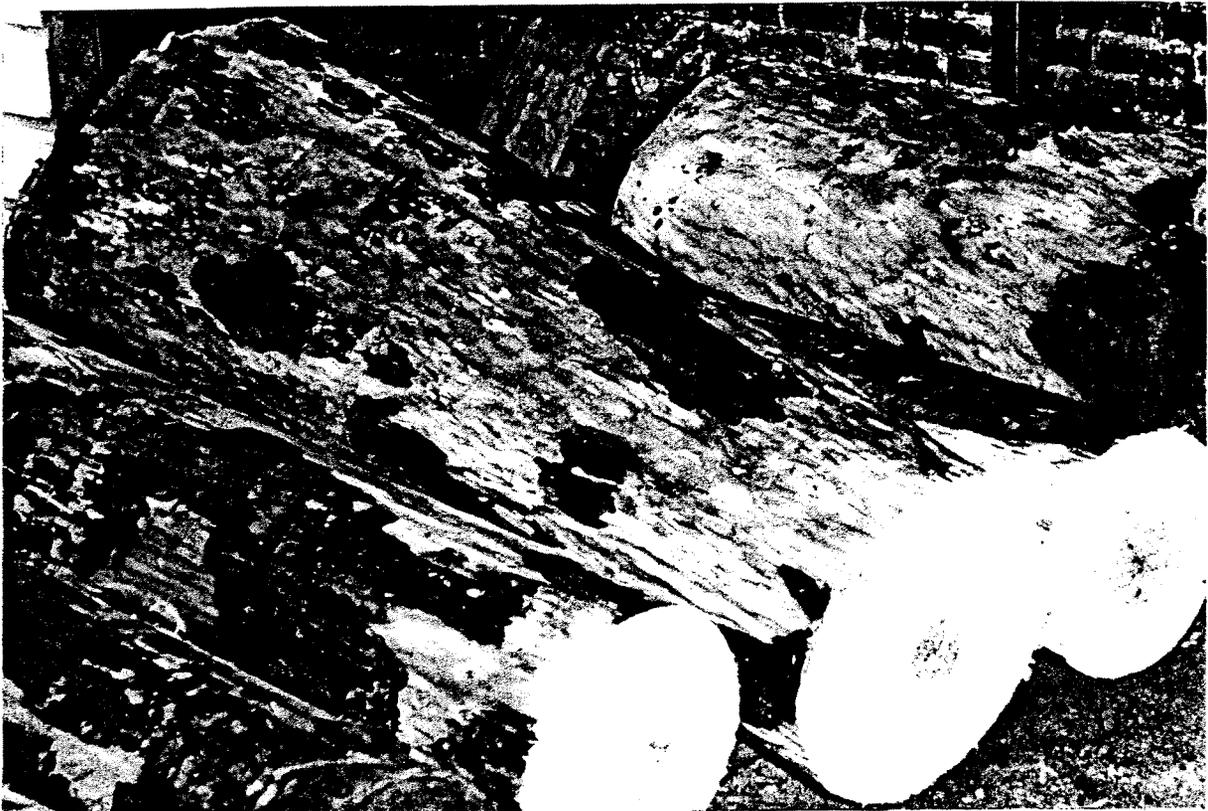
In extreme cases, and notably when trees are subjected to nearly permanent inundation, swell-butt wood is so brash, soft, and weak, and of such low density that it is practically worthless for veneer use; under such conditions, butt swell must be regarded as a defect.

Figure 13.--Butt swell.

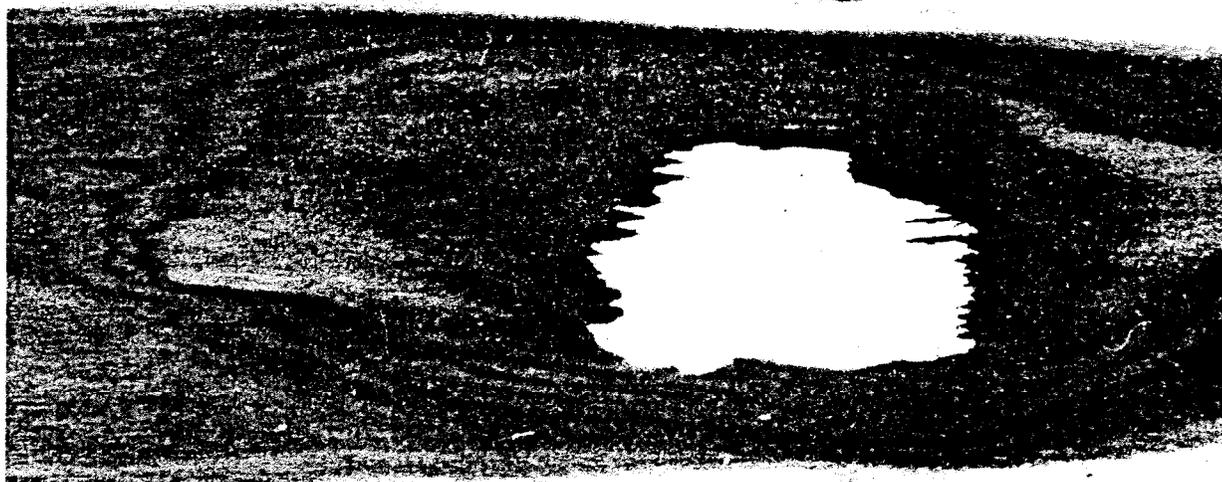
Holes made by tongs.--It is common in many logging operations to employ tongs in the skidding and loading of logs and blocks destined for a veneer mill. The broad, elongated, sometimes blunt points of such hooks, often 2 to 3-1/2 inches in length, tear and gouge **sizeable** holes in the surfaces of logs. Each time a log is handled in this manner a new pair of holes results. During the course of this study innumerable logs and blocks were observed in which tong holes were the only visible defects. Such holes not only limit clear sheet-width but cause stains and decay (fig. 16).

Figure 1.6.--This began as a tong hole. **Note stain and** incipient decay in otherwise defect-free veneer sheet.

The replacement of tong hooks with slings and chokers in the woods operations would eliminate this unnecessary waste. High-grade logs, for which top prices have been paid, could then be made to produce maximum yields of the quality veneer expected.

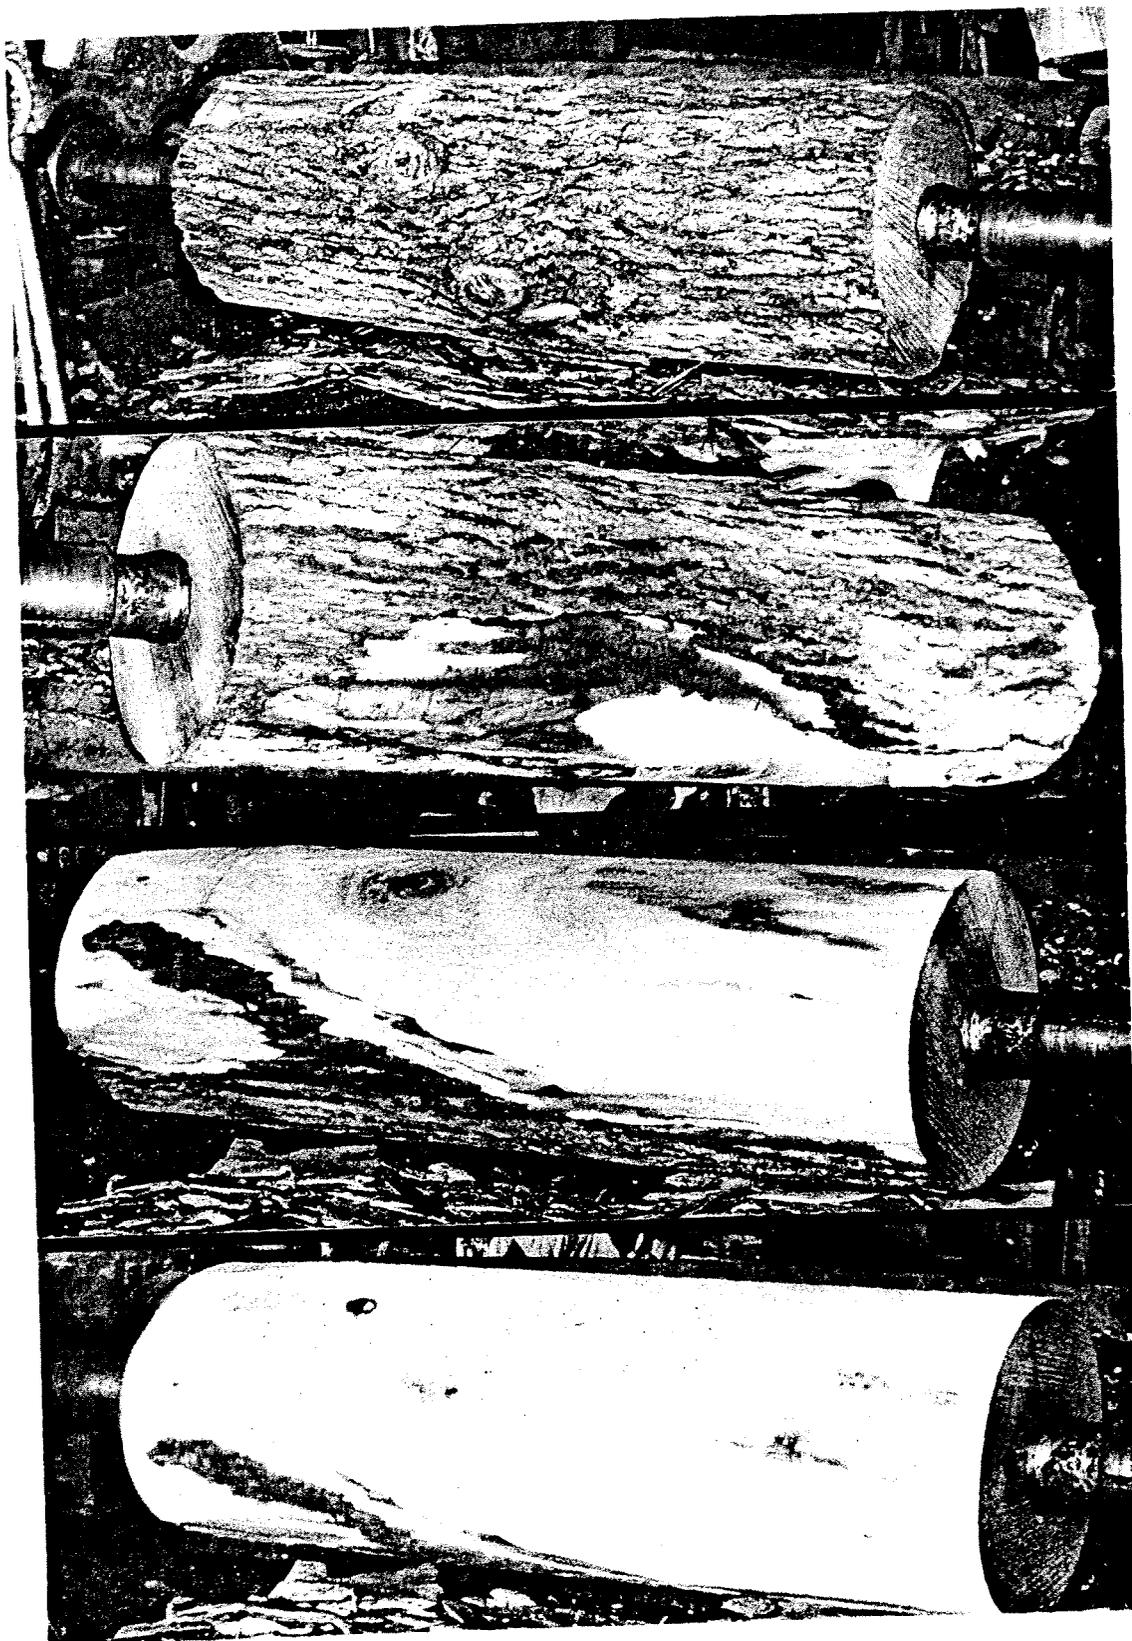
Knots of various kinds are by far the most common and most important defects in hardwood veneer logs. Exposed knots (fig. 17) are common features of small marginal logs and those cut from upper levels of a tree trunk. Butt logs from yellow-poplar, sweetgum, tupelo, and blackgum are exceptionally free from exposed knots, since the lower portions of the trunks of forest-grown trees of these species are usually clean and full-rounded by the time they attain peeler-log size.

Figure 17.--A series of photos tracing knots through a yellow-poplar block from bark to ∞

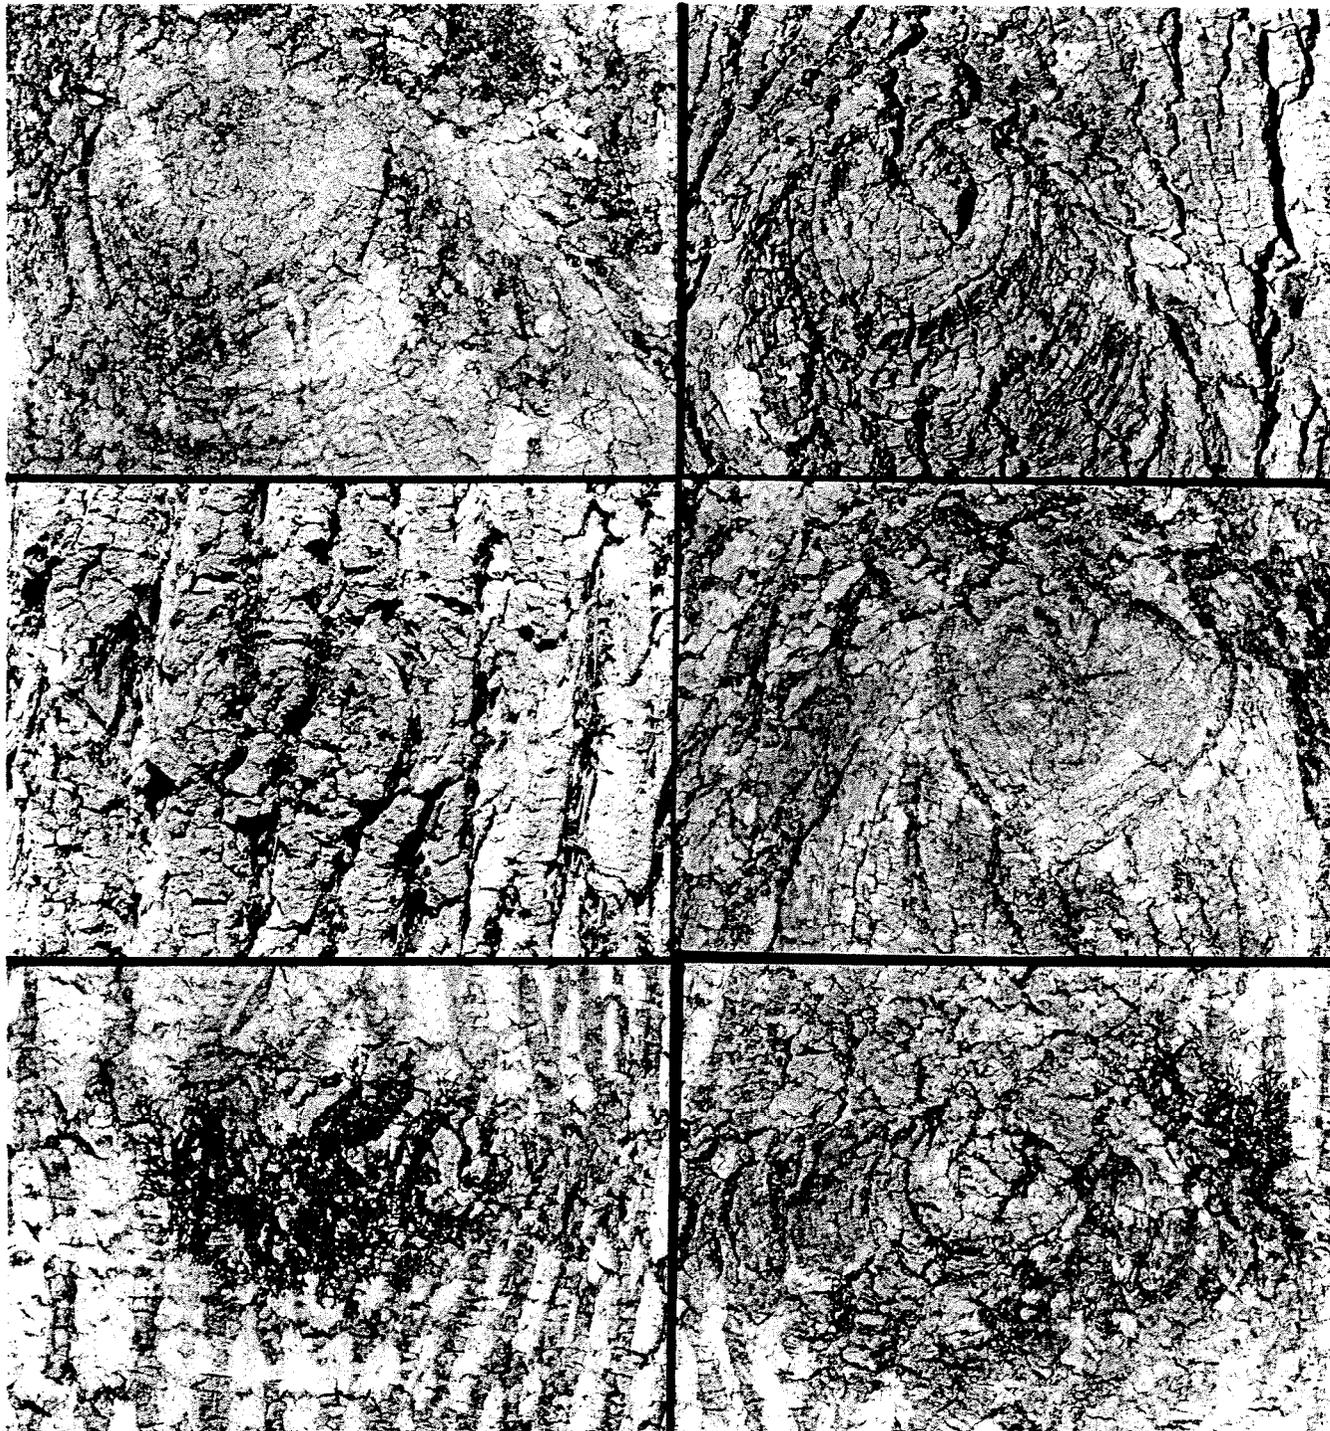
Figure 18.--Overgrowths in yellow-poplar.

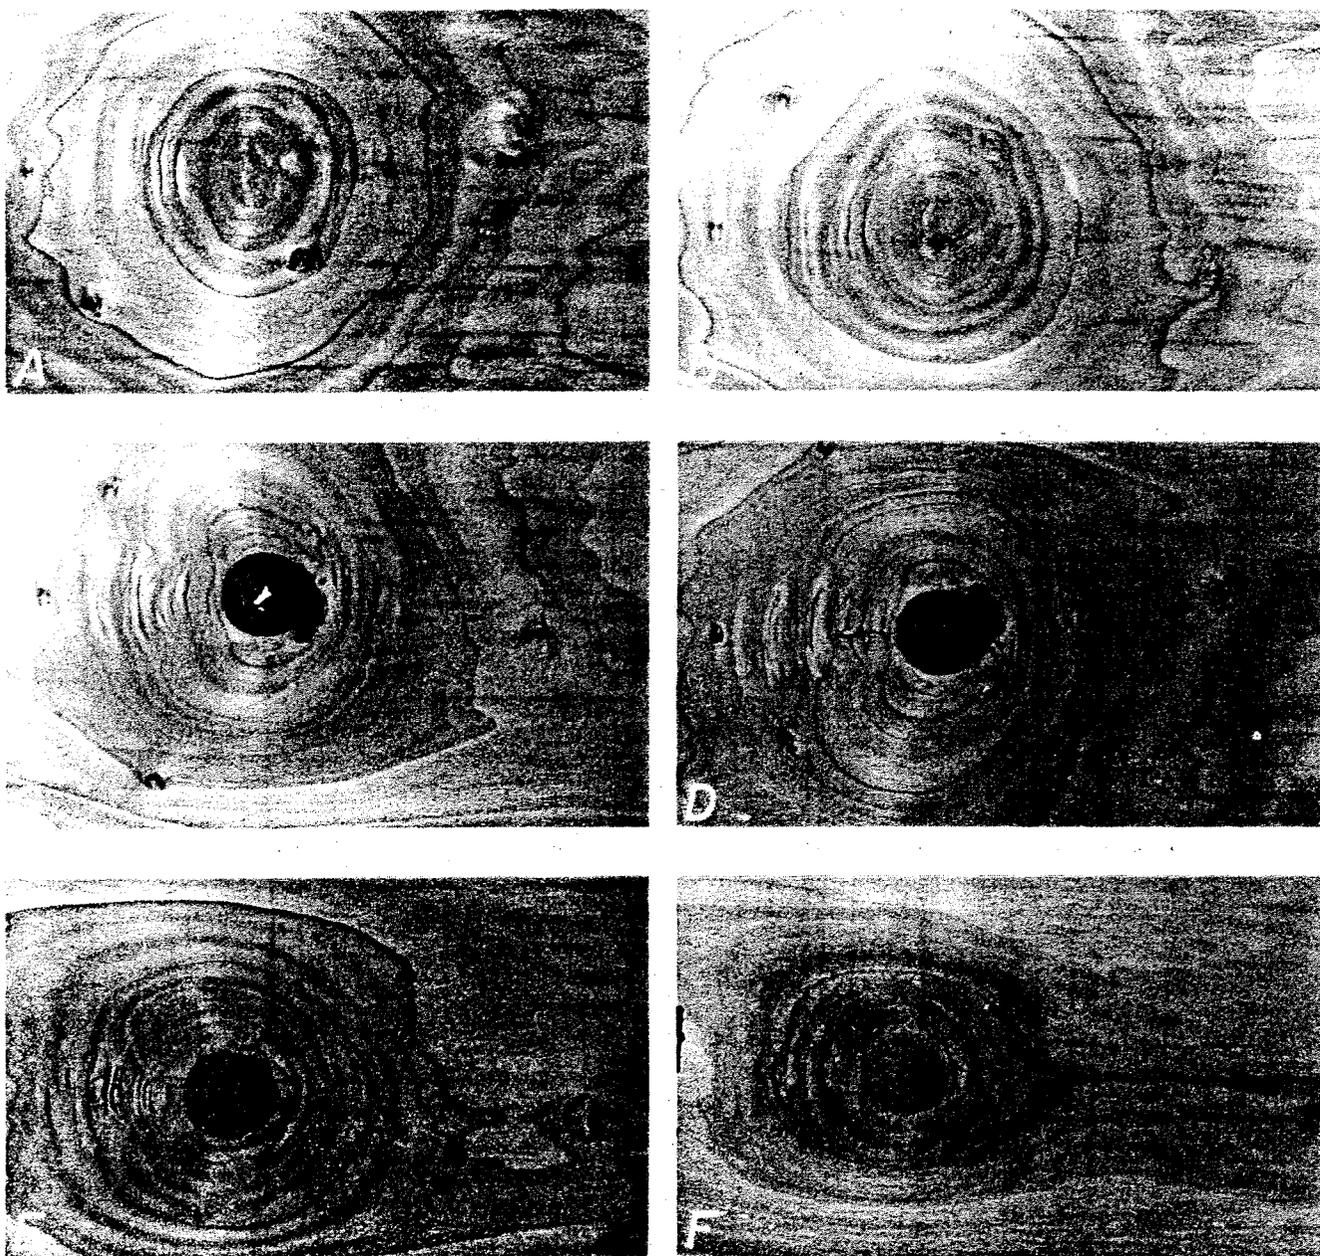
Figure 19.--Veneer **under** an overgrowth at approximately **2-inch** intervals along the radius of a yellow-poplar block.

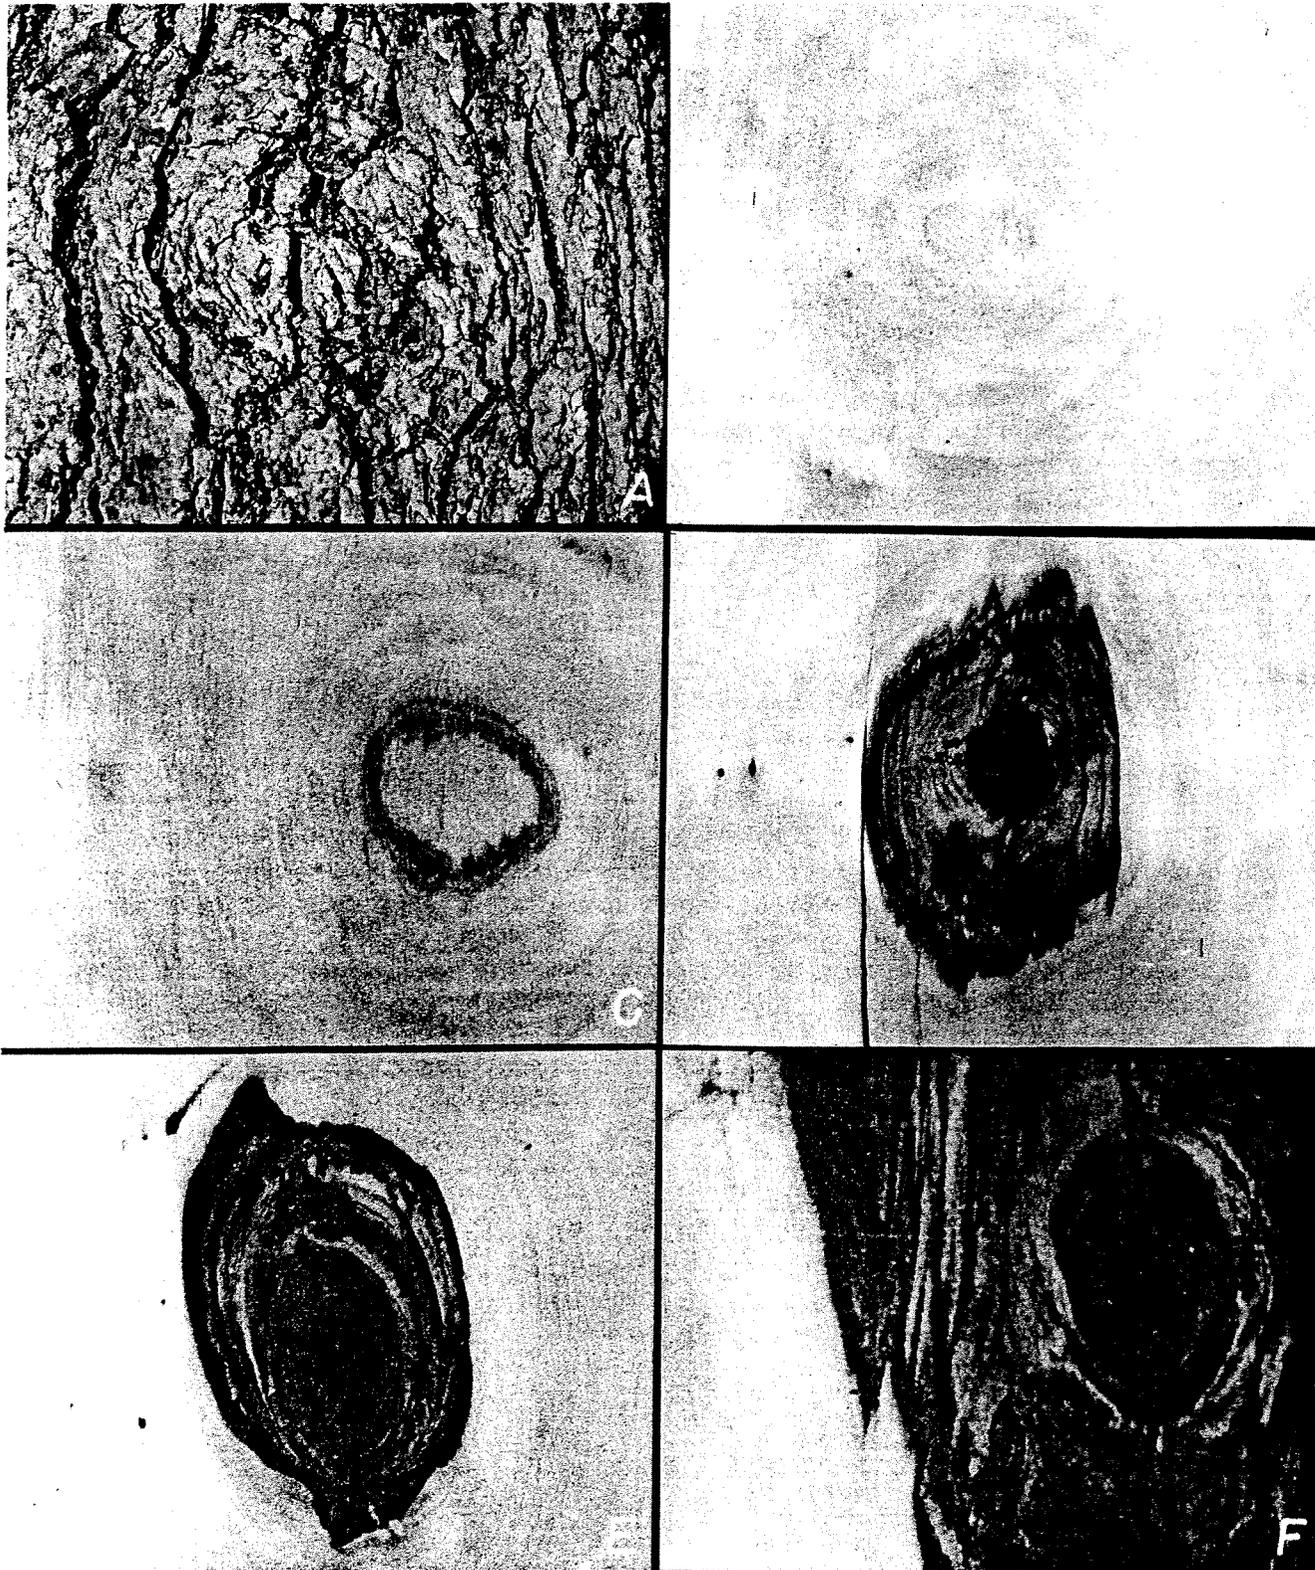
Overgrowths in sweetgum.--One of the most common types of overgrowth in second-growth sweetgum logs of small diameter is the "cat's eye." This is a slightly depressed bark distortion indicative of the presence of a buried branch immediately below (fig. 20). The distortions on larger logs or where the stub is more deeply buried are quite similar to those of yellow-poplar. Obliteration of overgrowths on sweetgum appears to take much longer than in yellow-poplar.

Figure 20. --Cat's eye and defect in underlying veneer from sweetgum block. Cat's eyes are usually slightly depressed.
