DEFECTS IN HARDWOOD VENEER LOGS: Their Frequency and Importance

E. S. Harrar

SOUTHEASTERN FOREST
EXPERIMENT STATION
Asheville, North Carolina

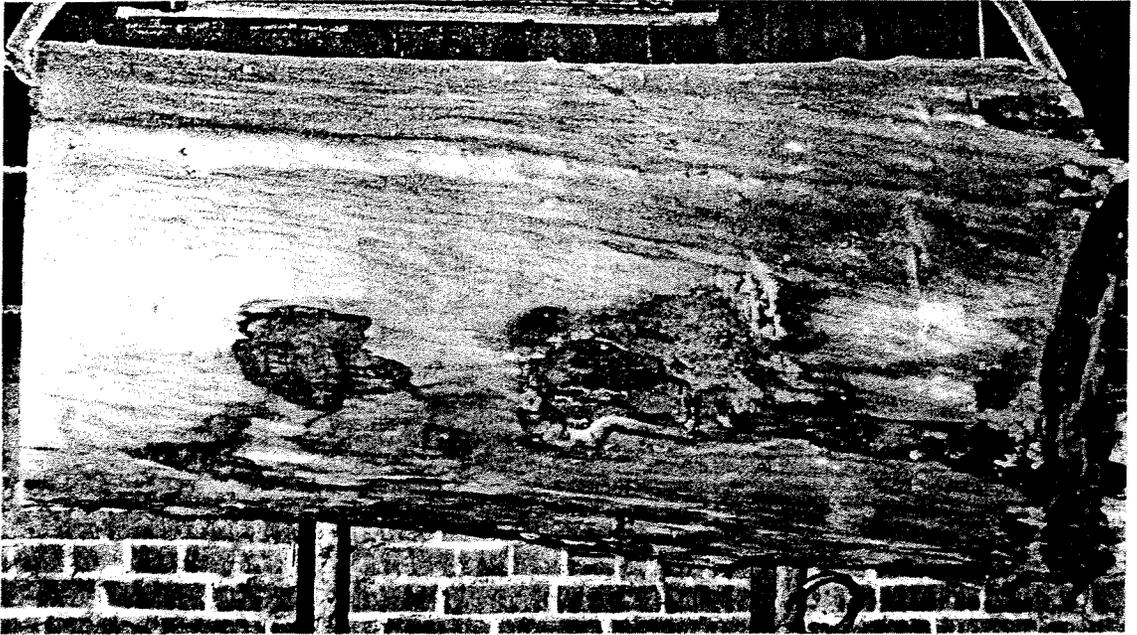
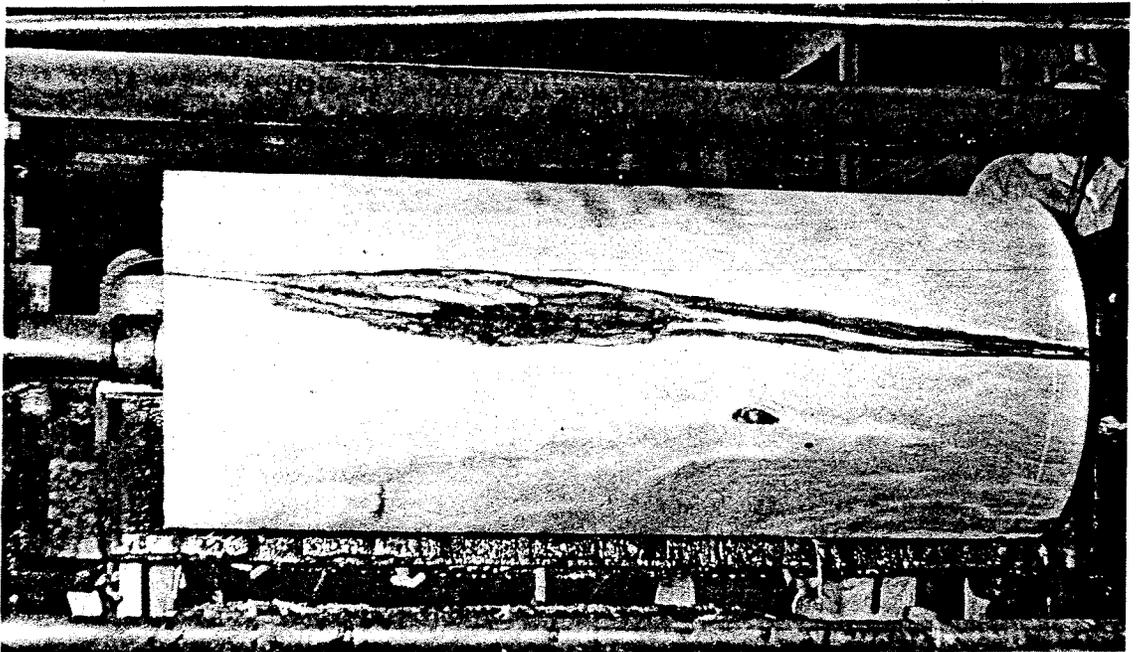
Figure 21.--Seam in sweetgum block. Note streak of decay below seam.

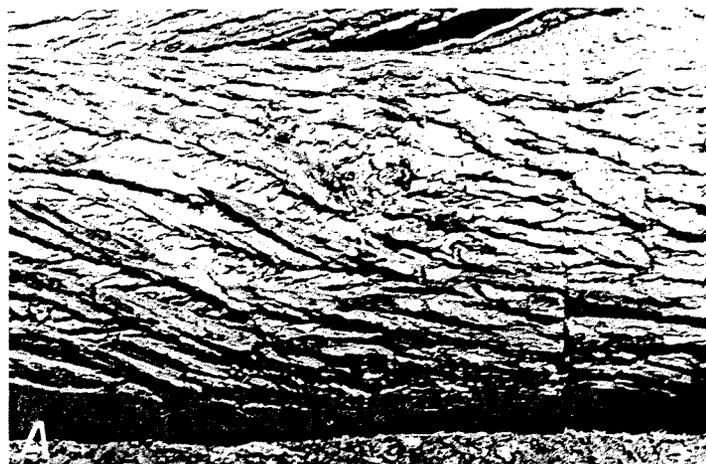
this latter condition. Spiral bark does not connote defect in the usual sense, but its presence on sweetgum logs (fig. 22) invariably indicates wood of inferior quality and limited utility. Logs with spiral grain produce veneers with rough, uneven surfaces that shrink and warp excessively in drying. In the development of any set of log grades involving sweetgum, the degrading effect of spiral bark must be considered, even when such logs are otherwise free from external indicators of defect.

Figure 22.--A, Spiral bark in sweetgum.
B, Rough cut veneer from spiral-bark log.

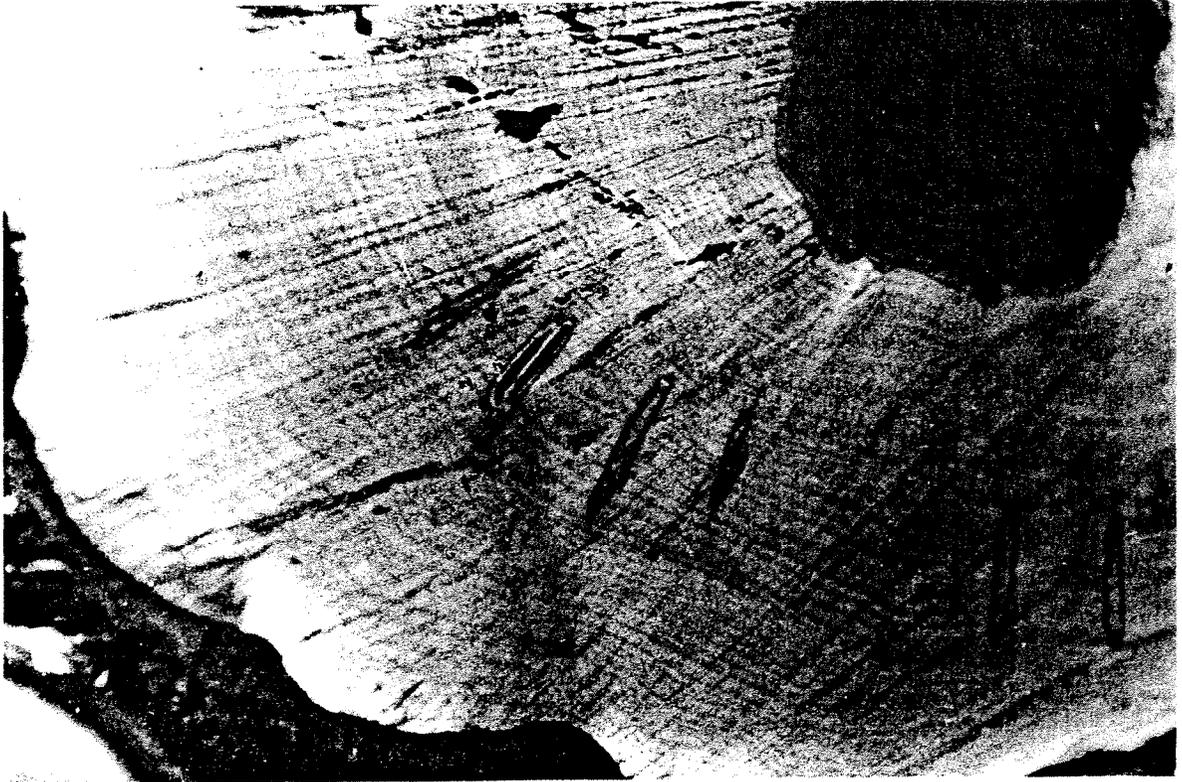
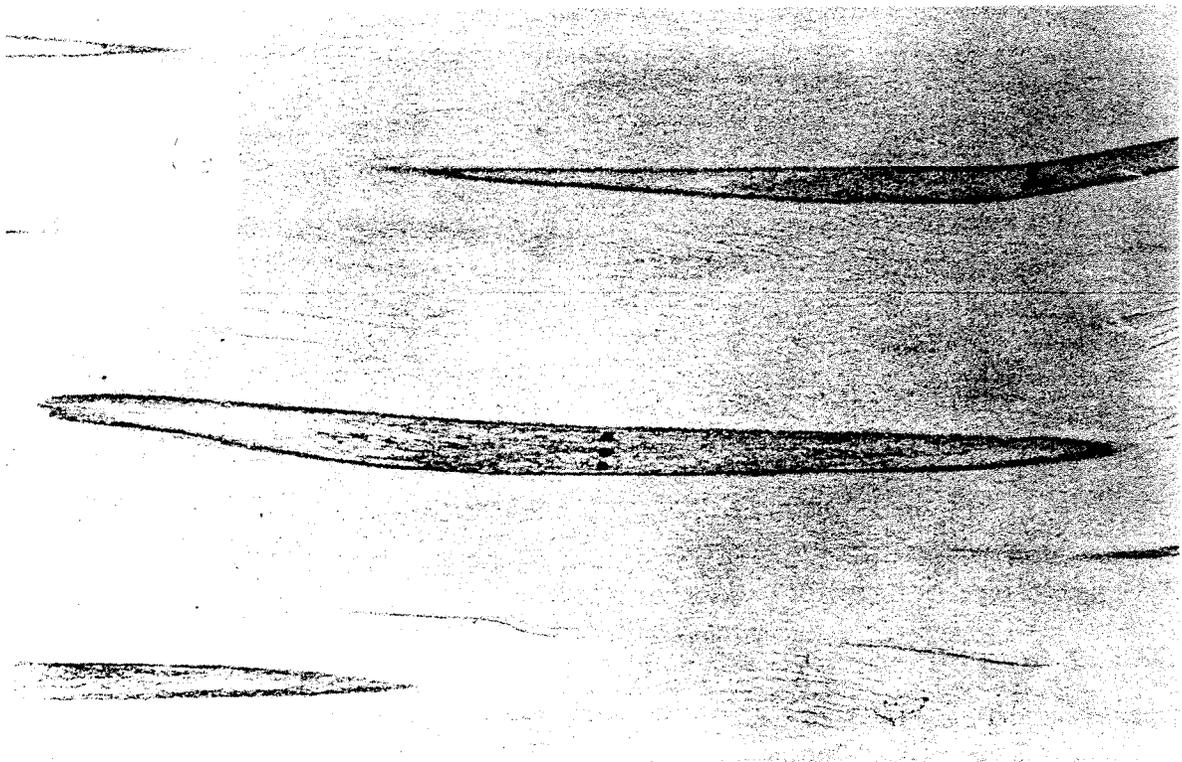
Figure 23.--A, Flag worm in sweetgum. B, Flag worm injury in veneer, with holes caused by Columbian timber beetle.

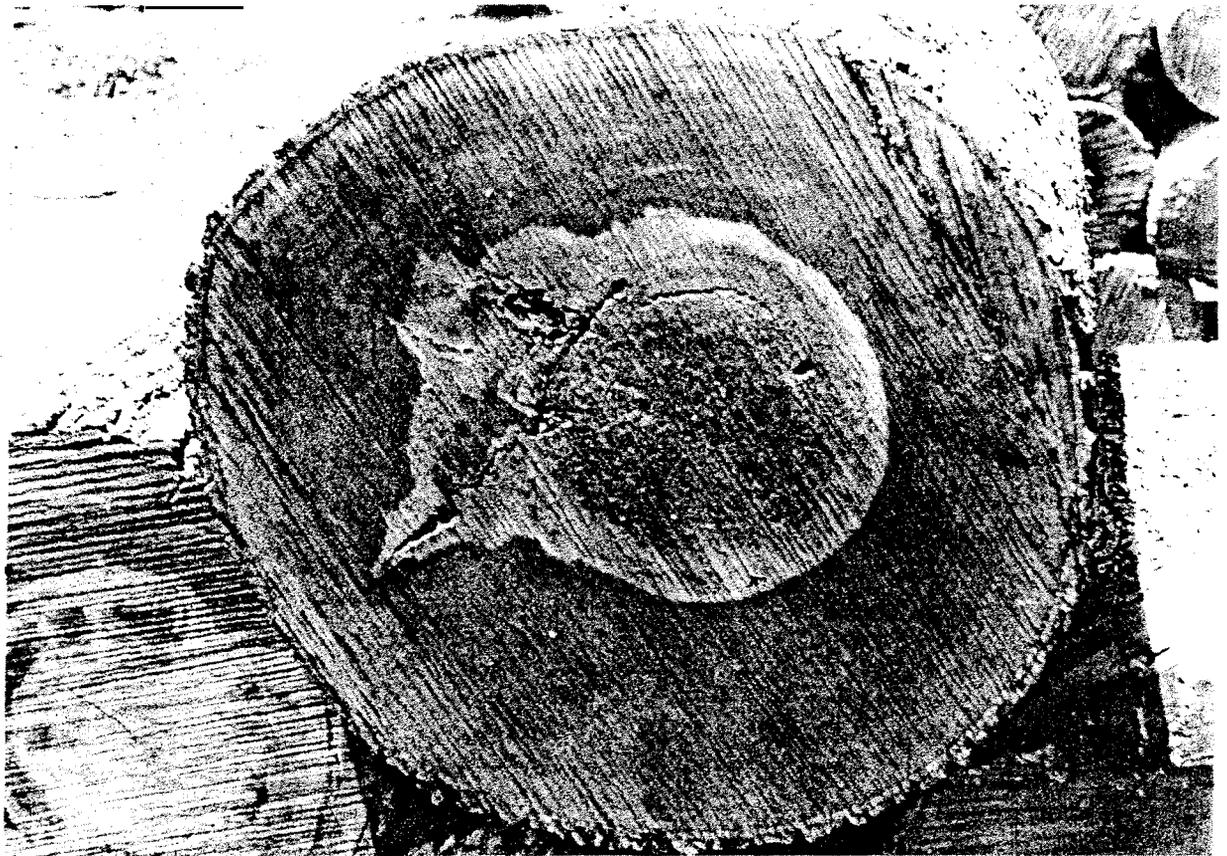
Figure 24.--Heart rot in yellow-poplar.

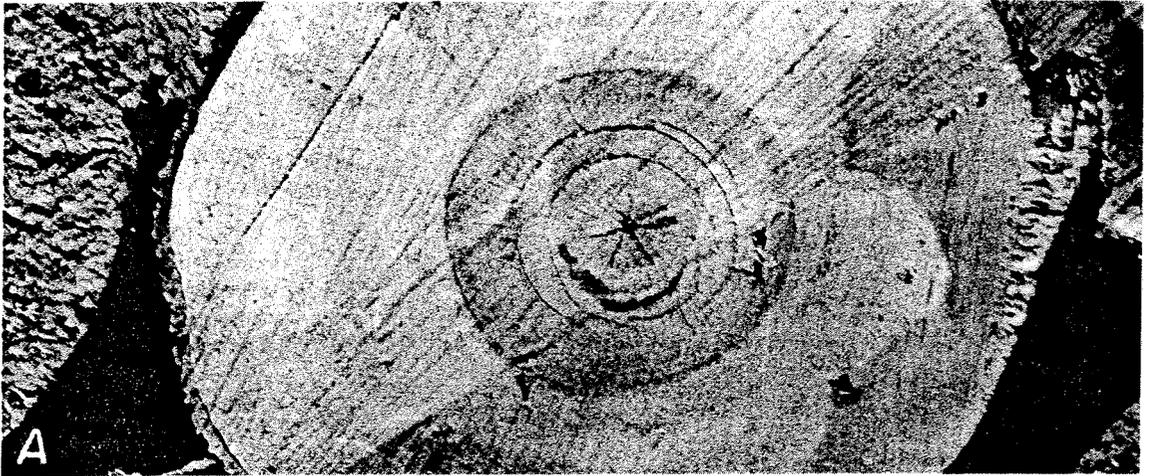
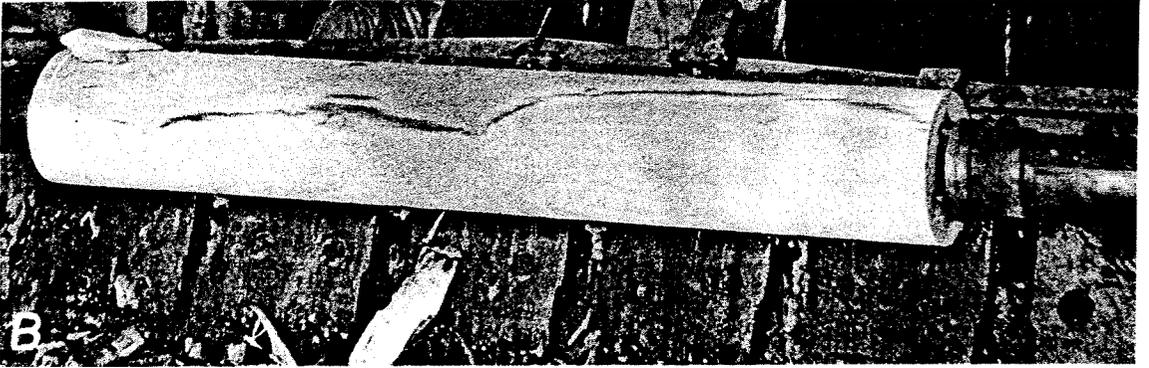
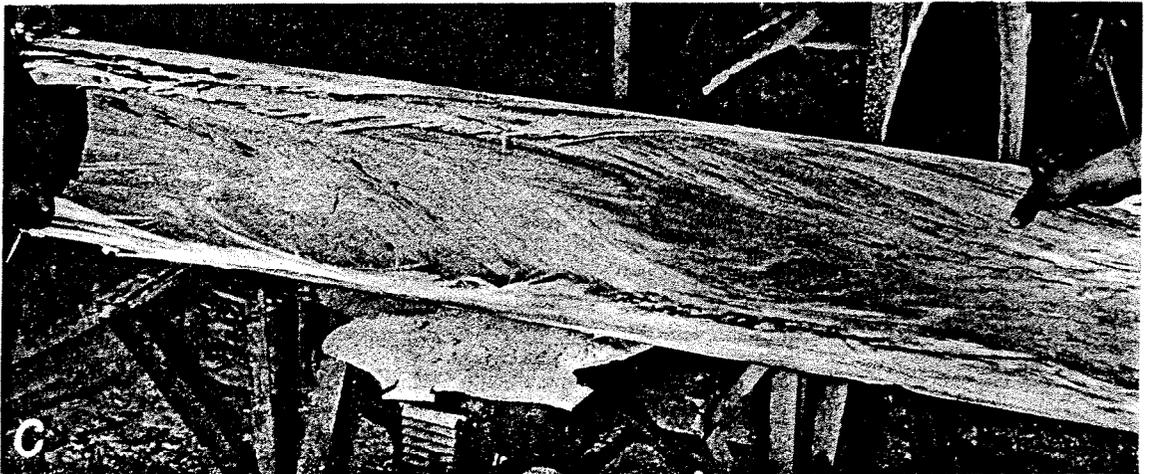
In effect, a log with loose heart comprises an inner cylinder of wood surrounded by a more or less detached outer layer (fig. 25). This, coupled with the fact that wood from the vicinity of loose heart is usually soft, brash, and below average density for that of the species, makes the turning of such logs difficult. Chucks cannot be firmly seated in soft, brashy wood,

and a block will "hang up" on the nose bar and knife; meanwhile if the chucks continue to turn, the heart center becomes free and further peeling is impossible. The use of larger chucks will often prevent this difficulty, but in any case the residual core is large and veneer yield small. Eccentric chucking of such blocks in a lathe permits a degree of salvage, but here again large cores are inevitable and veneer recovery is incomplete. When the central core about loose heart is particularly brash and weak, the revolving block may suddenly split open and break out of the lathe before peeling is completed, in which case it is rendered completely worthless for further production of veneer. Finally, if the loose-heart zone is **large** and the chucks fall inside of the loosened area, peeling is impossible.

Figure 25.--Loose heart in tupelo and its effect on the cutting of rotary veneer. In photo C the veneer core separated from rest of bolt when knife entered loose heart zone.

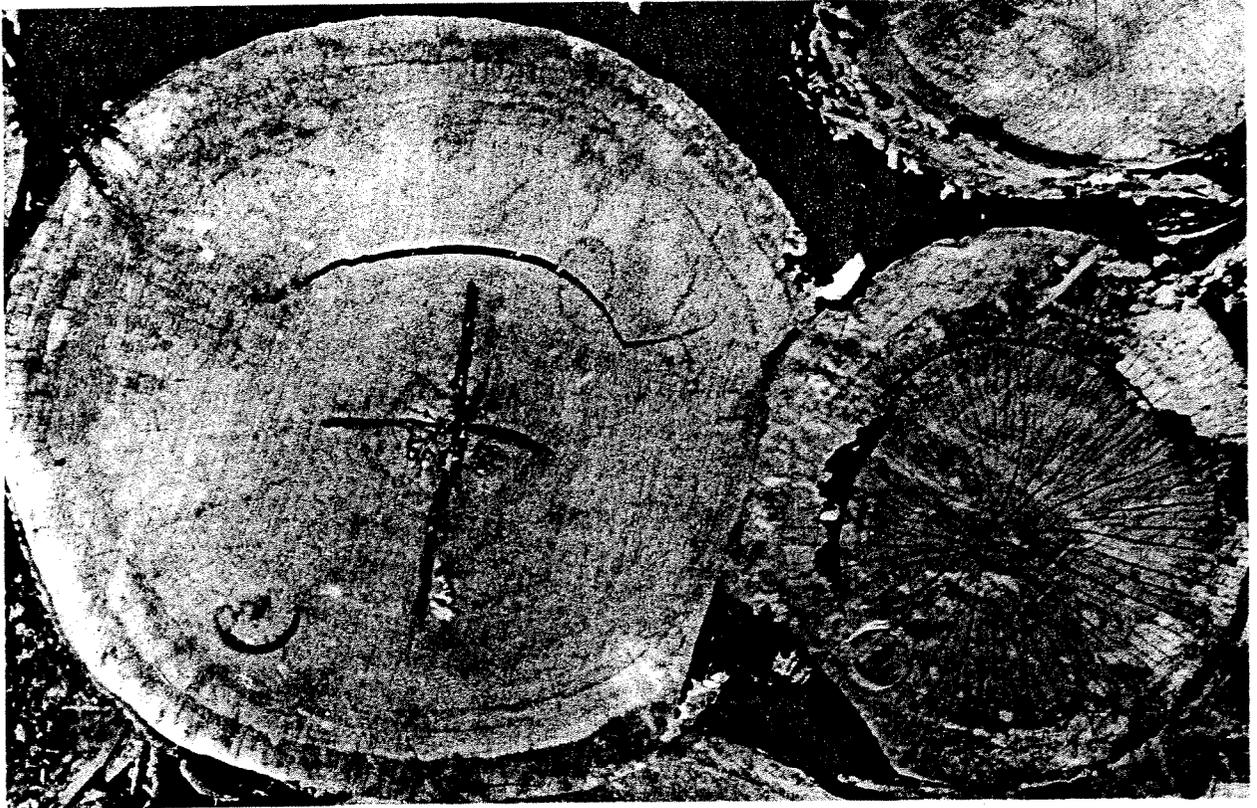
Figure 26.--Ring shake in tupelo log ends and in the veneer.

Among the four species under observation, ring shake was most prevalent in tupelo. Veneer cut from such material is often overly rough. The length of thin sheets is limited to the possible number of turns between any two adjacent lines of rupture, while in thicker stocks sheet continuity is interrupted by (1) checks extending into the sheet for varying distances from either of its edges or (2) partial separations appearing in the form of oblique fissures extending well into and even through the sheet from face to face.

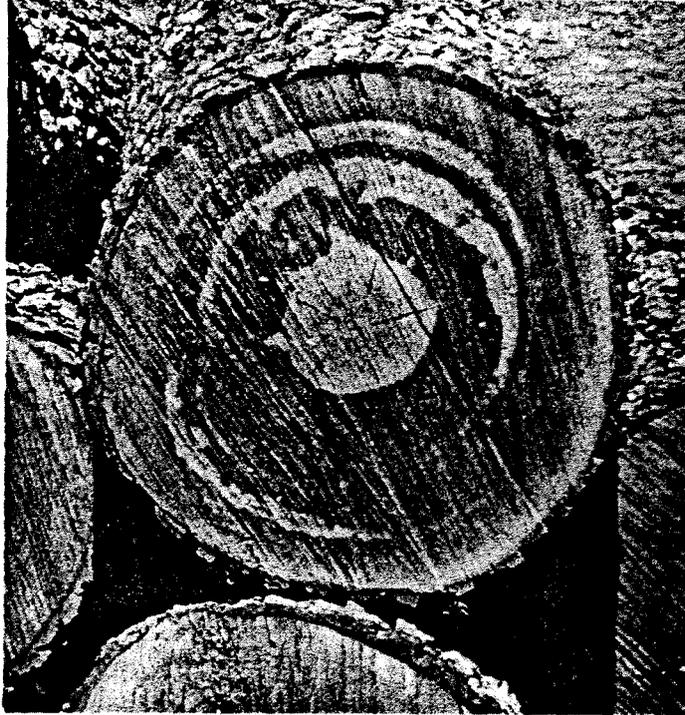
In veneer unselected for color, pathological heartwood is not objectionable and under normal circumstances cannot be regarded as a defect.

Figure 27.--Pathological heartwood in sweetgum.

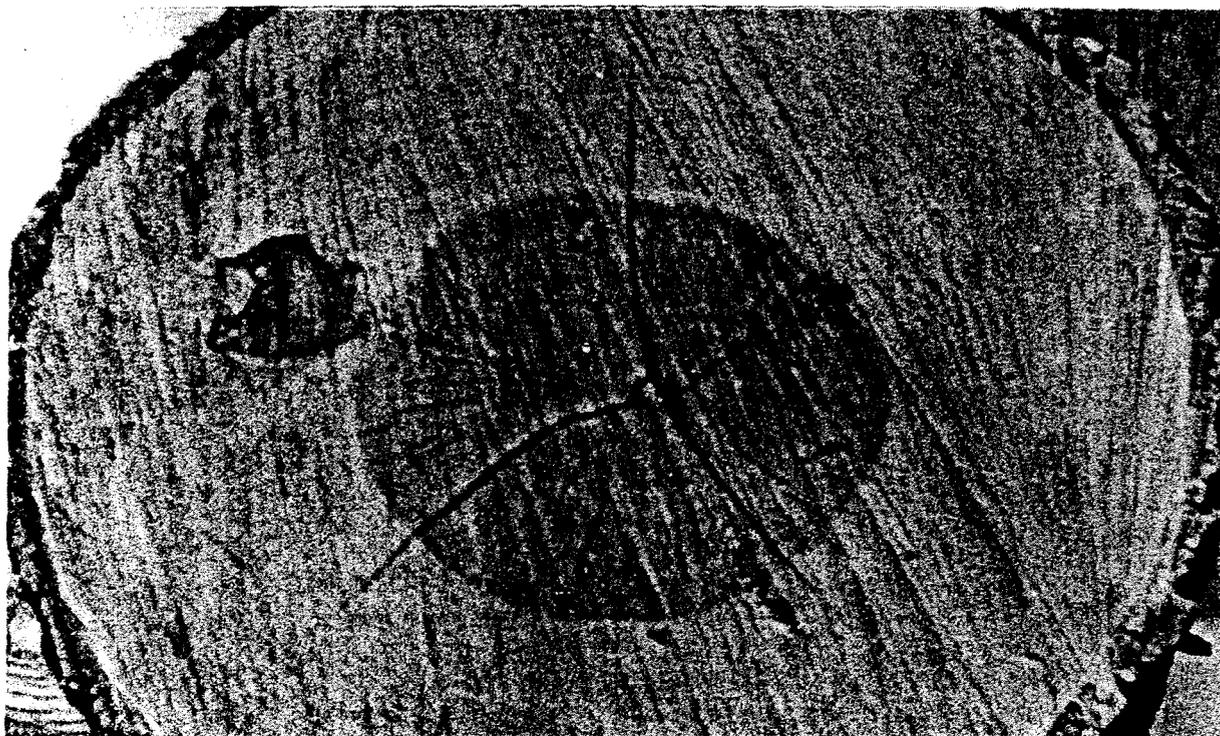
In veneer logs in which the lines of separation **are** poorly developed and fall wholly within the confines of residual cores, spider heart is not a defect. On the other hand, when one or more such lines of failure extend outward into the woody cylinder, long continuous sheets of veneer give way to the production of shorts. If only a single separation is encountered, sheet length is then equal to the circumference of the cylinder at the point where the knife crosses the break. Such sheets are suitable for panel production, but because of their variable lengths, clipping to a standard or

Figure 28.--Spider heart,

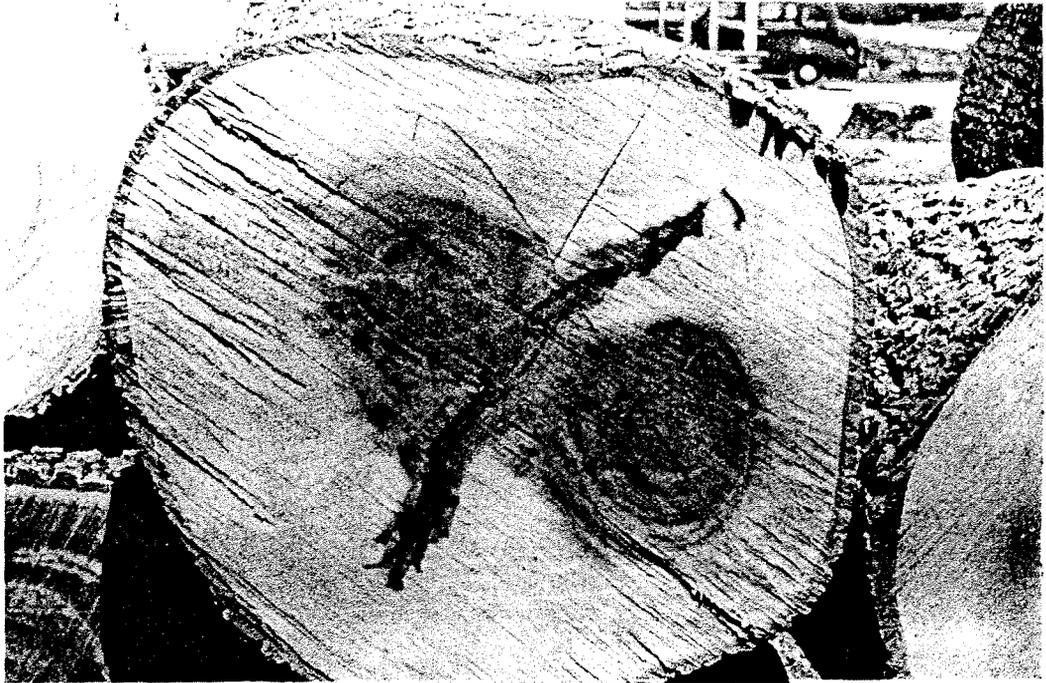
Figure 29. --Double pith Inyellow-poplar.

Double pith must be classed as a defect in veneer logs, because the swollen edge, the included bark, and excessive grain distortion affect veneer quality and quantity. Diagonal and cross grain in such logs are prevalent, and veneer may be excessively rough. End splitting of the sheets is frequent. As the knife crosses the central bark pocket, sheet continuity is broken, and only shorts can be produced from the residual cylinder.

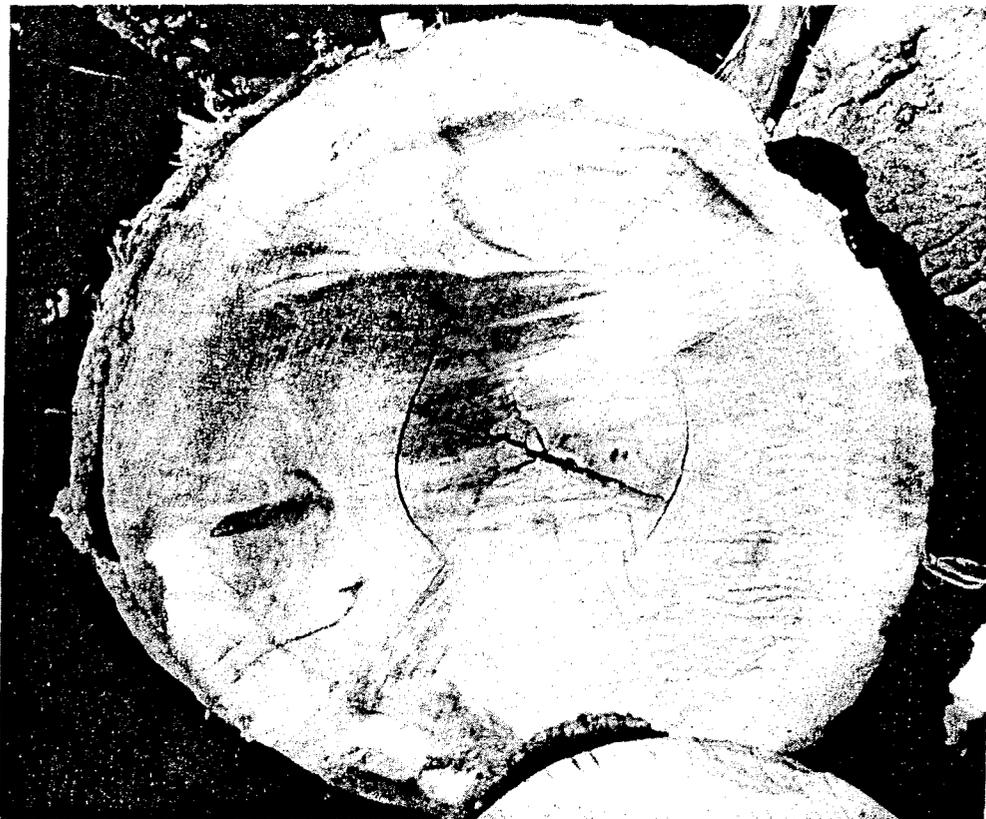
Figure 30.--Windshake. Note also associated ring shake.

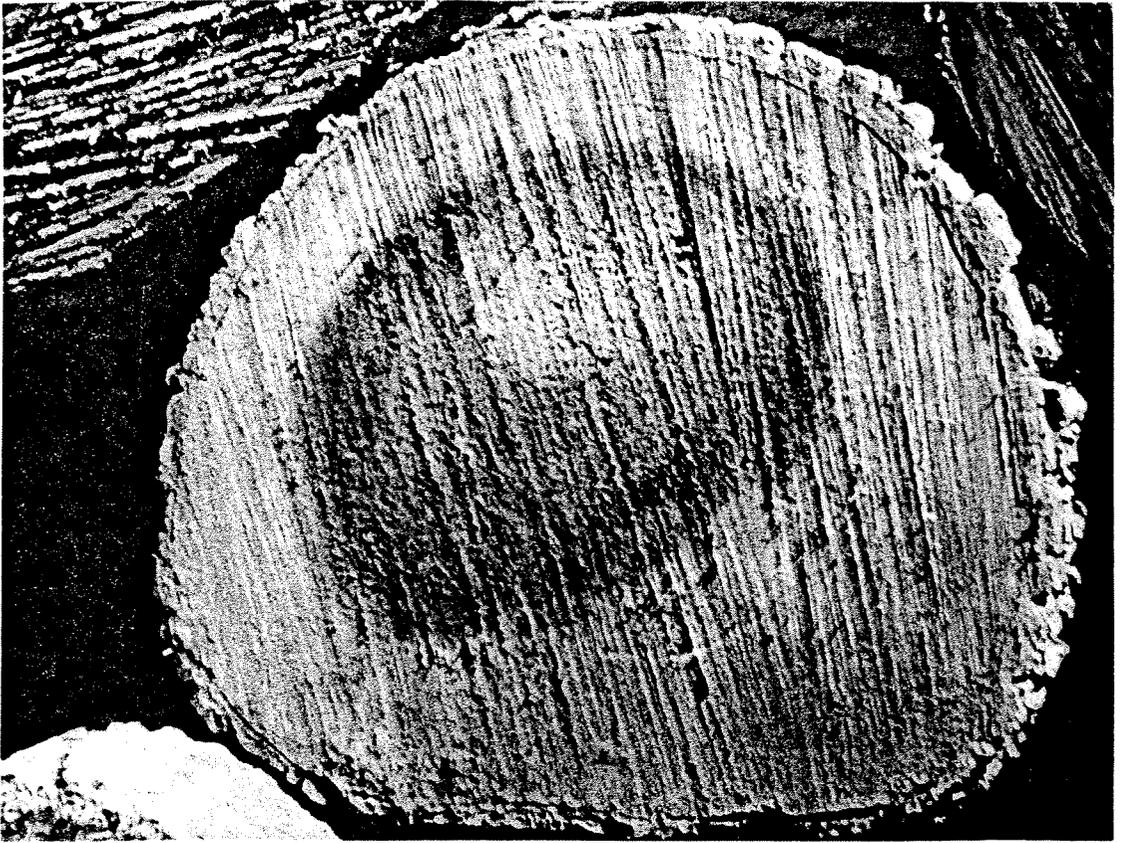
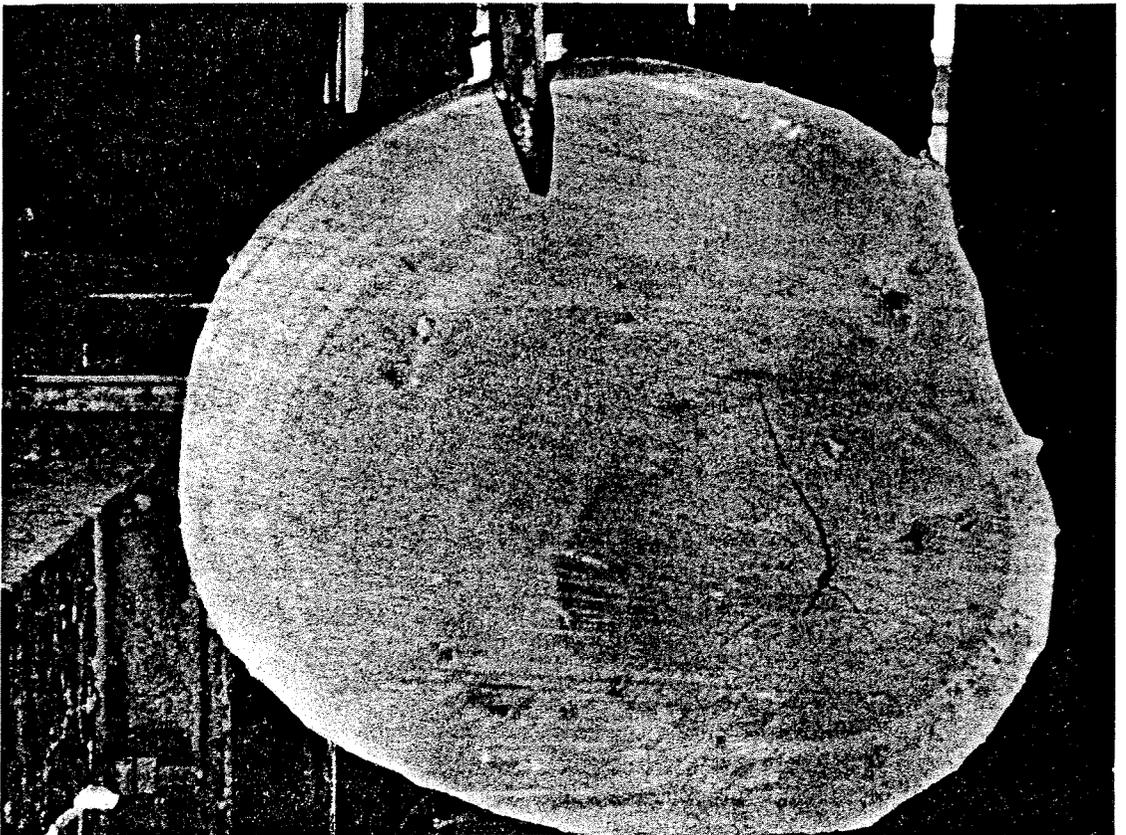
Many sound logs and blocks delivered to veneer plants are asymmetrical and feature flat sides, off-center piths or oval transverse sections (fig. 31). While such logs are frequently free from visible defect, they are less desirable for the production of rotary veneer than full-rounded stock. In the rounding, much clear peripheral wood goes into waste, and the salvageable shorts must be spliced to produce full-length sheets, thus adding to production costs. Allowance for waste should be made when grading and scaling such material.

Figure 31.--Out-of-round logs of yellow-poplar.
