Coarse sediment storage and connectivity and off-highway vehicle use, Board Camp Creek, Arkansas

Jonathan D. Phillips*, Daniel A. Marion

Tobacco Road Research Team, Department of Geography, University of Kentucky, Lexington, KY 40506-0027, USA

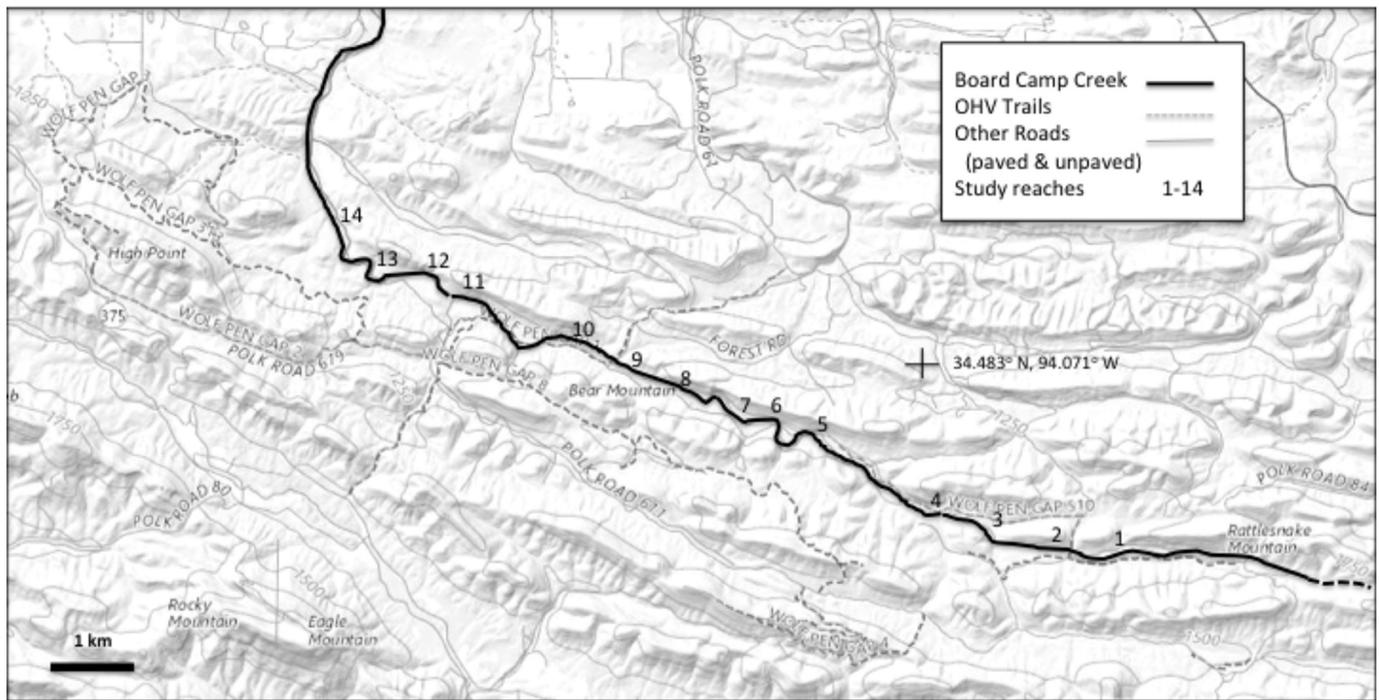
Fig. 1. Board Camp Creek; flow is southeast to northwest. Numbers indicate study reaches; base map from U.S. Geological Survey National Map. Main OHV trails in Wolf Pen Gap are shown; others also exist within the area. For a detailed current trail map see https://www.fs.usda.gov/Internet/FSE_DOCUMENTS/stelprdb5212722.pdf (last accessed 15 July 2019).

The BCC/WPG study area is in the Ouachita Mountains of western Arkansas (Fig. 1). The Ouachitas are generally east-west trending, parallel ridges. Peak elevations in the study area are typically about 420 to 480 masl. The climate is humid subtropical, with hot summers, relatively mild winters, and year-round precipitation. Mean annual precipitation in the WPG area is about 1350 mm, almost all in the form of rain.

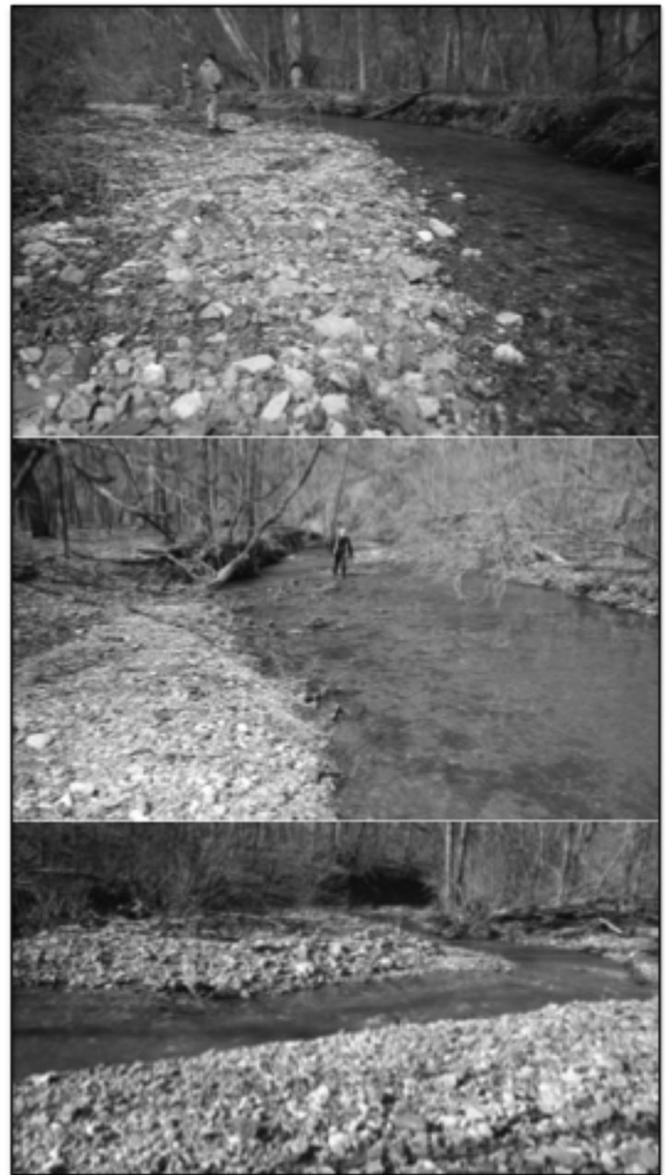
Fig. 2. Point (top), lateral (middle), and mid-channel (bottom) bars in Board Camp Creek.

Current sediment storage was quantified within each sample reach. Sediment storage features included point, lateral, and mid-channel bars (Fig. 2). These were field surveyed using the laser level and prism, measuring tape, and folding ruler or stadia rod, depending on their size and characteristics. The longitudinal length was measured, along with 3 to 12 width measurements (depending on size and geometric complexity) to determine mean width, and mean elevation relative to the channel thalweg and to the nearest banktop. Measurements were to the nearest 0.1 m for length and width, and 0.01 m for height. Total storage volume (m^3) was computed as the product of length, mean width, and mean height relative to the channel bed.

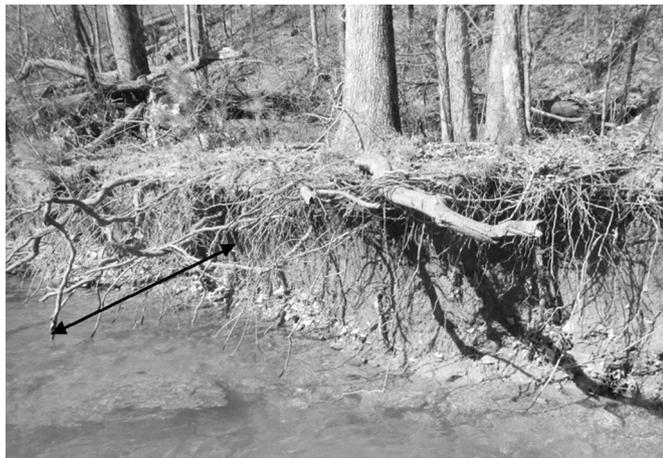
Fig. 3. Arrow indicates example measurement of minimum bank erosion based on exposed tree roots.

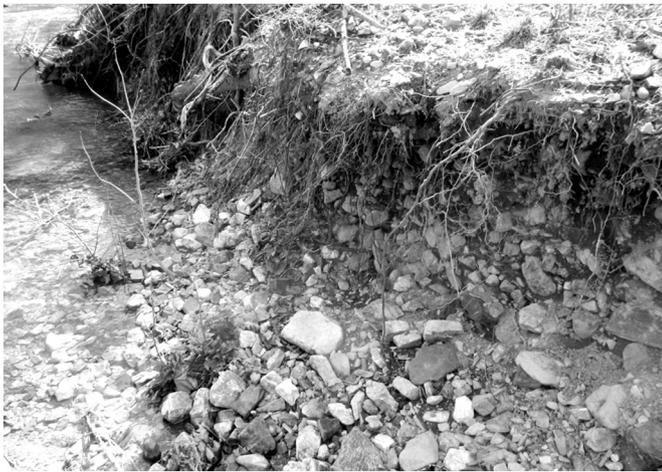
Fig. 4. Range of particle sizes exposed in eroding alluvial stream bank and adjacent lateral bar.

General characteristics of the study reaches are shown in Table 1. Alluvium ranges in size from fines to boulders, but is dominantly coarse-pebble to small-cobble size (Fig. 4). Bedrock outcrops in the channel bed and banks are common. The channel is flanked by relatively narrow floodplains on one or both sides along most of its length.

In addition to bank erosion and some input from the trail system, some coarse sediment may be supplied by slope processes. Further, regolith stratigraphy in the study area and elsewhere in the Ouachitas indicates ongoing creep (Phillips et al., 2005). Field observations show that, due to the typical joint, fracture, and bedding plane characteristics of the rocks, cobble size fragments of the harder (i.e., non-shale) lithologies are commonly produced. This is reflected in the size and frequency of rock fragments found in soils in the area (Olson, 2003). Thus, even in the absence of accelerated upland erosion, particles of this size would be common (as they are in relatively undisturbed streams in the region; Marion and Weirich, 2003; Fig. 4). Due to the high shear stresses

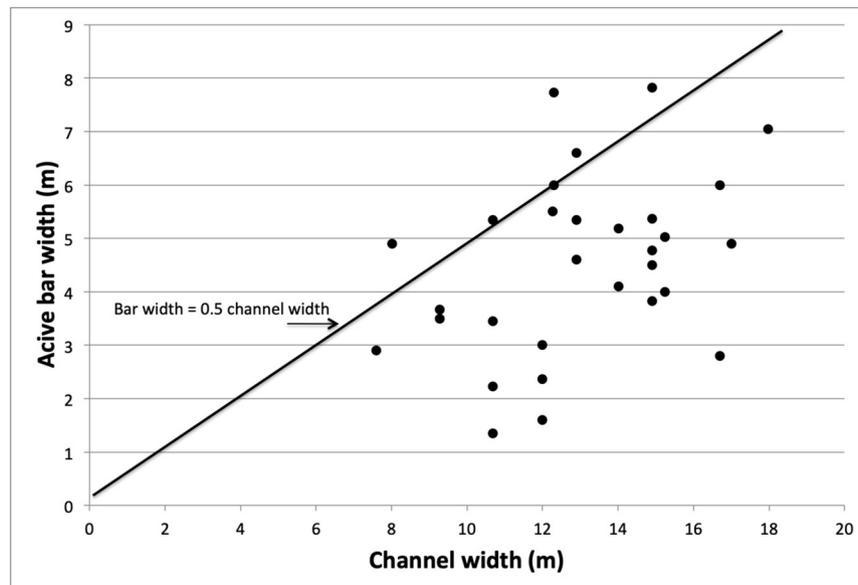
Fig. 5. Relationship between bar and channel width.

While bar width must be locally limited by channel width, it is not otherwise related to the banktop channel width of the representative cross section for each reach. Fig. 5 shows that all but 5 of the 31 storage features lie on or below a line representing a bar width equal to half of banktop channel width, illustrating the very general scaling relationship. Otherwise, there is considerable scatter. Similarly, Fig. 6 shows that all but three points fall below a line representing bar height = mean depth \times 2, but with otherwise no apparent relationship between mean depth and bar height or thickness. Recall, however, that all bar tops are below the banktop channel elevation. Overall, results suggest weak scaling representing the constraints of channel size on bar size, but also reflecting local variations in sediment supply vs. transport capacity relationships.

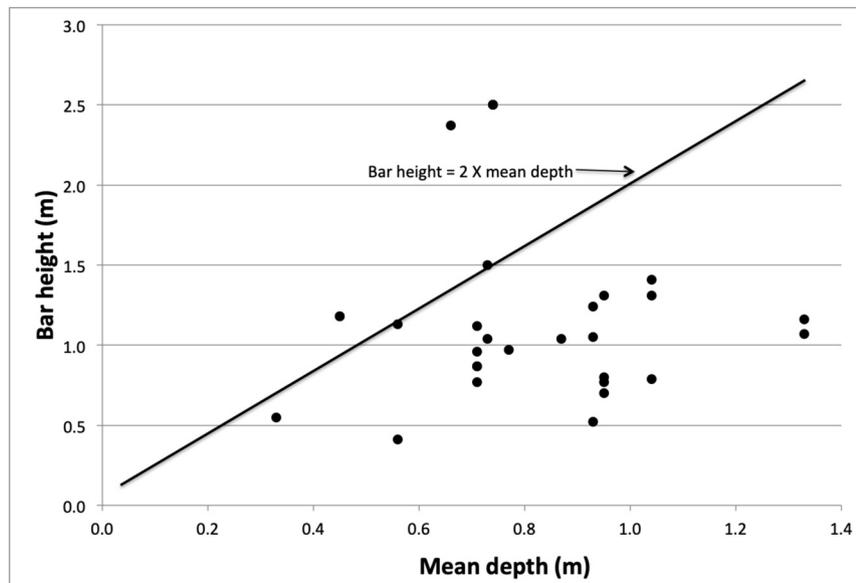
Fig. 6. Relationship between bar height and adjacent mean channel depth.

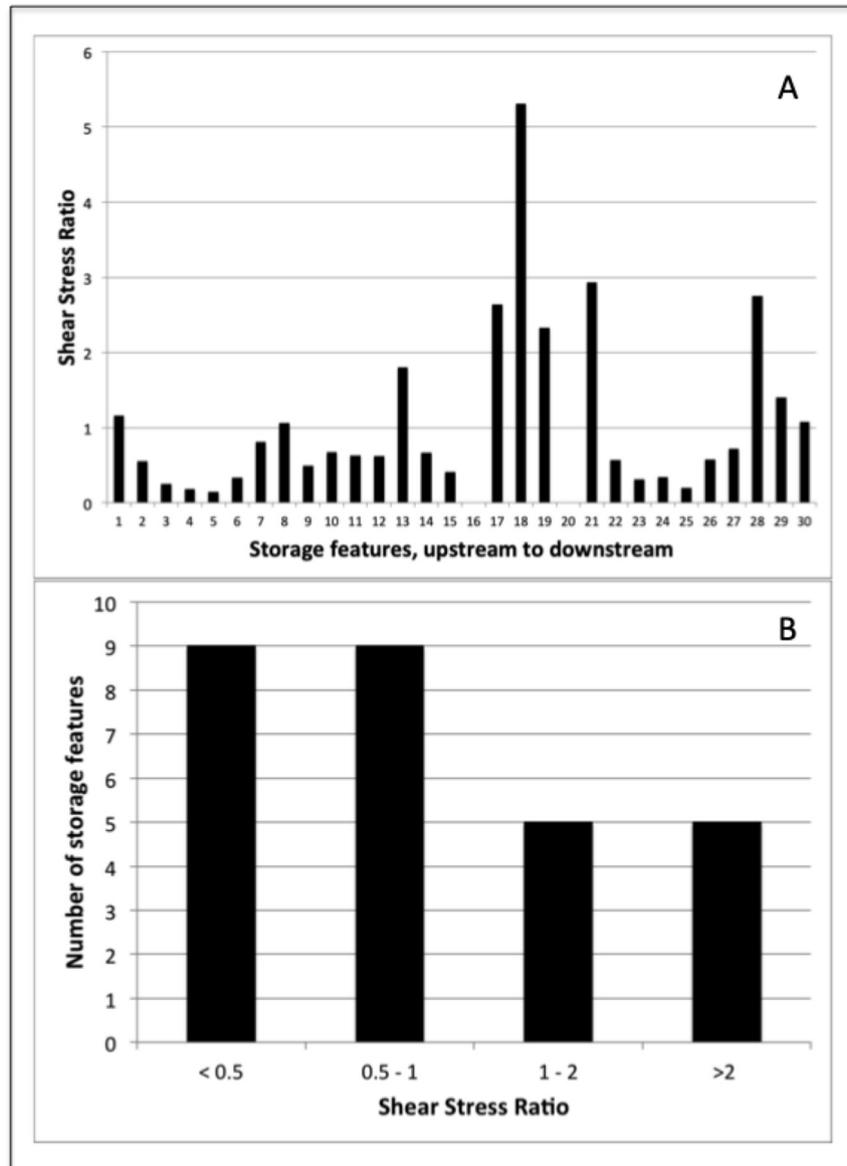
Fig. 7. Ratio of critical shear stress for largest mobile clast to estimated maximum shear stress at banktop flow. Largest mobile clast samples missing from bars 16 and 20 in A.

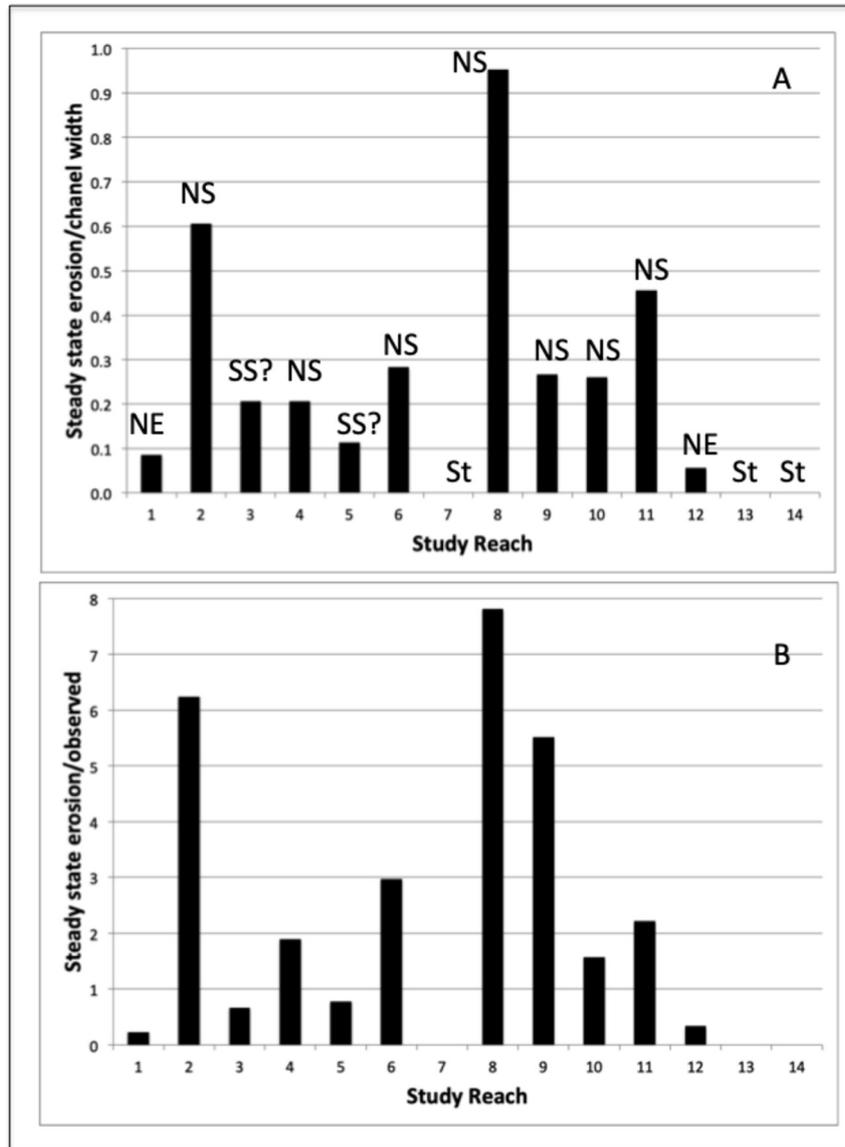
Fig. 8. Steady-state erosion relative to bankfull channel width (A) and to observed bank retreat (B). Top also shows the coarse sediment function of the reaches: NE = net erosion (sediment source); NS = net storage; St = storage only; SS = approximate steady-state.

Fig. 8 shows the sediment function of the reaches. Three sites have storage and no erosion (7, 13, 14), thus are deemed storage sites. For 7 of remaining 11 reaches the SSE was greater (by up to nearly eight-fold) than the observed retreat (Fig. 8). Therefore, a total of 10 reaches exhibit net storage. In all of these cases $SSE \geq 0.21 W$, and SSE is > 1.5 to nearly eight times the observed erosion (Fig. 8). Reaches 3 and 5 may be in approximate steady-state. Bank erosion necessary to balance measured storage is 0.21 W and 0.11 W, respectively, but in both cases less than observed bank retreat. Reaches 1 and 12 are net sediment sources.
