Water Quality Impacts from an ORV Trail Stream Crossing in the Talladega National Forest, Alabama, USA¹

Abstract

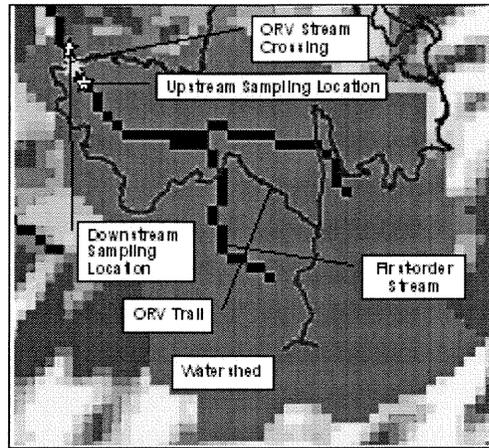
Figure 1 - Kentuck ORV trail and stream crossings. Spatial representation of the 113 ha

Permission was granted by the United States Department of Agriculture (USDA) Forest Service, Talladega Ranger District to conduct this study on their trail system. While the entire trail system is 30 miles long, a 2-mile looped portion of the trail was selected for this study. Before the data collection process could begin, certain criteria were established for selecting a suitable stream crossing to sample for SS loads: it had to be perennial, it needed to intersect the trail system, an ORV with a trailer had to be able to access it, it needed to have high enough flow rates to meet the data logger requirements, and there needed to be a sufficient stream bank for the installation of the data collection equipment. After this was completed, both a Geographic Information System (GIS) and a Global Positioning System (GPS) were used to identify and locate several streams within the trail system. The streams were assessed according to the set criteria, and a suitable stream was selected that had a bridge. The watershed area (113 ha) upstream from the stream crossing was delineated using GIS (Figure 1). The slopes of the trail approaching the stream from the left decreased from 18 percent to 1 percent slope and increased to 3 percent on the right side of the stream (Figure 2).

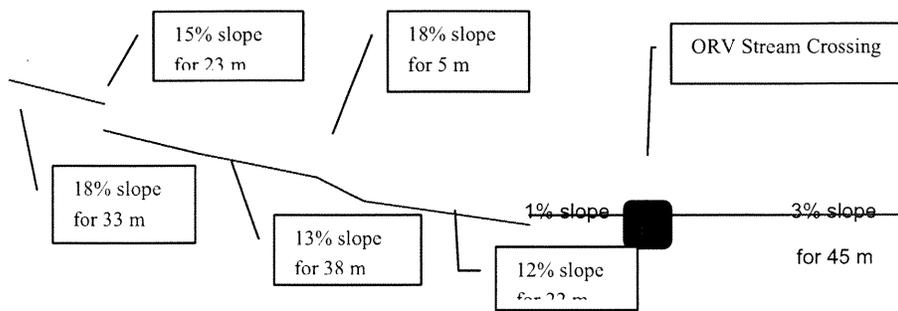
Figure 2 – Profile view of the ORV stream crossing

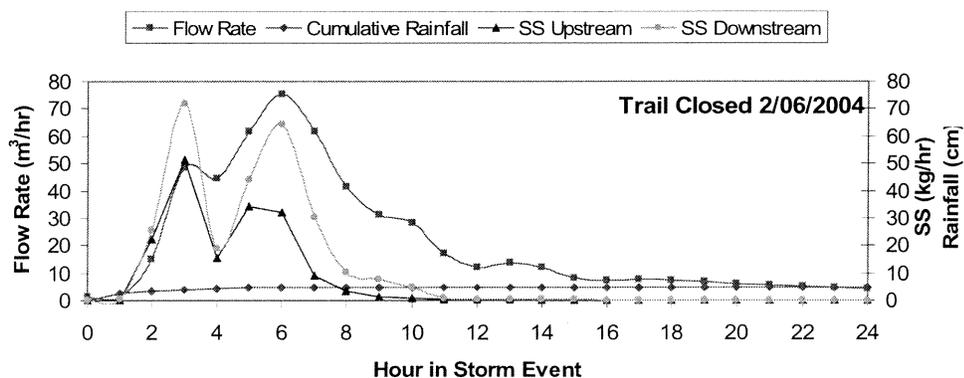
Figure 3 – Flow rate, cumulative rainfall, and suspended sediment loads from a 49 mm storm event that occurred on February 6, 2004 during trail closed condition.

When the data collection began (December 16, 2003) the trail was open for a short time. Soon after that, the trail was closed due to a highly degraded state. The trail remained closed until the end of February 2004. The trail had areas of exposed soil that had accumulated when the trail was open to ORV traffic. During trail closure, four storm events were recorded. These storm events included a 49 mm storm that occurred on February 6, 2004 (Figure 3).

The ORV trail stream crossing contributed 109 kg of sediment during this storm event, which constitutes about 39 percent of the load contributed by the 113 ha watershed (Table 1). Sediment loading to the stream reached its peak (75 kg/hr) during the 3rd hour due to the intense nature of the previous hour of rainfall. After this

event, the sediment load declined both above and below the stream crossing because of the decrease in rainfall intensity. The rainfall intensity increased again during the 5th and 6th hours and contributed a large sediment load from the ORV stream crossing. The ORV trail stream crossing contributed little sediment load from other storm events that occurred during trail closed condition (Table 1). It should be noted that these storm events had a return period of less than one year.

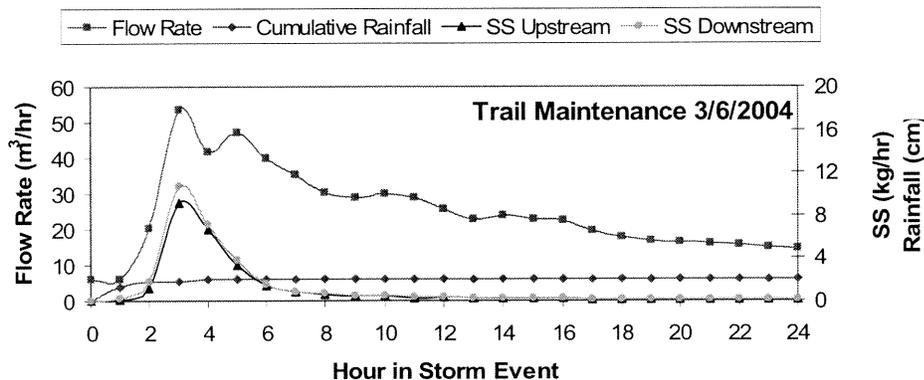
Figure 4 – Flow rate, cumulative rainfall, and suspended sediment loads from a 20 mm storm event that occurred on March 6, 2004 during trail maintenance condition.

As mentioned earlier, during the trail maintenance period (March 1, 2004 – March 16, 2004), a crawler tractor was used to remediate trail areas that contained standing water. Even though all of the soil that was removed from the trail surface during the “smoothing/blading” process was pushed to the center of the trail and compacted with repeated passes of the tractor, this process left loose soil on the trail when a 20 mm storm occurred on March 6, 2004. During the March 6th storm event there was a steady increase in rainfall during the first few hours. As a result, stream flow rate (57 m³/hr) and sediment load (30 kg/hr) measured by the downstream sampler reached their maximum values during the same hour (3rd), and slowly declined as the rainfall event ended (Figure 4). Two similar storm events occurring on January 25th and February 12th during the trail closed condition did not contribute nearly as much sediment as was contributed by this storm event (Table 1).

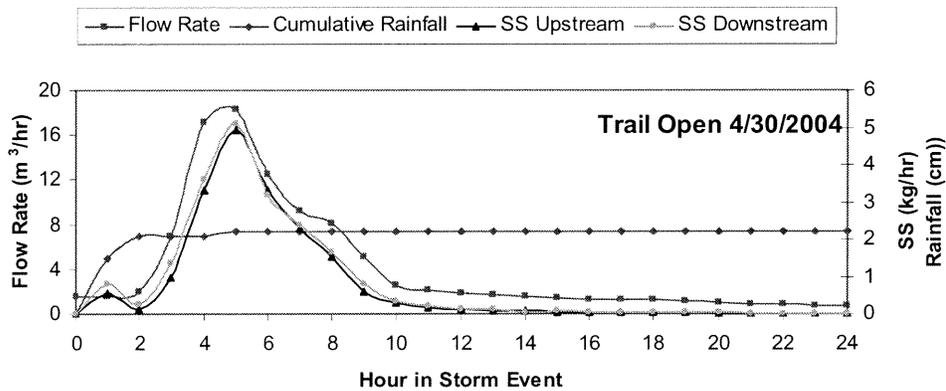
Figure 5 – Flow rate, cumulative rainfall, and suspended sediment loads from a 22 mm storm event that occurred on April 30, 2004 during trail open condition.

Shortly after the completion of the trail maintenance period, the trail was re-opened on March 20th to ORV use. The use of ORVs on a trail results in ruts, crevices, and the accumulation of loose soil that is spun off of the tires during fast accelerations and turns. Eight storm events after March 20, 2004 were recorded for this period. A 22 mm storm event (on April 30th) during this period resulted in 2.2 kg of sediment from the ORV trail stream crossing. The sediment load from this storm

event is slightly lower than the loads generated by a similar storm event that occurred on March 6th (Table 1). This 22 mm storm occurred after an 18 mm storm on April 26th. Since the soil was already wet, this storm event contributed large runoff and sediment loads. As shown in Figure 5, the rainfall during the April 30th storm peaked during a short time (during 2nd and 3rd hour) and resulted in a high intensity storm. A larger storm (36 mm) occurred on May 16th and did not contribute nearly as much sediment load due to a lack of rainfall prior to this storm event. The ground was fairly dry and did not result in much runoff and sediment load. In general, it was observed that when storm events occurred in succession there was an increase in the SS loads contributed by the ORV stream crossing.
