2007 Southeastern Friends of the Pleistocene Field Trip Guidebook

September 30, 2007

# Investigation of the Peeks Creek Debris Flow of September 2004 and Its Relationship to Landslide Hazard Mapping in Macon County, North Carolina

Rebecca Latham, Rick Wooten, Anne Witt, Ken Gillon, Tommy Douglas,  
Stephen Fuemmeler and Jennifer Bauer  
North Carolina Geological Survey, Swannanoa, North Carolina

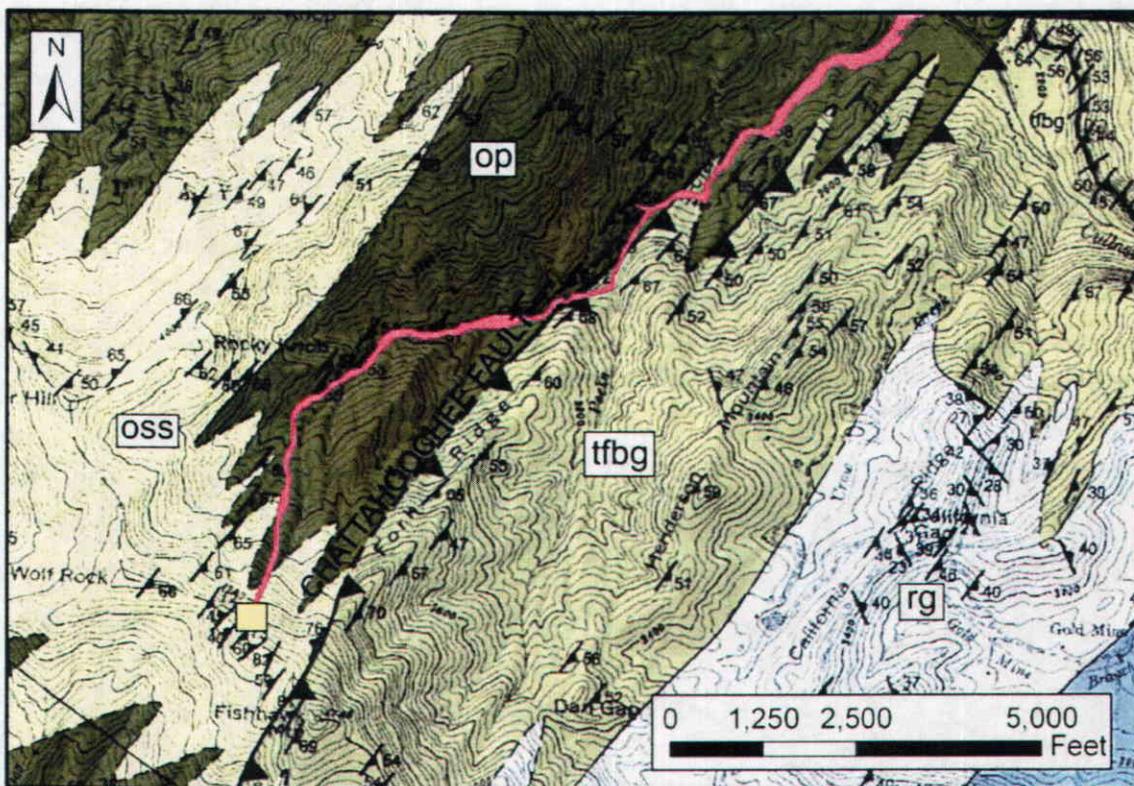
The Peeks Creek debris flow initiated in the Middle to Late Proterozoic metagraywacke and minor biotite-muscovite schist of the Otto Formation (figure 11) (Lamb, 2001). Two tonalite-trondhjemite dikes (figure 12) cross cut the metagraywacke in the source area of the debris flow. An exfoliation fracture oriented  $283-322^{\circ}/35-56^{\circ}$  NE defines the plane of failure in the headscarp. The debris flow then traveled through the biotite-muscovite schist dominated portion of the Otto Formation as well as the biotite gneiss and metagraywacke of the Tallulah Falls Formation. Multiple pegmatites are exposed along the track as well as amphibolites and minor metaconglomerates. Rock outcrops in the debris flow channel are freshly exposed (visually fresh state as defined by the Unified Rock Classification System (Williamson, 1984)). Foliation strikes northeast to southwest and dips  $80-90^{\circ}$  southeast to  $40-90^{\circ}$  northwest. Mesoscopic folds and ptygmatic veins are exposed along the whole length of the debris flow track.

**Figure 11.** Geologic map of the Peeks Creek slide area (from Lamb, 2001). Initiation zone indicated by yellow square, and track is outlined in pink. **Otto Fmn.:** **op** - biotite muscovite schist with minor metagraywacke, **oss** – metagraywacke with minor schist. **Tallulah Falls Fmn.:** **tfbg** - biotite gneiss and metagraywacke. **Rabun Granodiorite:** **rg** - megacrystic granodiorite.

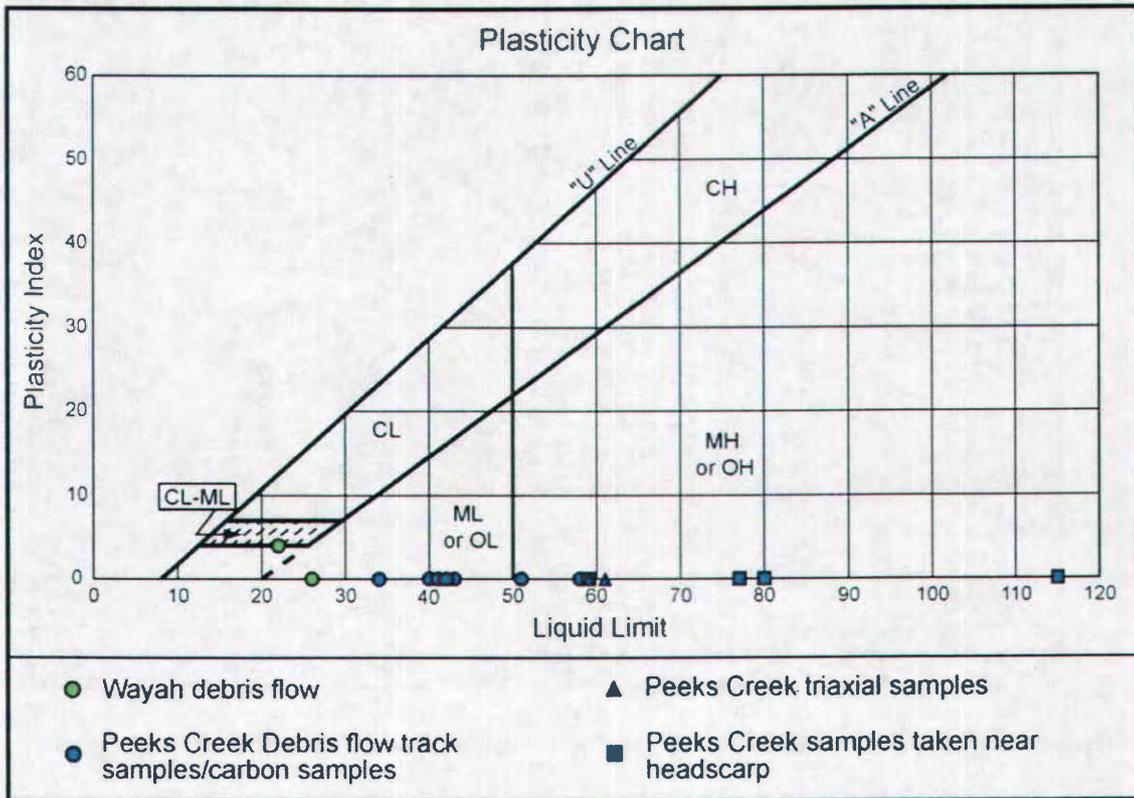
Surficial deposits vary along the length of the debris flow track. The USDA Soil Survey Map of Macon County (1996) defines the soil in the headscarp as the Cleveland-Chestnut-Rock outcrop complex which is comprised of sandy loam to cobbly sandy loam approximately 17-36 inches thick. Four soil samples were collected from the initiation zone (figure 13) for gradation, Atterberg, and triaxial tests. Results of the soil tests (figure 14) indicate that these samples are non-plastic, organic silty sand with low clay contents. The

**Figure 14.** Test results for the fine-grained portion (passing #200 sieve) of soils from two different debris flows in Macon County. The Peeks Creek soils have no measurable plastic limit while having high to very high liquid limit values.

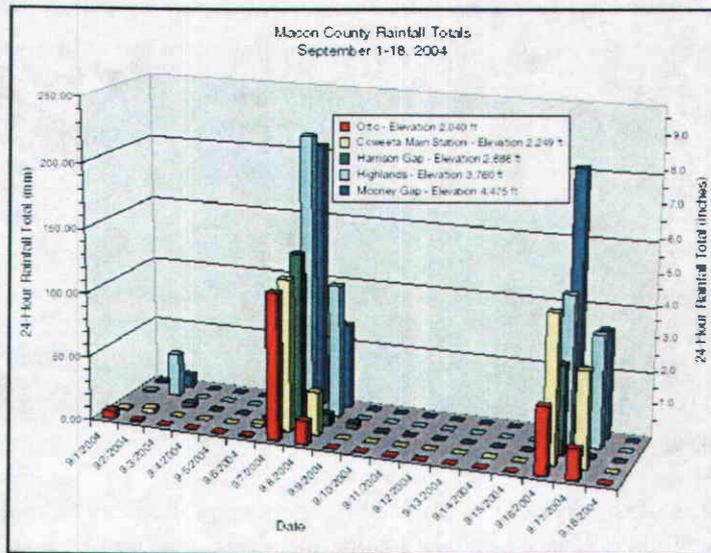
Elevation plays a role in precipitation amounts. Figure 17 shows a plot of precipitation versus time during the September hurricanes and rainfall measurements at various elevations throughout Macon County. The high elevation gauges recorded much higher precipitation amounts than the low elevation gauges, indicating that rainfall was higher at the initiation zone for the Peeks Creek debris flow (elevation 4,420 feet) than at the lower elevation rainfall gauges.

**Figure 17.** Rainfall totals collected from rain gauges at various elevations in Macon County over an 18-day period. Data from the U.S. Forest Service Coweeta Hydrologic Laboratory and the Integrated Flood Observation and Warning System.

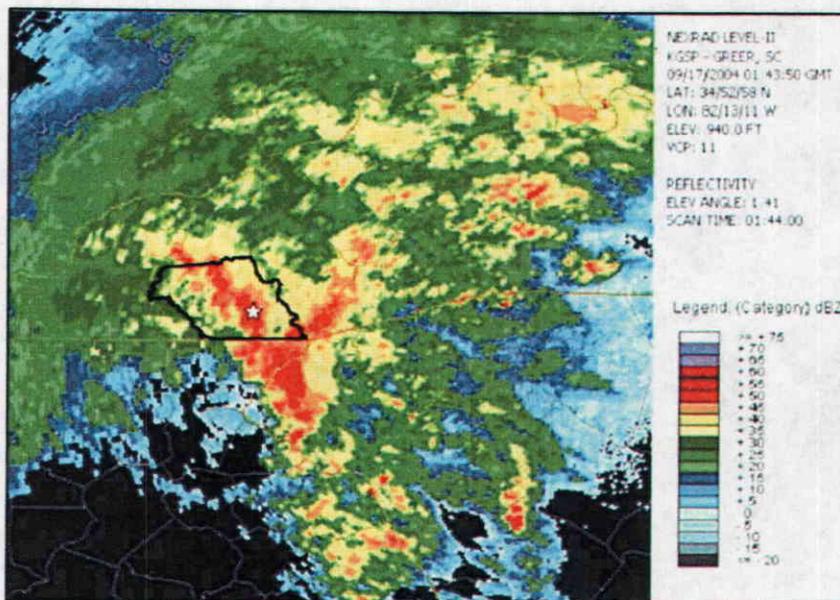
The National Weather Service (NWS) indicated that a spiral rain band within Ivan that contained intervals of deep vertical convection in thunderstorms that produced heavy rainfall. (figure 18) passed over Fishhawk Mountain at 9:48 p.m., approximately 20 minutes before the debris flow reportedly hit the Peeks Creek Community (Wooten *et al*, 2007).

**Figure 18.** KGSP WSR-88D 1.4° radar scan from the National Weather Service in Greer, SC showing heavy precipitation in spiral rain band crossing Macon County at 9:44 p.m. Precipitation intensity increases as reflectivity (dBZ) transitions from blue to red. The Peeks Creek debris flow indicated by the white star occurred at about 10:10 p.m. (from Wooten *et al.*, 2007).

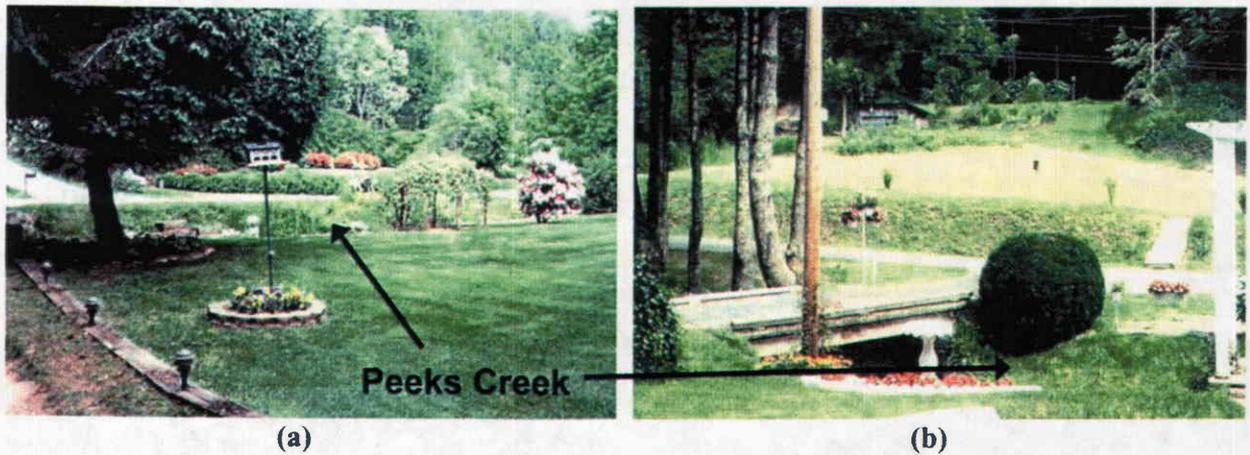
The residents of the Peeks Creek community describe the floodplain surrounding the creek as a “garden spot” before the September 2004 event. Many residents had built homes immediately adjacent to the Creek as shown by the photos of their front yards in figure 19.

**Figure 19.** Photos of the creek side yards of residences in the Peeks Creek community prior to the September 2004 debris flow. The bridge in (b) crosses the Creek. (Photos courtesy of Marilyn Jones)

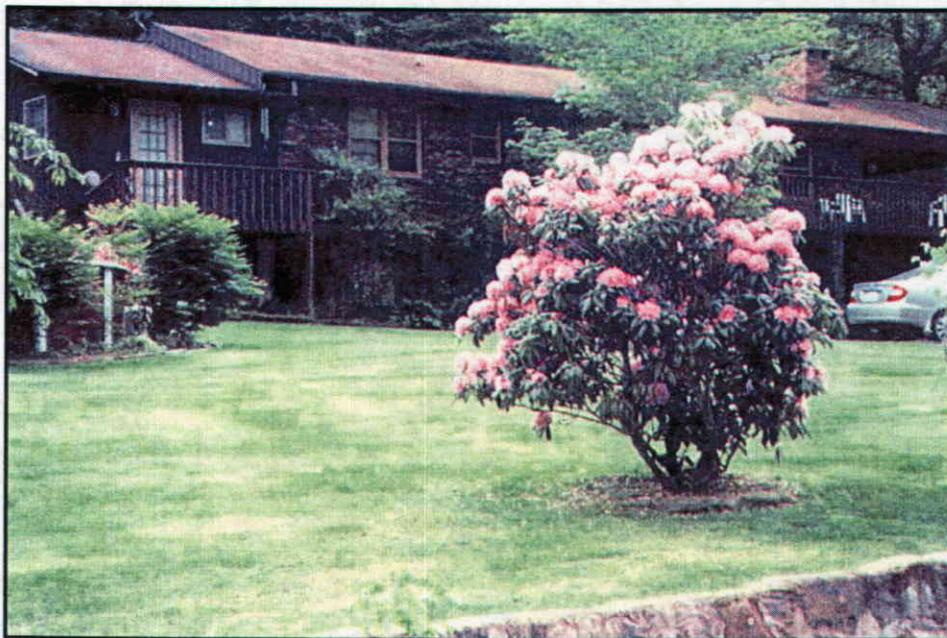
In figures 20 and 21 the residences of Wayne and Marilyn Jones (the brick house) and their neighbors (Larry and Nan Morris) are shown prior to the flood. Both houses were situated in the flood plain.

**Figure 20.** The Jones' residence adjacent to Peeks Creek. This photo was taken from Peeks Creek Road next to the creek. (Photo courtesy of Marilyn Jones)

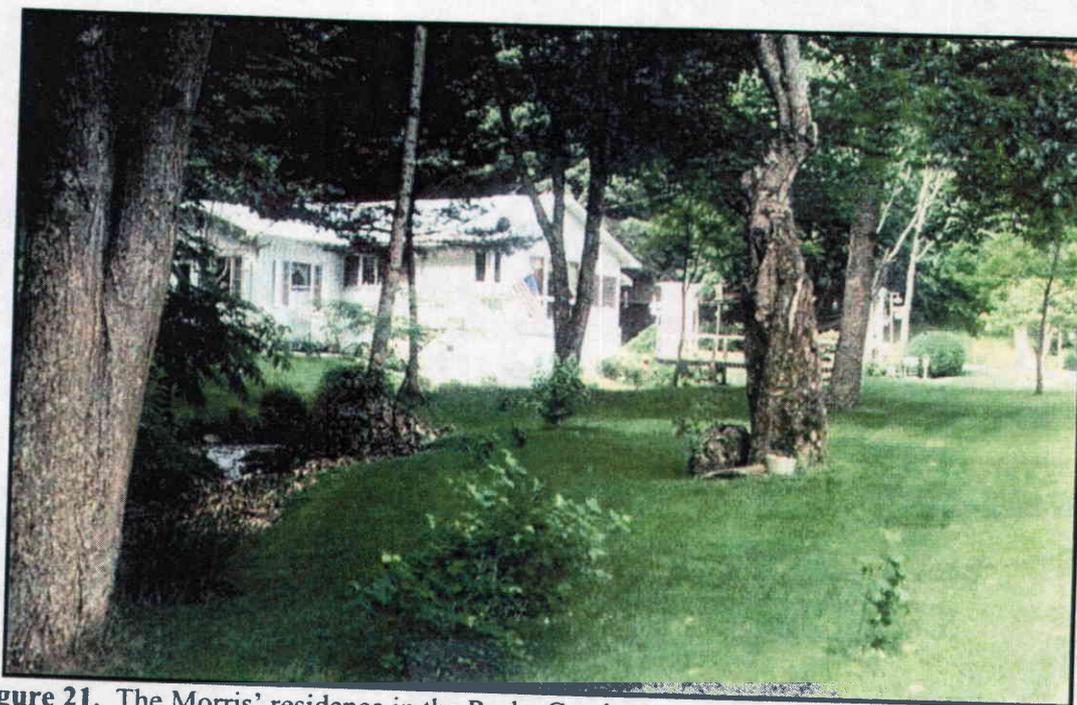
**Figure 21.** The Morris' residence in the Peeks Creek community prior to the debris flow. (Photo courtesy of Marilyn Jones)

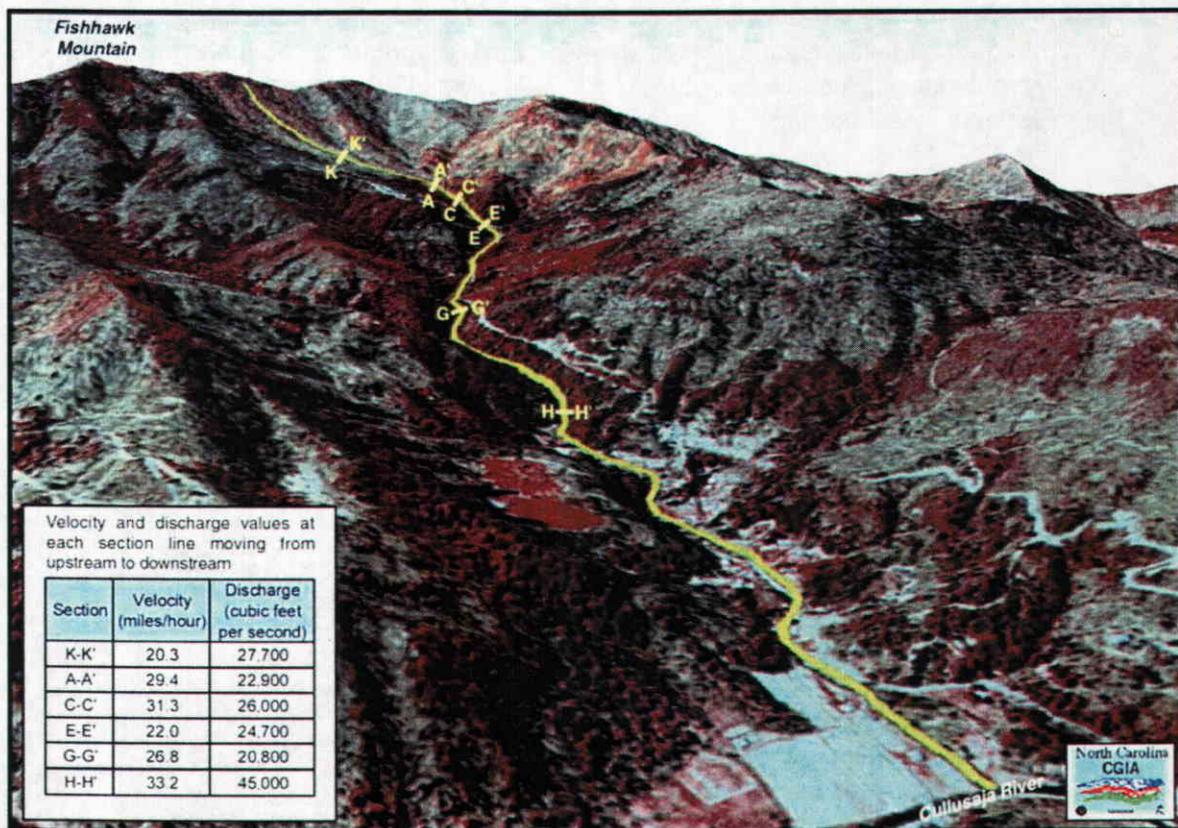
Estimates of velocity and discharge were calculated at six points along the debris flow track in order to gain a better understanding of why the debris flow was so destructive. According to Chen (1987), debris flows resemble hyperconcentrated stream flow and will bank as they travel around a curve in the channel. An estimate of velocity can be calculated given the radius of curvature of the stream channel, the superelevation angle of the material as it rounds the curve, the stream gradient, and acceleration due to gravity. If velocity is known, discharge can be calculated by multiplying the velocity times the cross-sectional area of the channel at that location (Fetter, 1994). Figure 32 shows the locations of the cross sections measured to calculate velocity and discharge and a table with the estimated values.

**Figure 32.** 3-D oblique view of a digital elevation model with a 1998 color-infrared digital orthophoto quarter quadrangle (DOQQ) superimposed. Shown are the locations of six cross sections measured by NCGS along the debris flow track to compute velocity and discharge estimates shown in inset table. Debris flow track is shown in yellow.

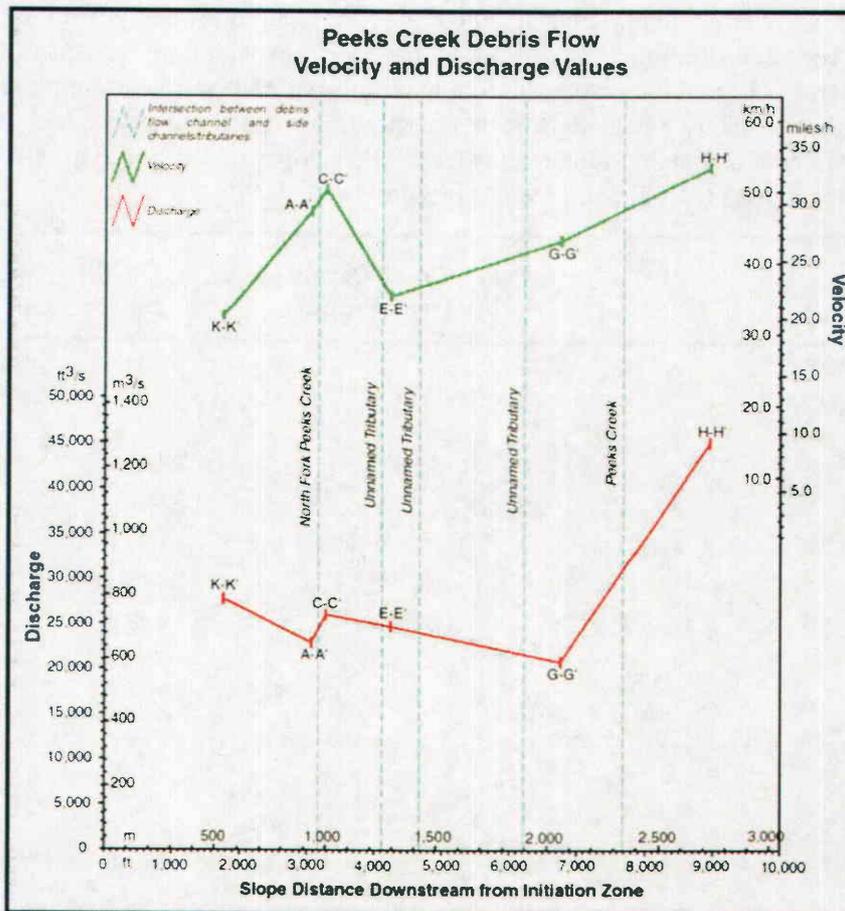
Velocity and discharge values vary along the debris flow track from the initiation zone down to the Peeks Creek community (figure 33). The minimum velocity calculated is 20.3 mph at section K-K', and the maximum velocity calculated is 33.2 mph at section H-H'. The minimum discharge calculated is 20,800 cfs at section G-G', and a conservative value for maximum discharge is 45,000 cfs at section H-H'. In comparison, the Pigeon River caused

**Figure 33.** Graph showing a plot of velocity (shown at top in green) and discharge (shown at bottom in red) versus slope distance from the initiation zone. Locations of section lines are shown on each line. Blue dashed lines indicate the locations of side channels that may have contributed significant flow to the debris flow.

Fluctuations in velocity can be attributed to variations in the stream channel gradient as well as to contributions of flow from side channels. The debris flow will decelerate along a lower gradient reach and deposit more material. Contribution from side channels could increase the velocity by increasing the flow and reducing the viscosity of the material, depending on the volume of flow in side channels. The main debris flow may have temporarily dammed some side channels, limiting their influence on the velocity of the material. The velocity at section K-K' (20.3 mph) is probably lower due to the relatively smaller amount of water present and its proximity to the initiation zone (i.e., it is just beginning to accelerate). The velocity decreases at E-E' to 22.0 mph, probably from a change in stream gradient, as the channel gradient flattens just upstream from this section line (figure 34). It most likely continued to decrease as evidenced by deposition in this flatter portion of the channel until just upstream of section G-G' (velocity here is 26.8 mph) where the debris flow transitioned into a narrower portion of the channel.

Discharge depends on the calculated cross sectional area of the debris flow and velocity. More scour will take place with higher velocity flow that can increase the cross sectional area. The depth to competent bedrock also dictates the amount of channel scour. Discharge is lowest at section A-A' (22,900 cfs) probably due to a flattening of the channel gradient (figure 34). Discharge increased at section C-C' (26,000 cfs) probably from the North Fork of Peeks Creek contribution. It continues to decrease downslope (minimum value of 20,800 cfs at section G-G') and then increases to a maximum of 45,000 cfs at section H-H' (figure 33). This is most likely due to significant contribution from the main channel of Peeks Creek, the steeper channel gradient, and steeper side slopes that produce greater amounts of runoff that increases the volume of water present.

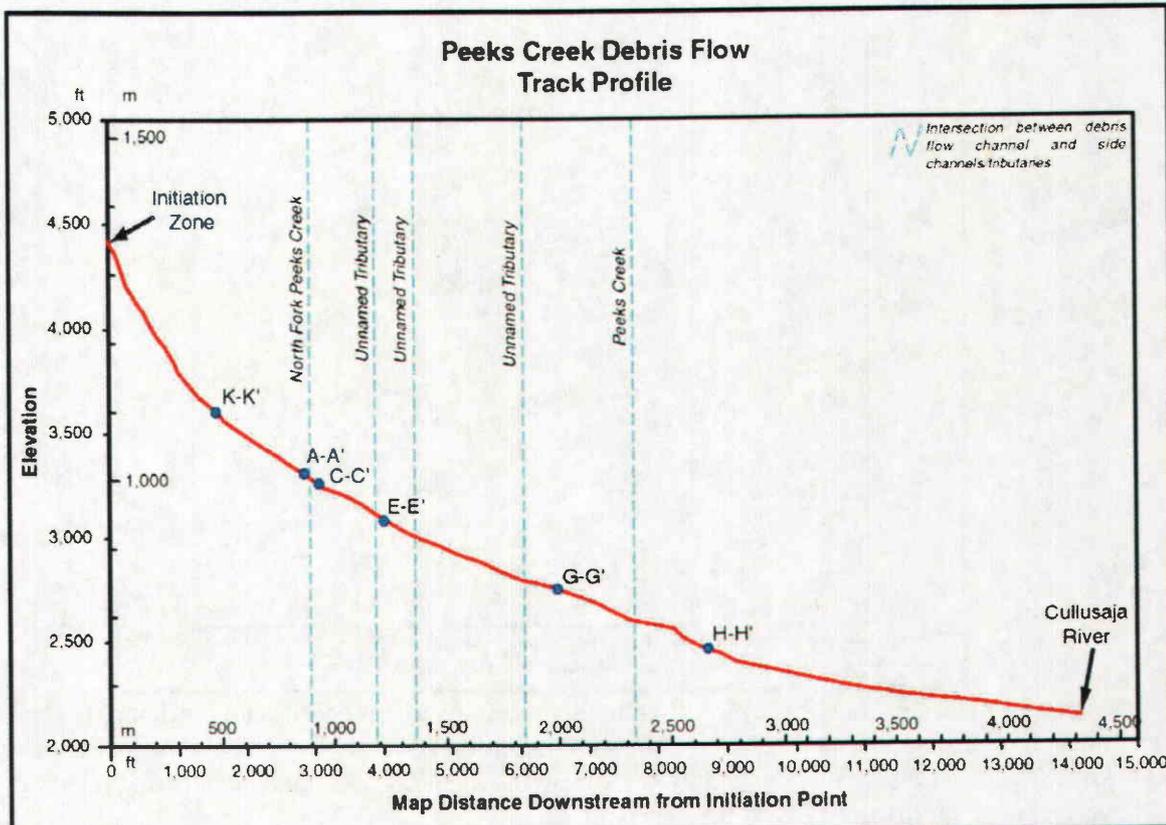
**Figure 34.** Graph of the debris flow track profile. Locations of section lines are shown by blue dots. Blue dashed lines indicate the locations of side channels that may have contributed significant flow to the debris flow. This could account for the fluctuations in velocity and discharge estimates. Vertical exaggeration used to show subtle changes in the channel gradient.

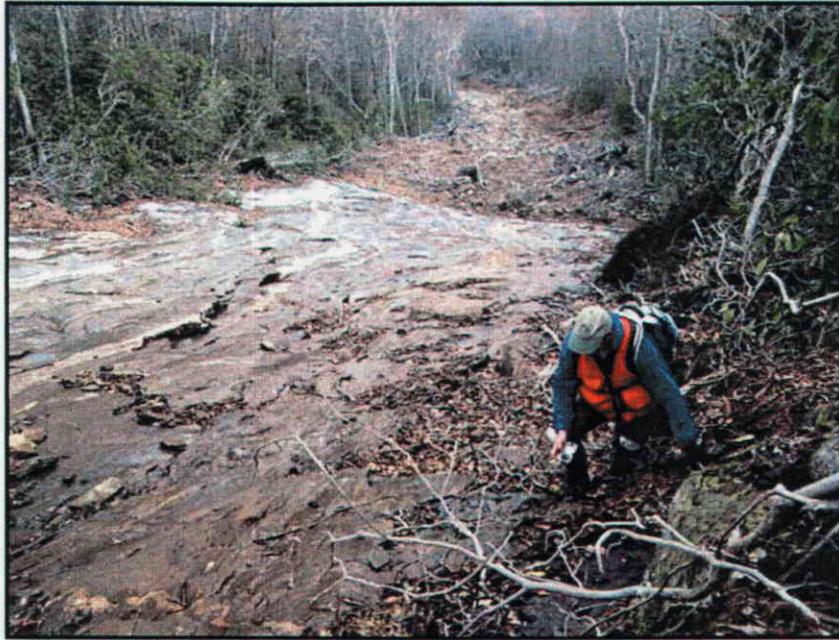
The extreme uphill part of the debris flow track ends at the headscarp where a debris slide initiated the debris flow. Before the slope failure, this area was heavily forested and no bare rock slope was exposed. The footing on the bedrock scar is quite slippery and climbing the rock is not recommended (figure 42).

**Figure 42.** Ken Gillon of the NCGS working his way up the side of the scar.

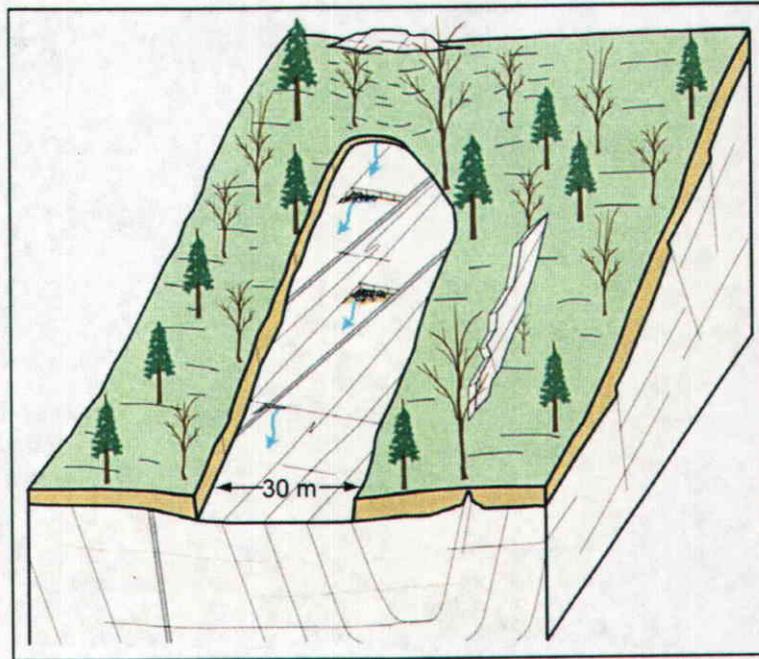
On the left side of the scar (if looking down from the top) is a nearly vertical foliation plane hidden in the trees (figure 43). The prominent horizontal fracture in the photo is an exfoliation plane; a similar type structure does not exist on the right side of the headscarp. The assumption is that slabs of rock were released along these fractures and created an exposed bedrock catchment. Over time the catchment accumulates soil and vegetation until an extreme rainfall event triggers a failure. The ~100 ft-wide by ~400 ft-long area that failed during Ivan is only a portion a larger colluvial catchment below the peak of Fishhawk Mountain (figures 1 and 44).

**Figure 44.** 3-D schematic of the September 16, 2004 (Ivan) Peeks Creek debris flow initiation zone within a large-scale colluvial catchment. Foliation and compositional layering in isoclinally folded bedrock strikes NE, subparallel to the long dimension of the scar. High-angle tectonic fractures strike NW, nearly orthogonal to foliation and compositional layering. Exfoliation fractures dip downslope 35°-53° and formed the slip surface between soil and bedrock. Blue arrows indicate areas of observed seepage. Dark grey bedrock features are thin (1 m thick) NE-striking, unfoliated tonalite-trondhjemite dikes.
