Evaluating Spent CCA Residential Decks for Second-life Products

Abstract: The amount of CCA treated wood being removed from spent residential decks is increasing at a tremendous rate. While most spent CCA treated wood is being disposed in landfills, further useful and environmentally beneficial alternatives have to be met. This research estimated the percentage of recoverable lumber from spent CCA decks that can be recycled into other usable products. Six residential decks were removed from service, by either demolition or deconstruction procedures. It was found that 86% of the CCA treated wood from the residential decks could be recovered as reusable CCA treated lumber. It was also found that deconstruction of a residential deck, rather than demolition, was not a factor in the volume of CCA treated wood recovered. Chemical and mechanical properties of the removed CCA treated wood were also analyzed. The chemical retention of the deck material proved that most of the spent CCA treated wood could be used in above ground applications. The stiffness of spent CCA treated wood from residential decks was approximately equal to that of recently treated CCA wood. The strength properties w

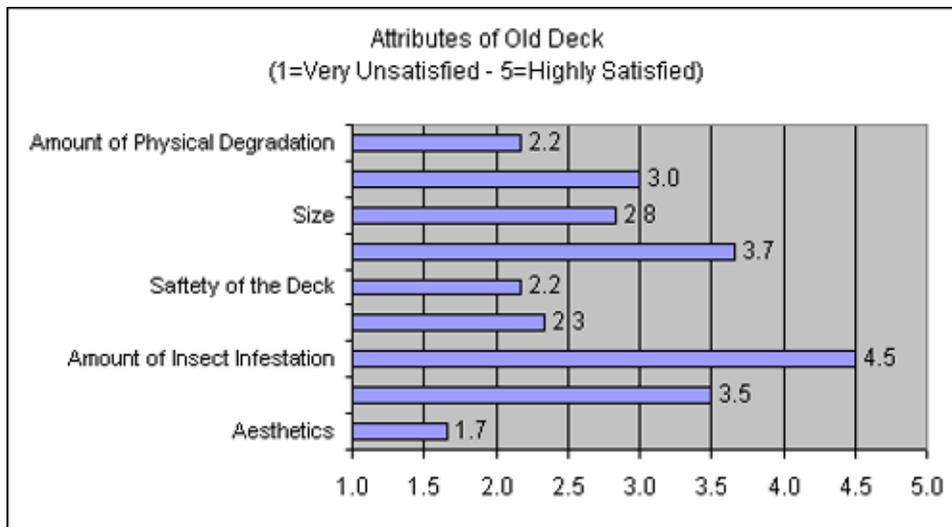
Figure 1. Deck owner's satisfaction level of removed deck attributes.

Several questions were asked of the deck owner regarding the reason for removal and attributes of the deck prior to removal. Not surprisingly, aesthetics, poor safety features, and physical degradation of the wood were listed as the top reasons for deck removal. The overall satisfaction level of the deck from the owners was low. Of the six decks obtained four owners claimed to be unsatisfied with the deck while the other two were satisfied. Another question asked the deck owner was who made the decision on the building material used to construct the new deck. Two-thirds of the owners indicated that the building contractor made the decision and the other third stated that they made the decision. The results of the questions were interesting because with all the negative press about the safety and environmental concerns with CCA treated wood most owners and building contractors still chose this material. Therefore, the research suggests that the cost of material, and possibly the ease of fabrication, is still a bigger factor than the possible negative side affects that environmental groups and the media have portrayed CCA treated wood to be associated with. The final question asked the deck owners to rate several attributes of the spent residential deck from a range of 1 (very satisfied) to 5 (very unsatisfied). The results of the question are displayed in Figure 1. The amount of insect damage, or lack there-of, was the highest rated attribute in terms of satisfaction. The deck owners rated overall deck construction and the lack of decay in the deck to be above average. Deck owners rated the aesthetics, amount of degradation, safety, and style of the deck as low in terms of their satisfaction. This indicated that the performance of the CCA chemical met the standards desired by the homeowners, but the quality of construction and the physical degradation of wood (i.e., warp, twist, bow, etc.) did not meet the homeowners desired level of expectation.

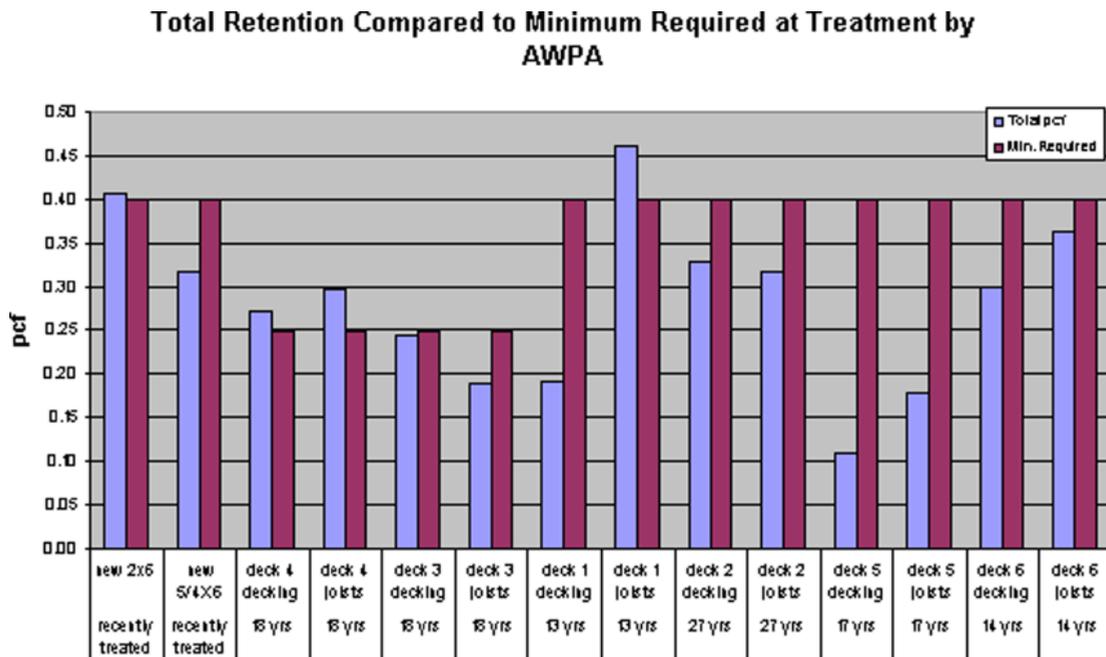
Figure 2. Retention of CCA in joists and decking from removed decks and recently treated wood.

A majority of retention levels from the chemical assay samples taken from the decking and joists of the residential decks were lower than the minimum standard required for recently treated wood, as shown in Figure 2. The chemical assay samples from the joists and decking from Deck No. 4 were above the minimum standards required by AWWA, as shown in Figure 3. Other than Deck No. 4, the decking samples used for chemical assay from Deck

The service time of the decks in this sample did not have an effect on the retention level. As seen in Figure 2 there appears to be no correlation between amount of time in service and retention levels lower than the minimum required. Other factors, such as the possibility of lower then required retentions during the pressure treatment process, and environmental conditions while the decks were in-service, could have had a larger influence on the retention of preservative treating chemicals.

From chemical analysis, the samples from the joists had, on average, a higher chemical retention compared to the samples from the decking of the six removed residential decks. The average retention of the chemical assay samples from the decking was .26 lb/ft³, and was .301 lb/ft³ from the joist samples. The joists chemical assay samples, on average, were approximately 87% of the original chemical retention after preservative treatment. The decking samples, on average, were approximately 73% of the original chemical retention after preservative treatment. Lack of physical and environmental exposure of the joists compared to the decking could have been factors in the difference in preservative chemical retention.

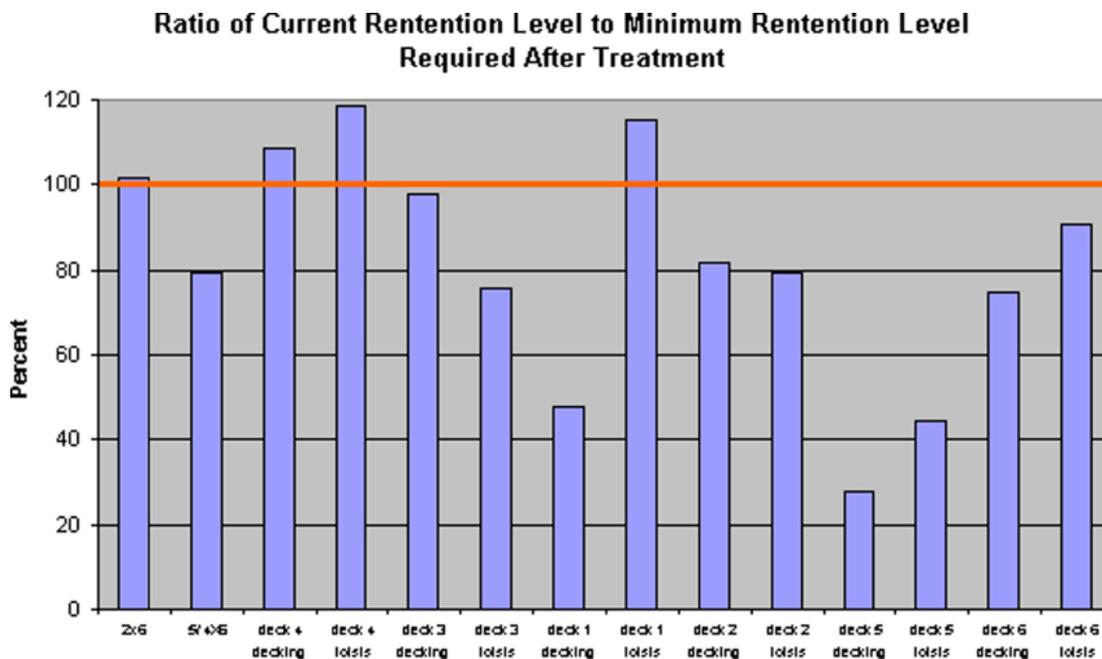
Figure 3. Ratio of minimum required at treatment and current retention of CCA.

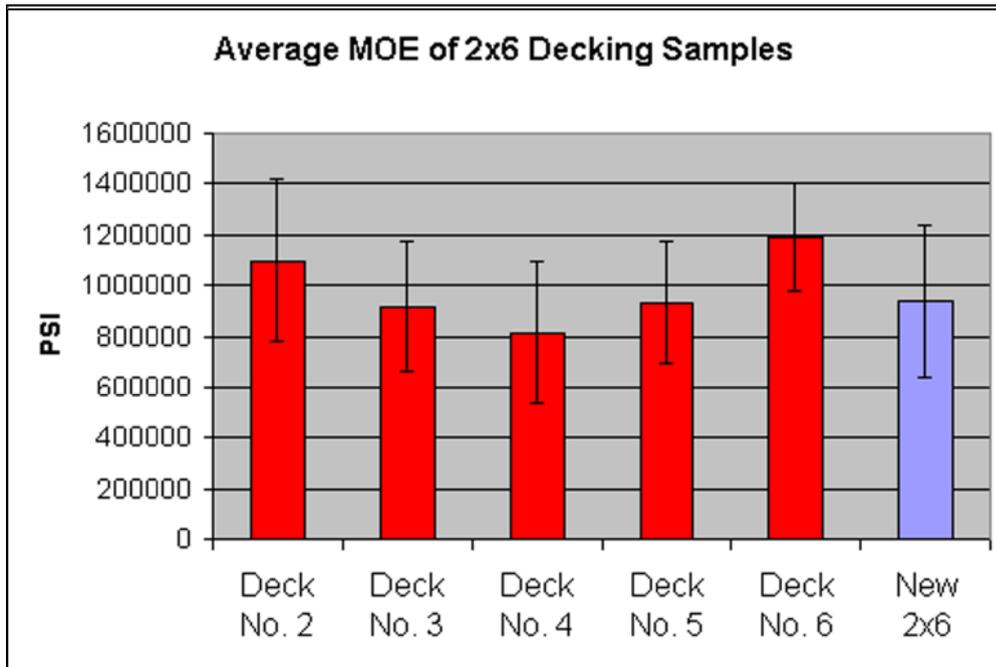
Figure 4. Average MOE values and distribution of 2x6 decking samples.

* Darker columns represent decking samples statistically equal or greater than recently treated 2x6s.

The MOE values from Deck No. 2, No. 3, No. 4, and No. 5 were found to be statistically equal to the recently treated wood, and the values from Deck No. 6 were found to be greater, as shown in Figure 4. The MOR values from Deck No. 6 and No. 2 were the only decks found to be statistically equal to the recently treated 2x6s, as shown in Figure 5. The decking for Deck No. 1 was composed of 5/4x6 RED, therefore this material was compared to recently treated 5/4x6 RED. The average MOE values from deck No.1 was 1.2×10^6 psi, and 1.3×10^6 psi for the recently treated 5/4x6 RED, which were found to be statistically equal. The average MOR values for Deck No. 1 and the recently treated 5/4x6 RED was 6,263 psi and 7877 psi respectively, were found to be statistically unequal.

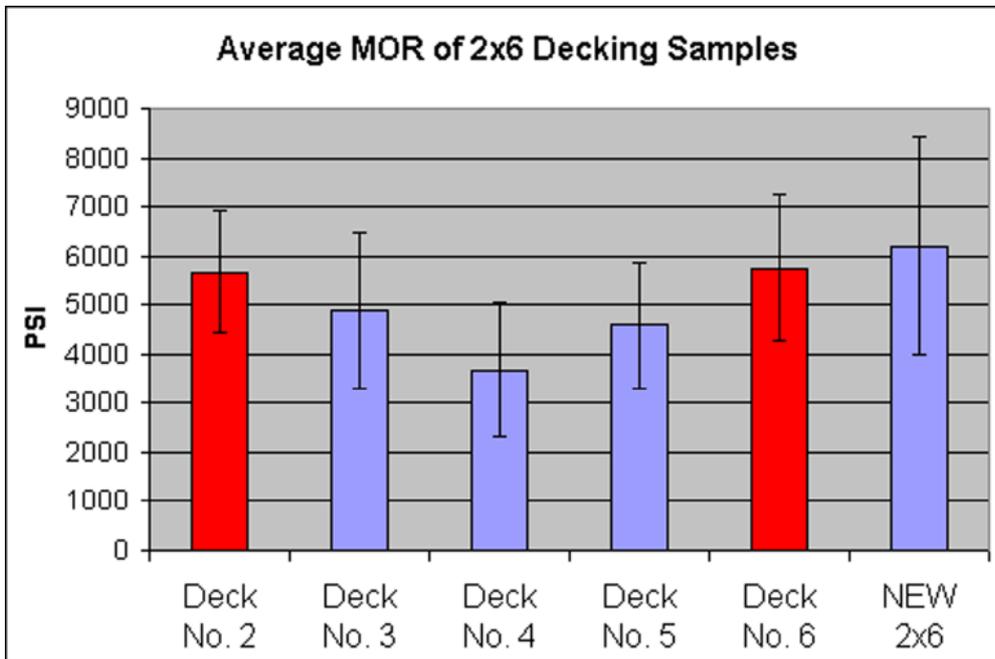
Figure 5. Average MOR values and distribution of 2x6 decking samples.

* Darker columns represent decking samples statistically equal or greater than recently treated 2x6s.

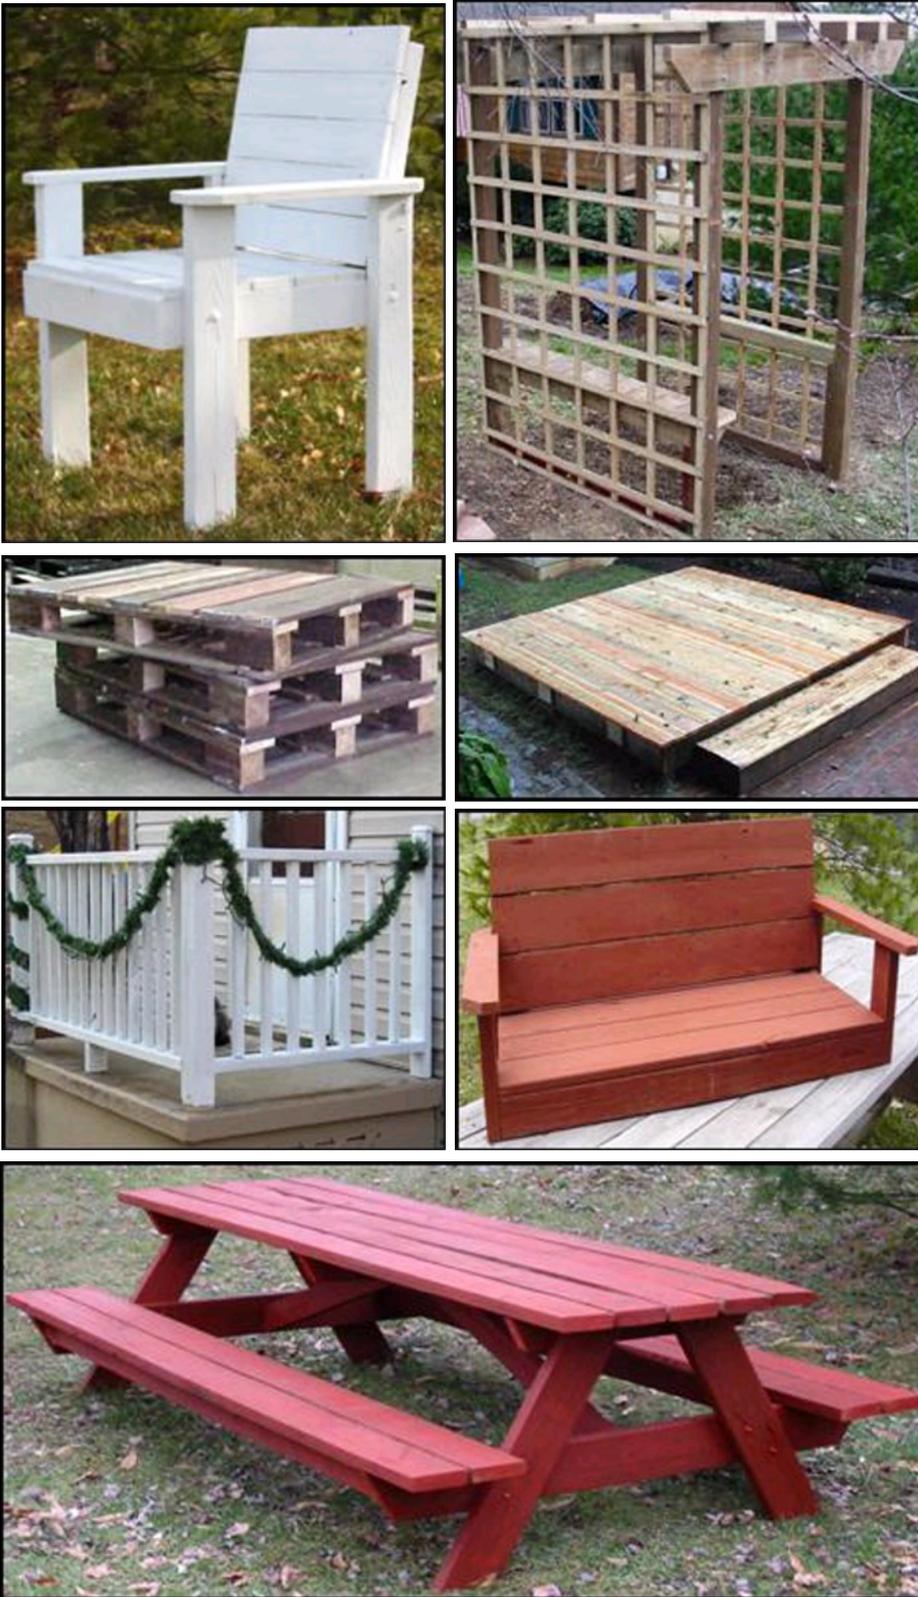
Figure 6. Products produced from recovered CCA treated wood. Outdoor chair (top left), Trellis (top right), Block Pallets (2nd row left), Deck (2nd row right), Railing (3rd row left), Swing (3rd row right), and Picnic Table (bottom).

Products were manufactured from the recovered CCA treated wood of residential decks. Products were chosen that were practical, easily fabricated, required little carpentry training or skill, and a small number of fairly inexpensive tools. Table 6 displays the products made, material and hardware used, cost of the hardware, and man-hours needed to build the products. Several other products can also be made, including walking bridges, trail guides, signposts, and other landscaping components. Several products produced during this study are shown in Figure 6. The material used the most to produce these products was 2x4s, 2x6s and 1x6s. It was found that the highest recovered volume of a deck is 2x6 lumber; therefore it is beneficial that products can be made from this material. Feasible products that utilize 2x8 material or joists from old deck need to be found, in order to recycle the high volume of 2x8 lumber being removed from residential decks.
