Repair & Reinforcing Pallet Stringers With Metal Plates

By J.W. Clarke, T.E. McLain, M.S. White, and P.A. Araman

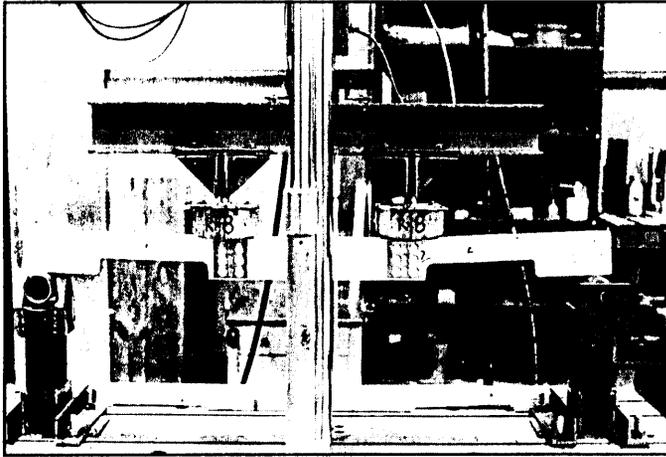
Figure 2:
Test setup used to determine the bending strength and stiffness of stringers. This stringer is reinforced with plug-type MCPs.

One substudy examined the relative performance of different styles of MCPs for repair of the very common between notch (BN-type) failures. The six BN study plates are described in Table 1. Examples of plug and slot-type pallet plates are shown in test specimens in Figures 2 and 4. First six identical groups of 1-1/2" wide, notched oak stringers (30

pieces in each group) were tested in bending similar to stringers in pallets racked across the stringers (RAS). Each group had the same average initial bending strength. The broken stringers were then repaired, each group with a different plate type, according to NWPCA guidelines. The repaired stringers were then retested and repaired performance (RP) determined. This bending test is shown in Figure 2.
