McCullough, M.C., D.E. Eisenhauer, M.G. Dosskey, and D.M. Admiraal. 2006. Hydraulic characteristics of beaver dams in a Midwestern U.S. agricultural watershed. Paper No. 14917. In: Proceedings of the World Environmental & Water Resources Congress, May 21-25, 2006, Omaha, NE. American Society of Civil Engineers, Reston, VA. (Refereed Paper)

Hydraulic Characteristics and Dynamics of Beaver Dams in a Midwestern U.S. Agricultural Watershed

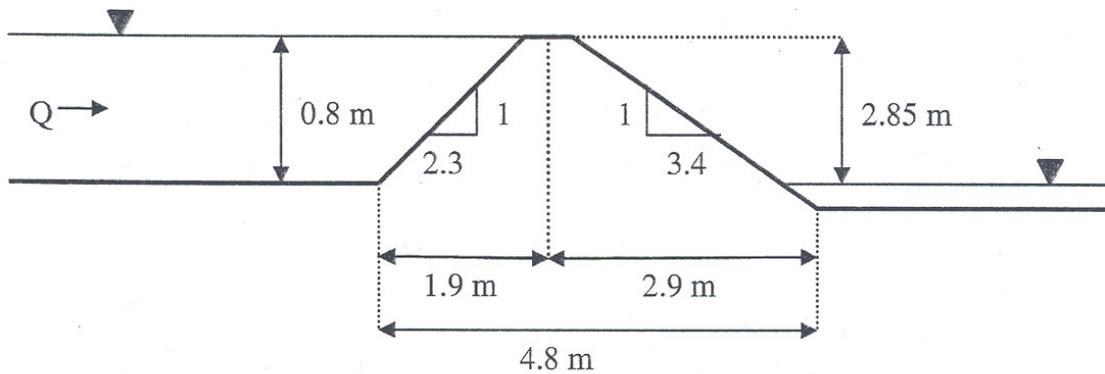
Figure 1. Representation of the side profile of a beaver dam on Little Muddy Creek.
Drawing is not to scale.

A replica beaver dam was constructed in the laboratory based on the survey of a beaver dam on Little Muddy Creek (Figure 1). Actual dimensions of the beaver dam were replicated in the laboratory, with the exception of the actual dam width. The laboratory channel was 0.91 m wide, while the actual beaver dam surveyed was 3.7 m wide. The replica beaver dam consisted of a pressure-treated plywood structure installed into the laboratory channel. The smooth plywood simulates the smooth mud surfaces on the upstream slope of beaver dams that we observed. Sticks from actual beaver dams in the field were collected and attached to the plywood replica dam to mimic roughness observed in the field. They were fastened to the dam with small wire.

Field observations and photos were used to mimic the structure of the sticks on the dam. Larger diameter sticks were first attached to the bottom of the downstream face of the dam with gradually smaller diameter sticks being attached while working up the downstream dam face. The pattern of stick attachment was similar to shingling a roof, with the sticks on the top of the dam covering the sticks further down the dam on the downstream face. No sticks were attached to the upstream face of the dam, replicating the smooth mud surface of the beaver dams observed in our watershed.

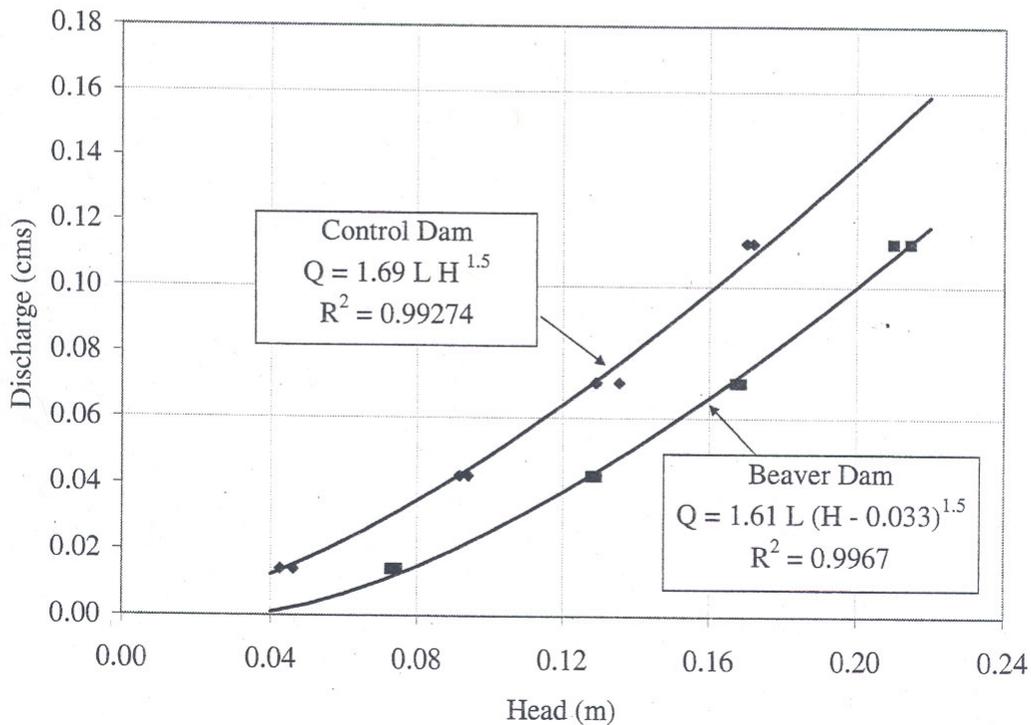
Figure 2. Rating curves for control dam and simulated beaver dam.

When compared to the smooth dam, the replica beaver dam showed an increase in water surface elevation for each of the four flow rates (Figure 2). This increased water surface elevation was approximately 30 cm for the lowest flow rate and 60 cm for the highest flow rate. The rating curve fitted for the control dam was: $Q = CLH^{3/2}$, where $C = 1.69 m^{1/2}/s$. The rating curve for the replica beaver dam was $Q = CL(H - H_0)^{3/2}$, where $C = 1.61 m^{1/2}/s$ and $H_0 = 0.033 m$.

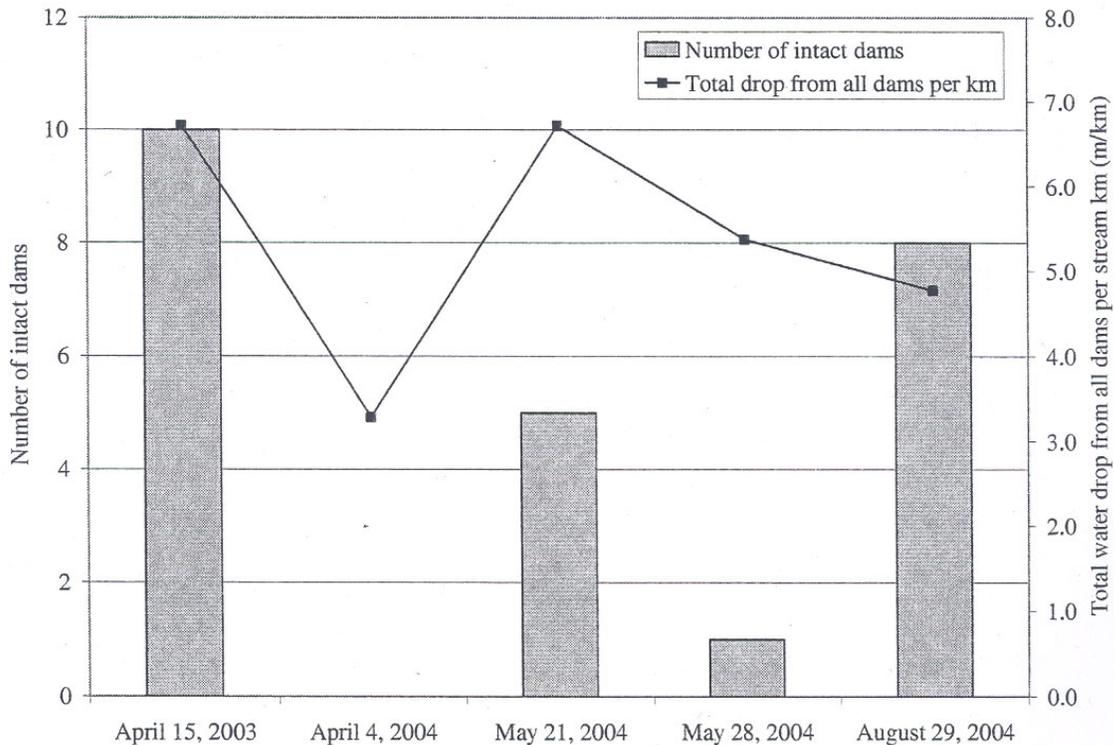
Figure 3. Number of intact beaver dams over the survey period and impacts of the beaver dams on water drop.

The field surveys of beaver dams showed a wide variation in hydraulic status of individual dams over the period from 2003 to 2005 (Figure 3). Dam integrity was seen to be compromised by storm runoff and general decline due to abandonment of the area by beavers. Dams that were damaged by increased storm runoff were not consistently repaired by beavers and repair may vary seasonally, however data is limited in making an assessment of seasonal beaver activity. The total water level drop per stream kilometer tended to correlate with the number of intact dams with the exception of the August 29, 2004 survey, when the number of intact dams increased while the total drop/km decreased. This data suggests that although the number of dams that were repaired had increased, they had not rebuilt to previous heights. This may be due to beavers abandoning the area or decreased dam building activity during the summer months.
