Wood Performance in Doorways of Single-Family Houses

THOMAS W. POPHAM, RODNEY C. DeGROOT, AND RONALD W. HOWE

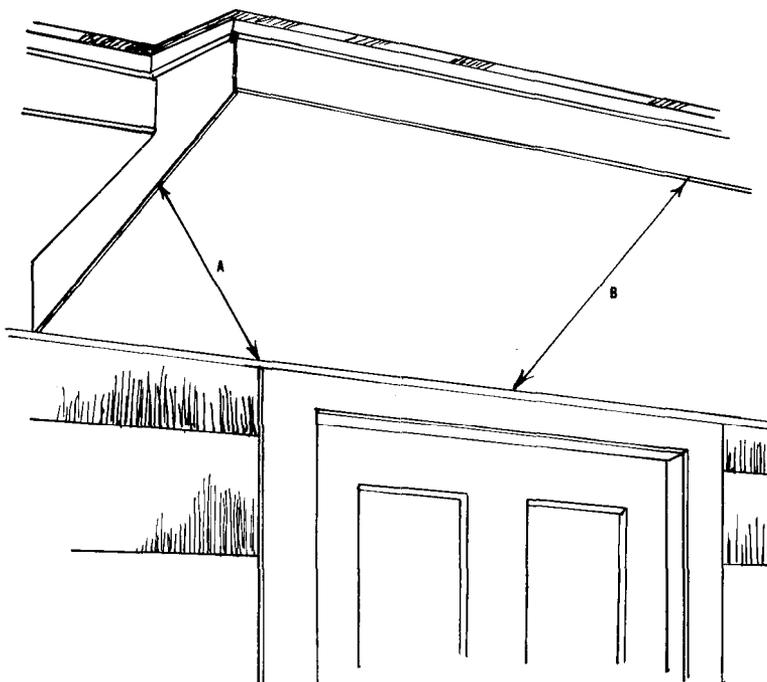
Figure 1 .-Measurement of overhang at doorways: A, Overhang distance to nearest edge from doorway; B, Overhang distance to edge directly in front of the doorway. In some instances A and B are the same.

Doors were divided into four groups by direction faced. An analysis of covariance, with distance to the edge of the overhang as covariate, was made to determine if the directions doors faced affected their moisture content. Moisture contents at the locations around the door were regressed against the distance

to the edge of the roof in front of the door and against the minimum distance to the edge of the overhang for each group of doors and all doors combined. A second degree polynomial was suggested by the assumption that at some point increasing the overhang offers no additional protection.

The average distance to the edge of the roof directly before the doorways was 57 inches. The average minimum distance to edge of roof overhang above the doorways was 49 inches. Regression analyses of the relationships between distance to edge of roof overhang and wood moisture content never explained more than 5 percent of the variation in observed wood moisture contents.

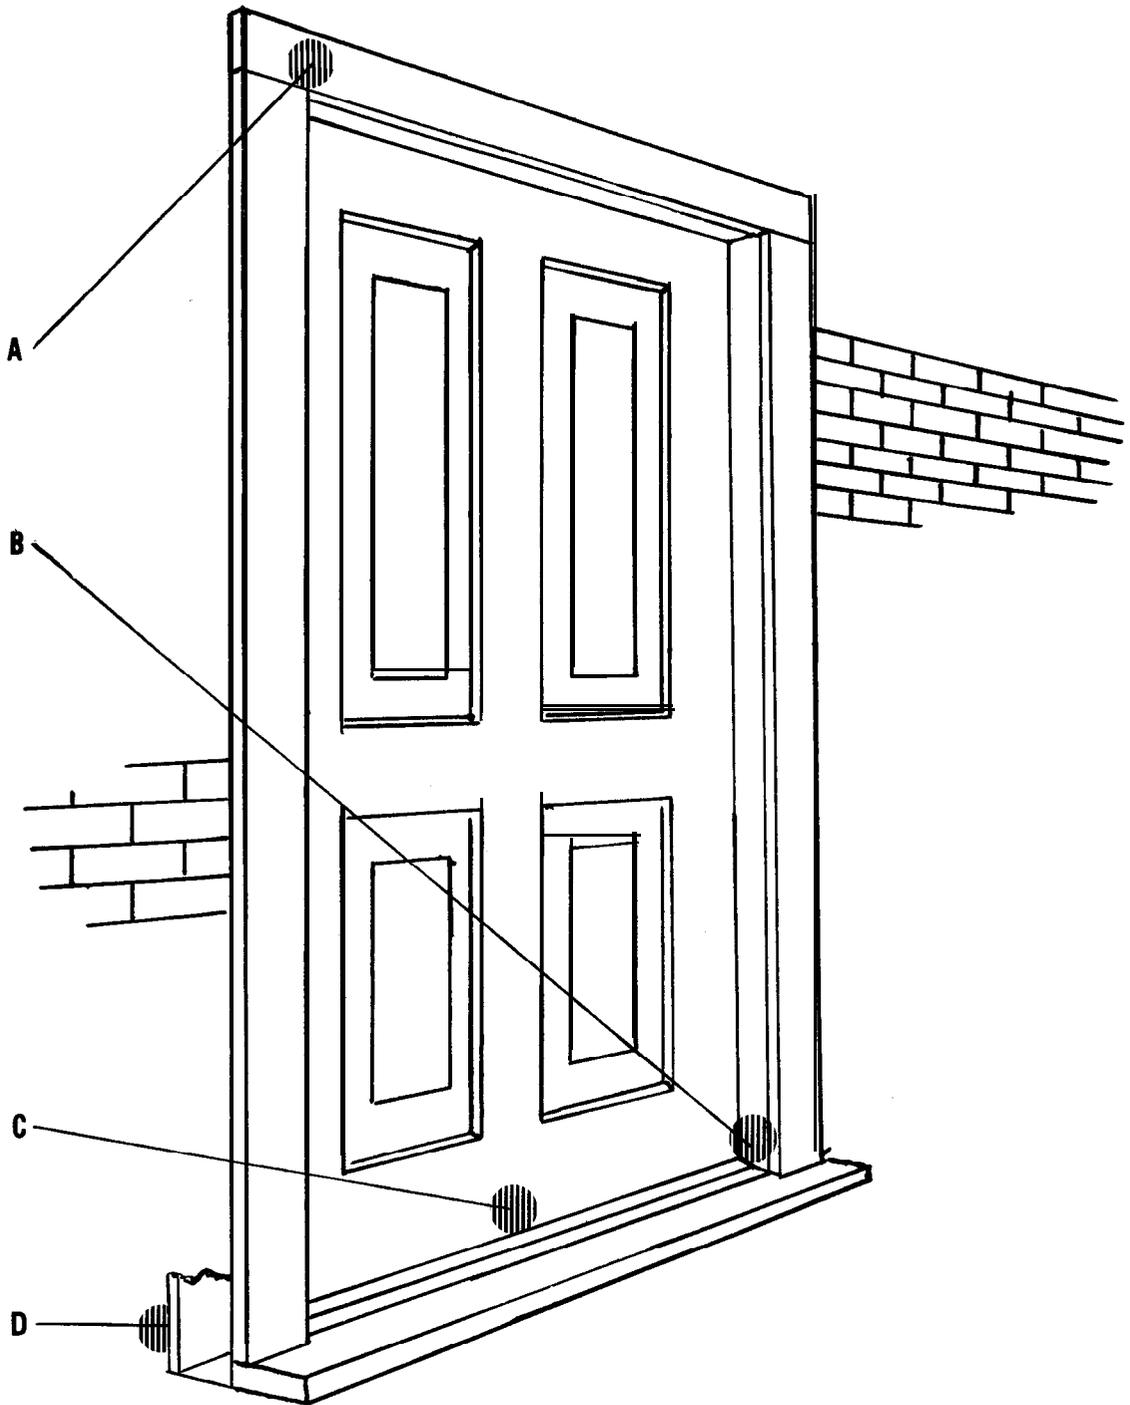
Figure 2.—*Moisture content measurements in doorway area; A, Top of the exterior casing; B, Exterior base of the jamb; C, Exterior bottom of the door; D, Base of the interior casing.*

The average wood moisture content of the frames was 11 percent (Standard deviation = 1.84) at the top of the exterior casing, 13 percent (sd. = 6.04) at the

exterior base of the jamb, and 15 percent (sd. = 7.58) at the base of the interior casing. The consistency of wood moisture contents at the top of the exterior casing is the result of the protection the roof overhang

affords to this part of the doorway. Moisture content at the top of the exterior casing was never above 30 percent, but in nine houses, either the exterior base of the jambs or the interior casing had moisture con-
