# MONITORING SEDIMENT PRODUCTION FROM FOREST ROAD APPROACHES TO STREAM CROSSINGS IN THE VIRGINIA PIEDMONT

Kristopher R. Brown, W. Michael Aust, and Kevin J. McGuire<sup>1</sup>

**Abstract**--Reopening of abandoned legacy roads is common in forest operations and represents a reduced cost in comparison to new road construction. However, legacy roads may have lower road standards and require additional best management practice (BMP) implementation upon reopening to protect water quality. Silt fences and elevation measurements of trapped sediment were used to quantify annual sediment delivery rates for reopened bare and existing gravel forest road approaches to stream crossings in the Virginia Piedmont. Additionally, rainfall simulation experiments were performed on reopened legacy road stream crossing approaches to quantify the cost-effectiveness of a range of gravel surface coverage for control of total suspended solids (TSS) concentration from road surface runoff during storm events. In the sediment trap study, mean annual sediment delivery for the reopened bare approaches ( $98 \text{ Mg ha}^{-1} \text{ year}^{-1}$ ) was 7.5 times greater than that of the gravel approaches ( $13

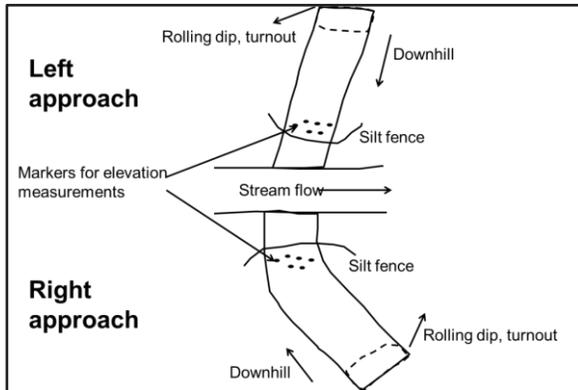
Figure 1--Plan view of the sediment trap study plots and instrumentation.

were not immediately connected to stream channels. Where cut and fill road profiles existed, in-sloping and outboard edge berm installation were used to redirect all runoff and sediment to the base of the plot, where silt fences were installed across the entire width of the running surface (and ditch, if applicable) to trap all sediment from the road prism, similar to the method suggested by Robichaud and Brown (2002) (fig. 1). Silt fences were also installed at the base of three culvert crossing approaches on a graveled road that was constructed in November 2010. Finally, silt fences were installed at the base of a legacy gravel road approach to a culvert crossing that was reshaped with a bulldozer blade and re-graveled. Reshaping included in-sloping to the cutbank on the backslope portion of the hillslope and crowning at the toeslope. The treatments resulted in five bare and four graveled road segments.

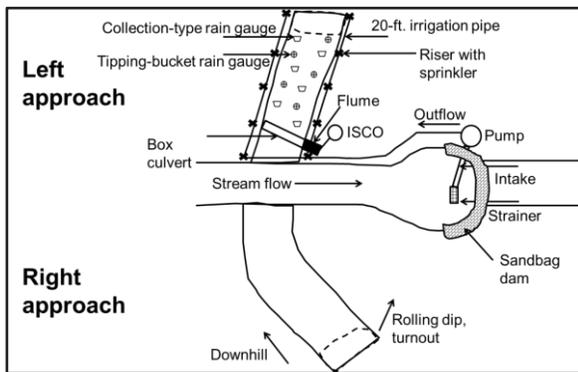
Figure 2--Plan view of the rainfall simulation study plots and instrumentation.

A high-pressure pump with an 18-horsepower gas-driven engine and a maximum flow rate of 37.9 L/second was used to pump source water for the rainfall simulation experiments from temporary impoundments that were created approximately 50 m downstream of each stream crossing (fig. 2). The irrigation setup included a 10.2-cm intake hose with a strainer, a 7.6-cm outflow component, and fire hose to connect to

7.6-cm aluminum irrigation pipelines that ran parallel to the road approach and on both sides of the road. A 3.0-m pipe and 90° angle couplings joined the two parallel segments of pipe at the base of the road plot. The pipelines ran on each side of the road surface and consisted of 6.1-m irrigation pipes that were coupled together for the length of the approach. A water control structure and open-top box culvert served as the upper and lower boundaries of the road approach plots, respectively. Similar to the silt fence study plots, in-sloping and outboard edge berm installation were used to redirect all runoff and sediment to the box culverts at the base of the plots. Quick coupling risers with sprinkler heads were located at 6.4-m intervals along the study plots, and they stood 3.4-m high. The same irrigation pipe and risers were used previously in rainfall simulation experiments to test agricultural BMP effectiveness to minimize soil erosion during rain events (Dillaha and others 1988). The irrigation setup is designed to apply rainfall to the study plots at a rate of 5.1 cm hour<sup>-1</sup>. A series of three rainfall simulation experiments, ranging in length from 10 to 50 minutes, were performed for each treatment (Bare, Gravel 1, and Gravel 2) for each of the six road approach study plots for a total of 3 x 3 x 6 = 54 rainfall simulation experiments.

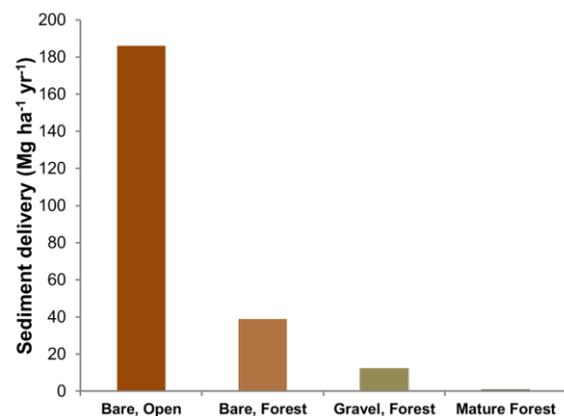
Figure 3--Mean sediment delivery rate ( $\text{Mg ha}^{-1} \text{ year}^{-1}$ ) by road surface type (bare, gravel) and forest canopy cover (open, forest) as compared with typical erosion rates in a mature forest setting. Canopy cover during the growing season and litterfall during the fall and winter seasons helped to reduce bare soil percentages, and thus sediment delivery rates at the "Bare, Forest" sites.

**Sediment trap study**--Total rainfall during the study period (August 5, 2011 to August 5, 2012) was 1495 mm. Mean annual sediment delivery for the reopened bare approaches ( $98 \text{ Mg ha}^{-1} \text{ year}^{-1}$ ) was 7.5 times greater than that of the gravel approaches ( $13 \text{ Mg ha}^{-1} \text{ year}^{-1}$ ). Problem road approaches were associated with inadequate water control ( $> 75 \text{ m}$  intervals for water control structures) and 90 to 100 percent bare soil conditions throughout the year. Reopened bare road approaches having both forest canopy cover during the growing season and litterfall ground coverage during the fall and winter months had lower sediment delivery rates than bare approaches located in a clearcut area

with 4-year-old loblolly pine regeneration (fig. 3). Median sediment delivery per measurement period was  $2.0 \text{ Mg ha}^{-1}$  for the bare plots and  $0.3 \text{ Mg ha}^{-1}$  for the gravel plots (Chi-square statistic = 22.2, d.f. = 1,  $p < 0.0001$ ). These findings exemplify the importance of proper implementation of water control and gravel surfacing BMPs to minimize direct inputs of surface runoff and sediment from forest road approaches to stream crossings. For haul roads, the Virginia Department of Forestry BMP manual recommends that gravel surfacing be used to cover the entire road approach that is delivering sediment to the stream and to redistribute stormwater runoff from the road surface and out over a well-vegetated or rough surface at least 7.6 m before the stream crossing (VDOF 2011).

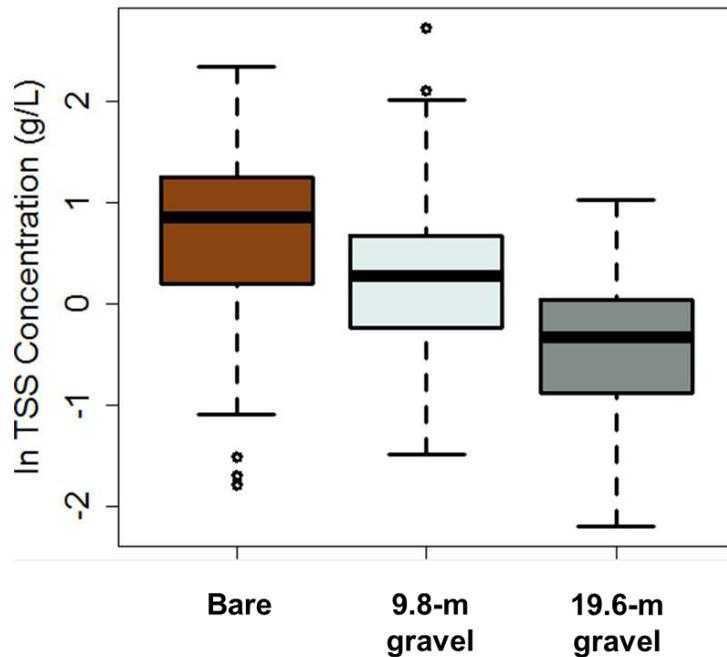
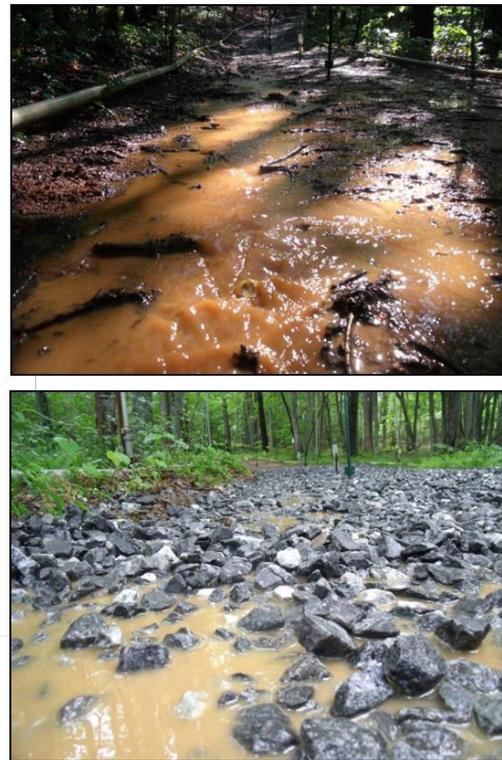
Figure 4--Box and whisker plots (showing the 5<sup>th</sup>, 25<sup>th</sup>, 50<sup>th</sup>, 75<sup>th</sup>, and 95<sup>th</sup> percentiles) of natural log-transformed TSS concentration of surface runoff ( $\text{g L}^{-1}$ ) for all of the rainfall simulation experiments by treatment type (Bare, Gravel 1, and Gravel 2). N = 228, 222, and 231 for the Bare, Gravel 1, and Gravel 2 treatments, respectively.

**Rainfall simulation study**--Simulated rainfall events had recurrence intervals of  $< 1$  to 5 years for Critz, VA. Surface runoff was commonly generated within the first 5 minutes of the onset of rainfall. Gravel application reduced TSS concentration of surface runoff from the road approach study plots (fig. 4). Median TSS concentration of road surface runoff ( $g \text{ L}^{-1}$ ) for the Bare treatment rainfall simulations ( $2.34 \text{ g L}^{-1}$ ; 90 to 100 percent bare soil conditions) was 1.8 times greater than Gravel 1 ( $1.32 \text{ g L}^{-1}$ ; 25 to 50 percent gravel surface coverage) and 3.3 times greater than Gravel 2 ( $0.72 \text{ g L}^{-1}$ ; 50 to 100 percent gravel surface coverage). All treatments were significantly different (Bare  $>$  Gravel 1  $>$  Gravel 2).
